St Francis Xavier Rectory Update

Summary of observations of the
Rectory at 26 Chestnut Land
Road, New Milford

St Francis Xavier Parish Rectory

- 26 Chestnut Land Road, New Milford
- Built in 1810; 3900 square feet
- Not on New Milford Historical Registry

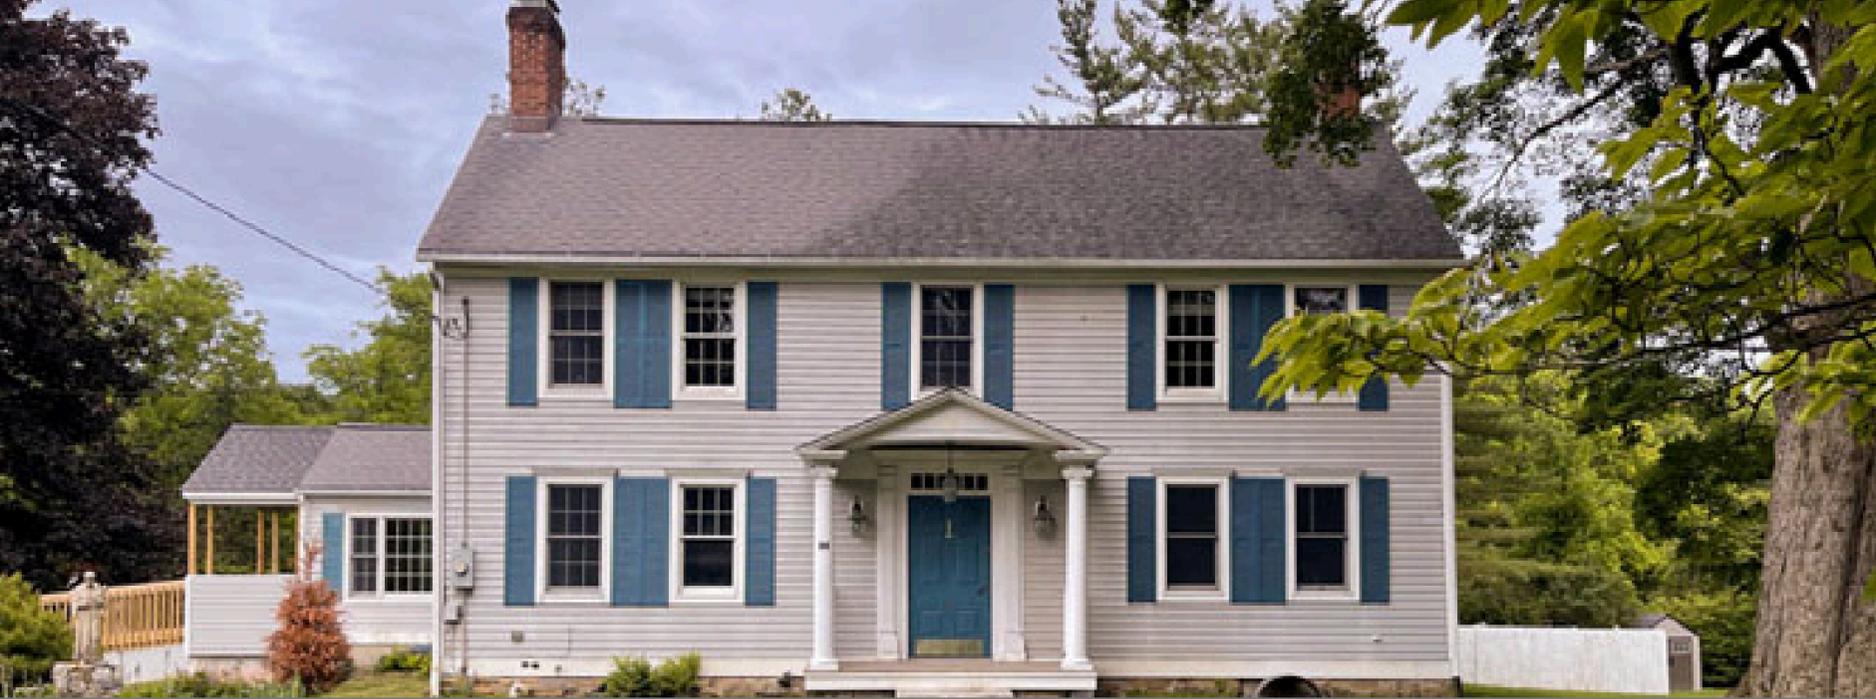
- Due to settlement of foundation, the 1st and 2nd floor is sloping creating a falling hazard for occupants
- Several iterations of floor finishing have rotted and been superficially replaced by plywood
- The stairways are not ADA compliant, therefore, requiring near-term ADA remediation to enable certificate of occupancy
- Bathrooms also require near-term ADA remediation
- A contract with a structural engineer will be required to evaluate all existing framing for recommendations for repair or replacement

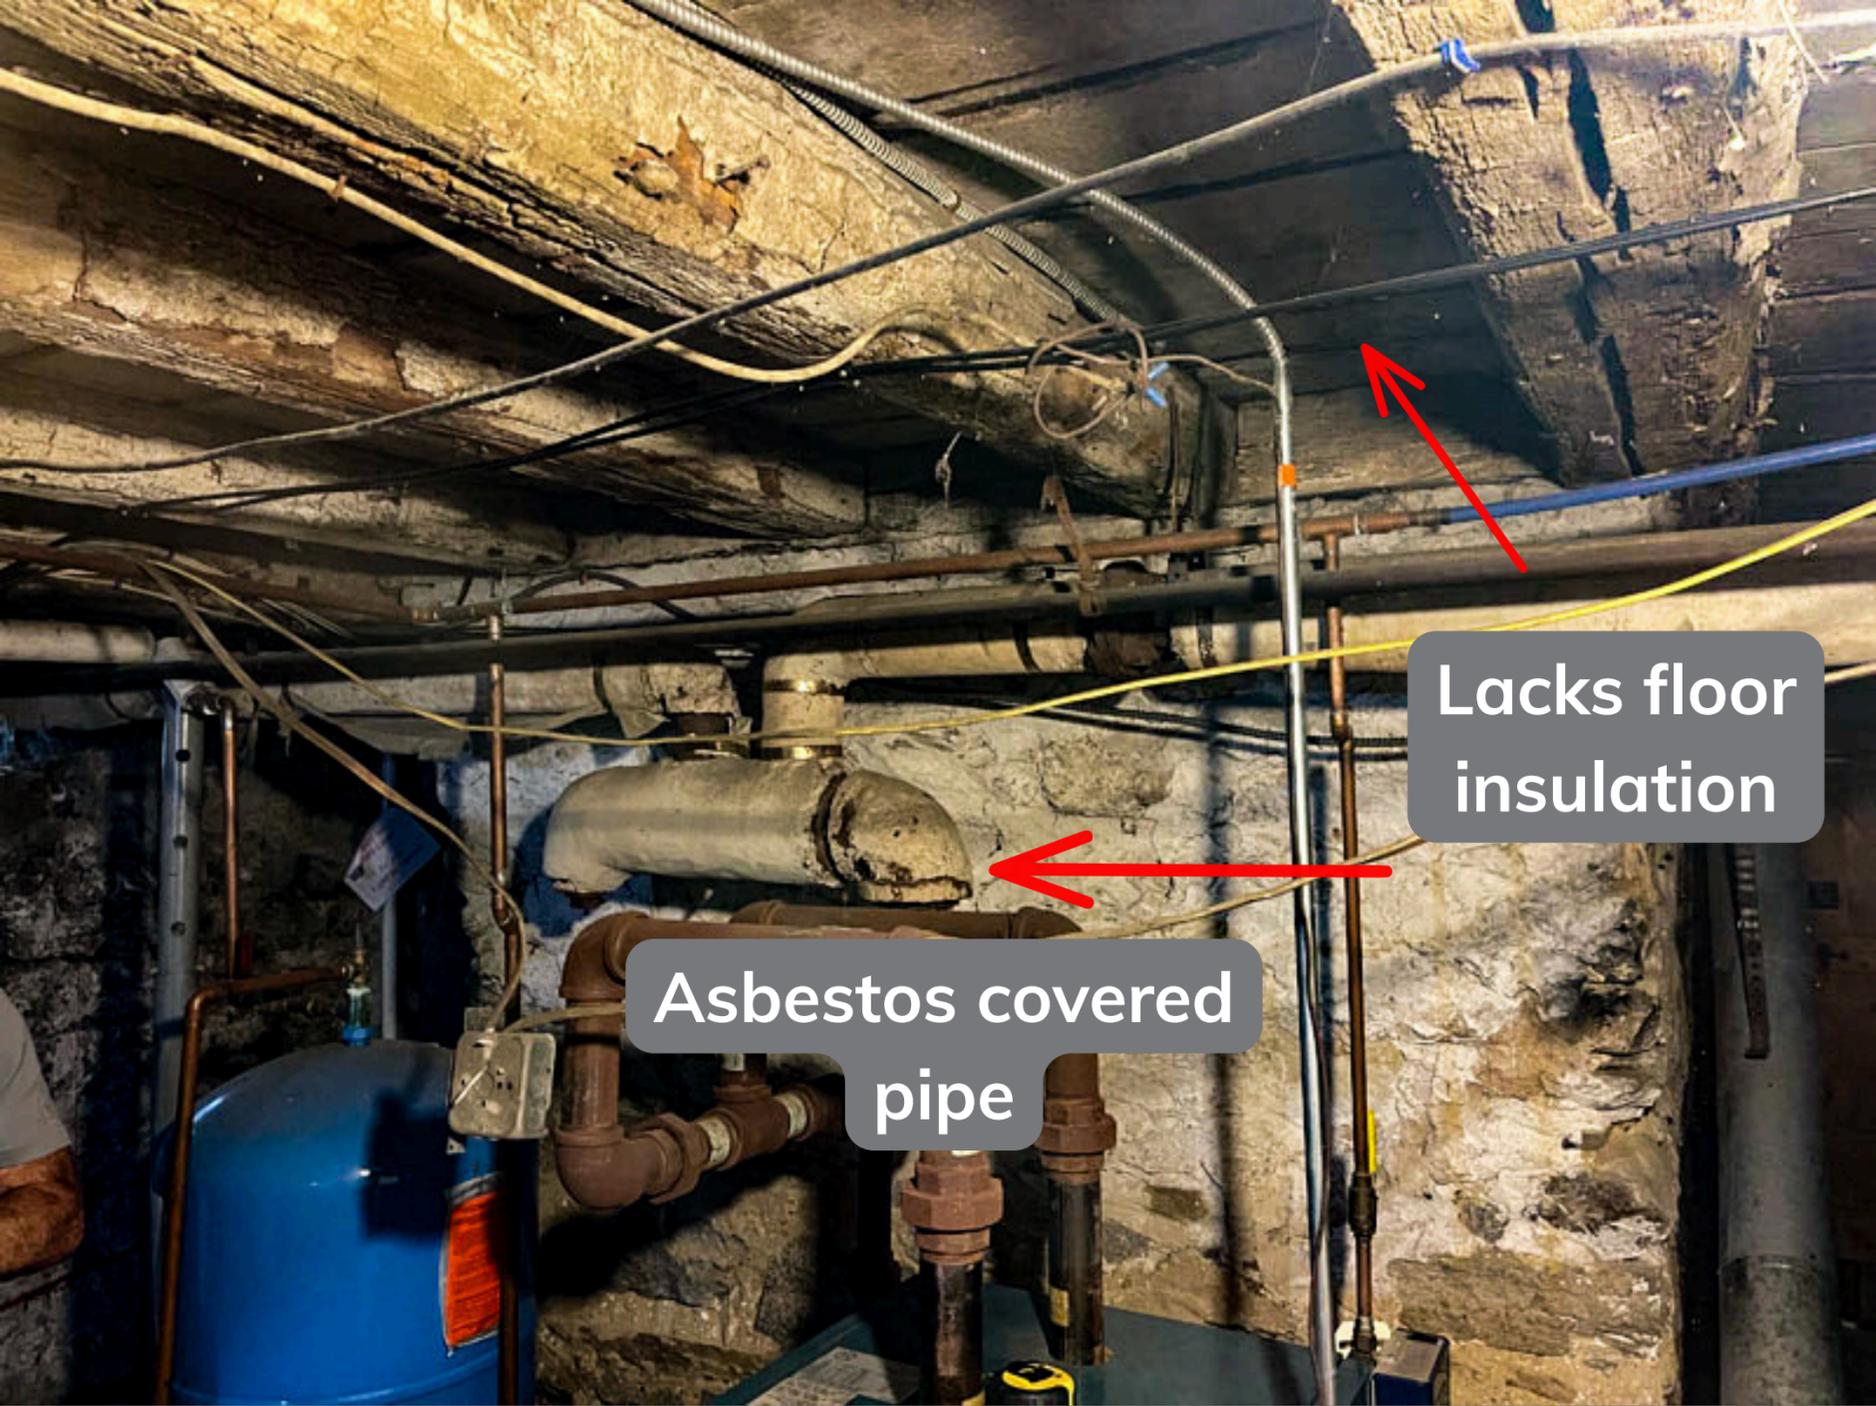
Framing

Existing timber joists have deteriorated and appear to be no longer structurally sound.

The resulting risk is the compromised ability of the floor system to support its design loads, e.g. weight of occupants, furniture, and building materials, which could cause a failure in the floor assembly.

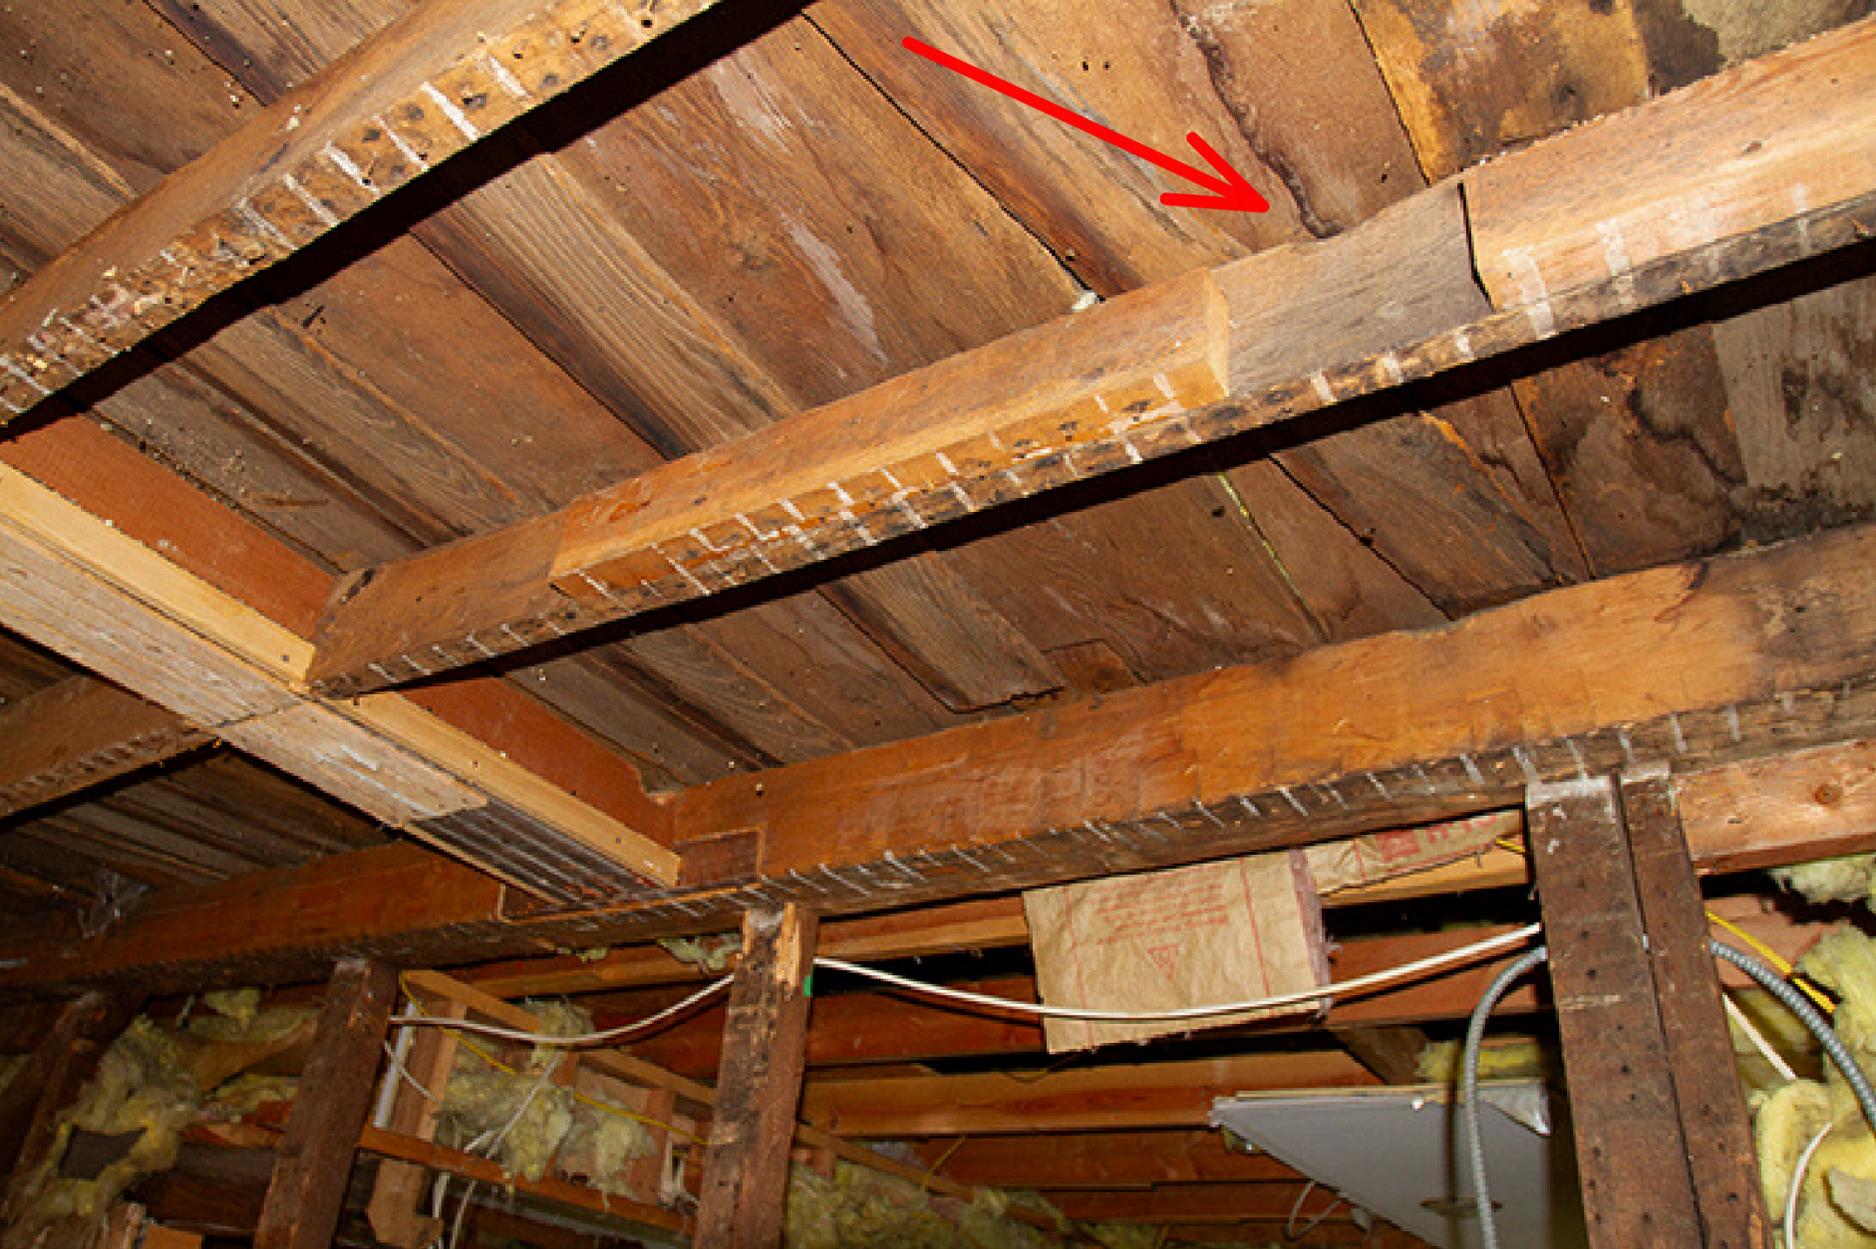
Framing

Existing framing with splices that impact structural integrity.

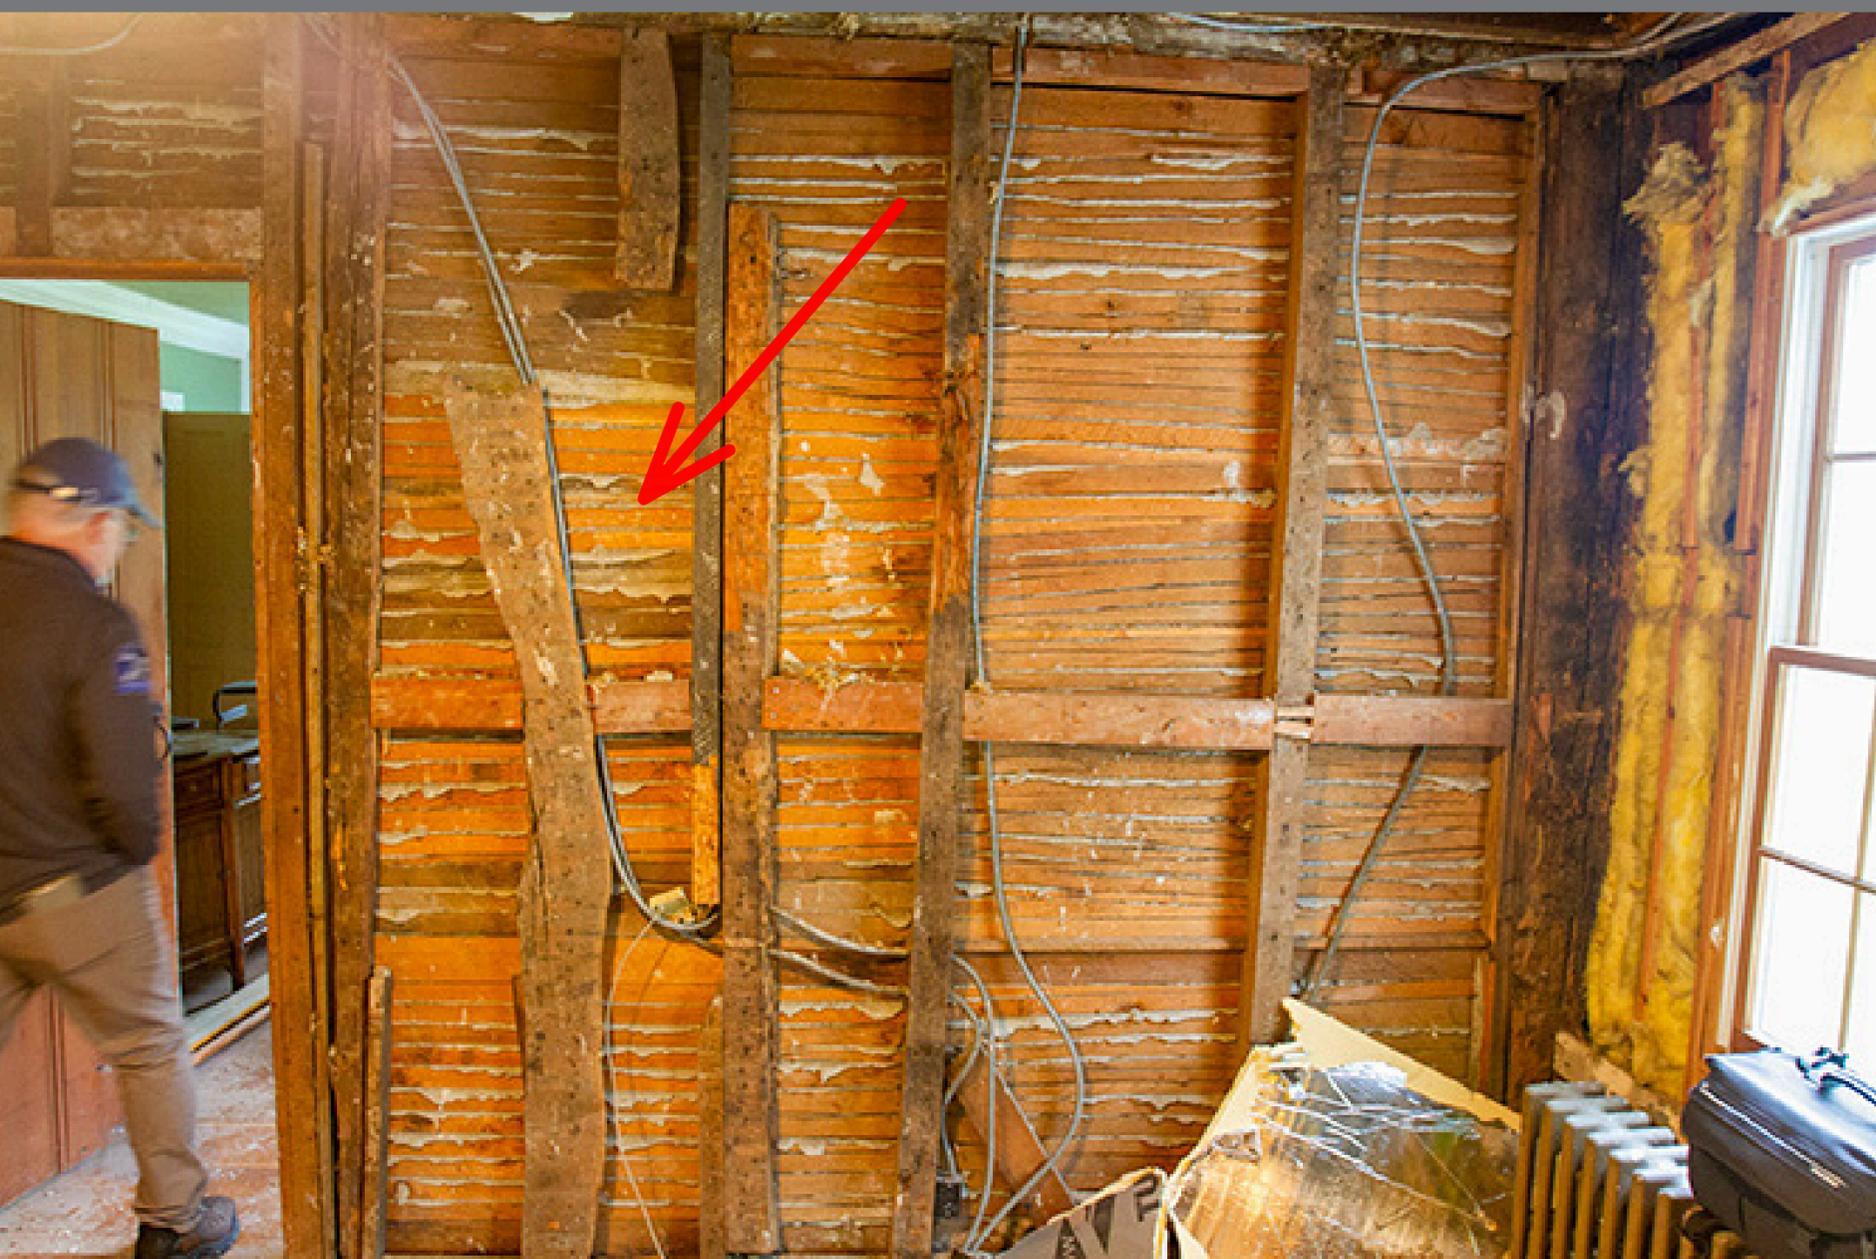
Due to the age of the rectory, we observed existing framing showing its lack of structural integrity.

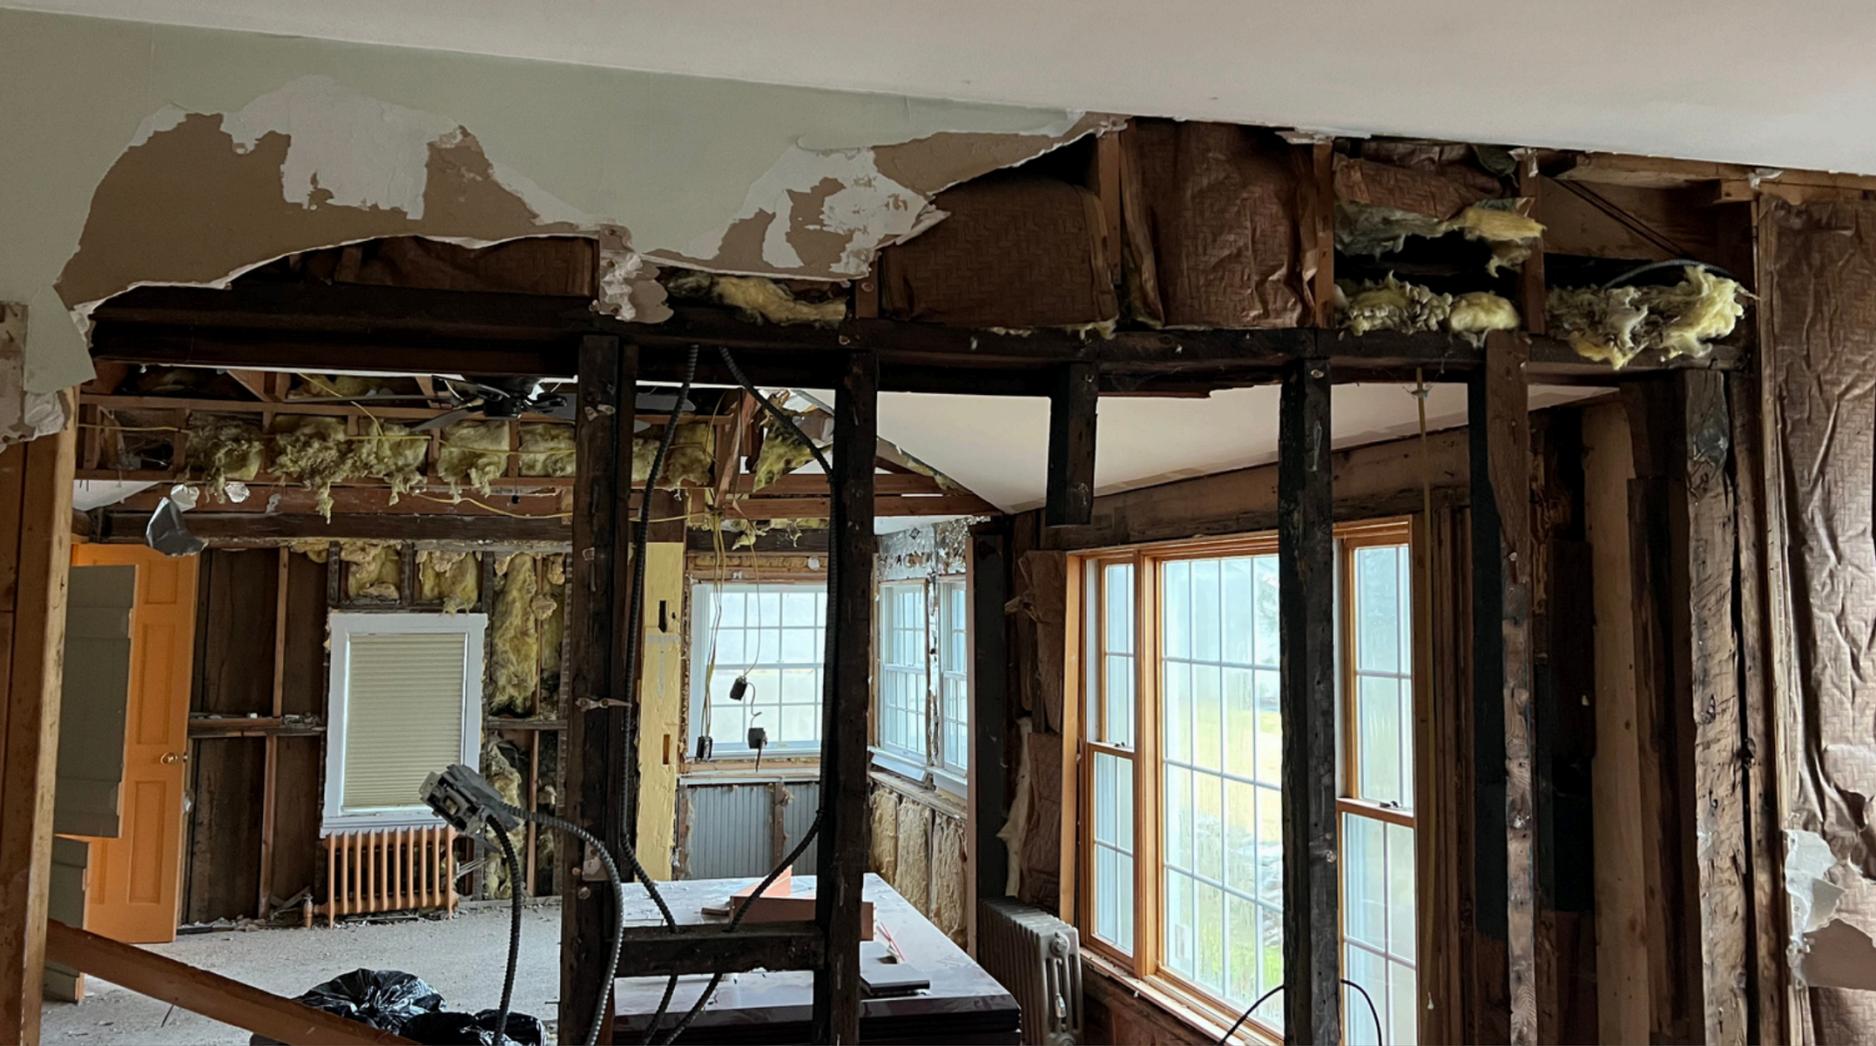
After exposing the interior framing, we discovered more outdated electrical wiring.

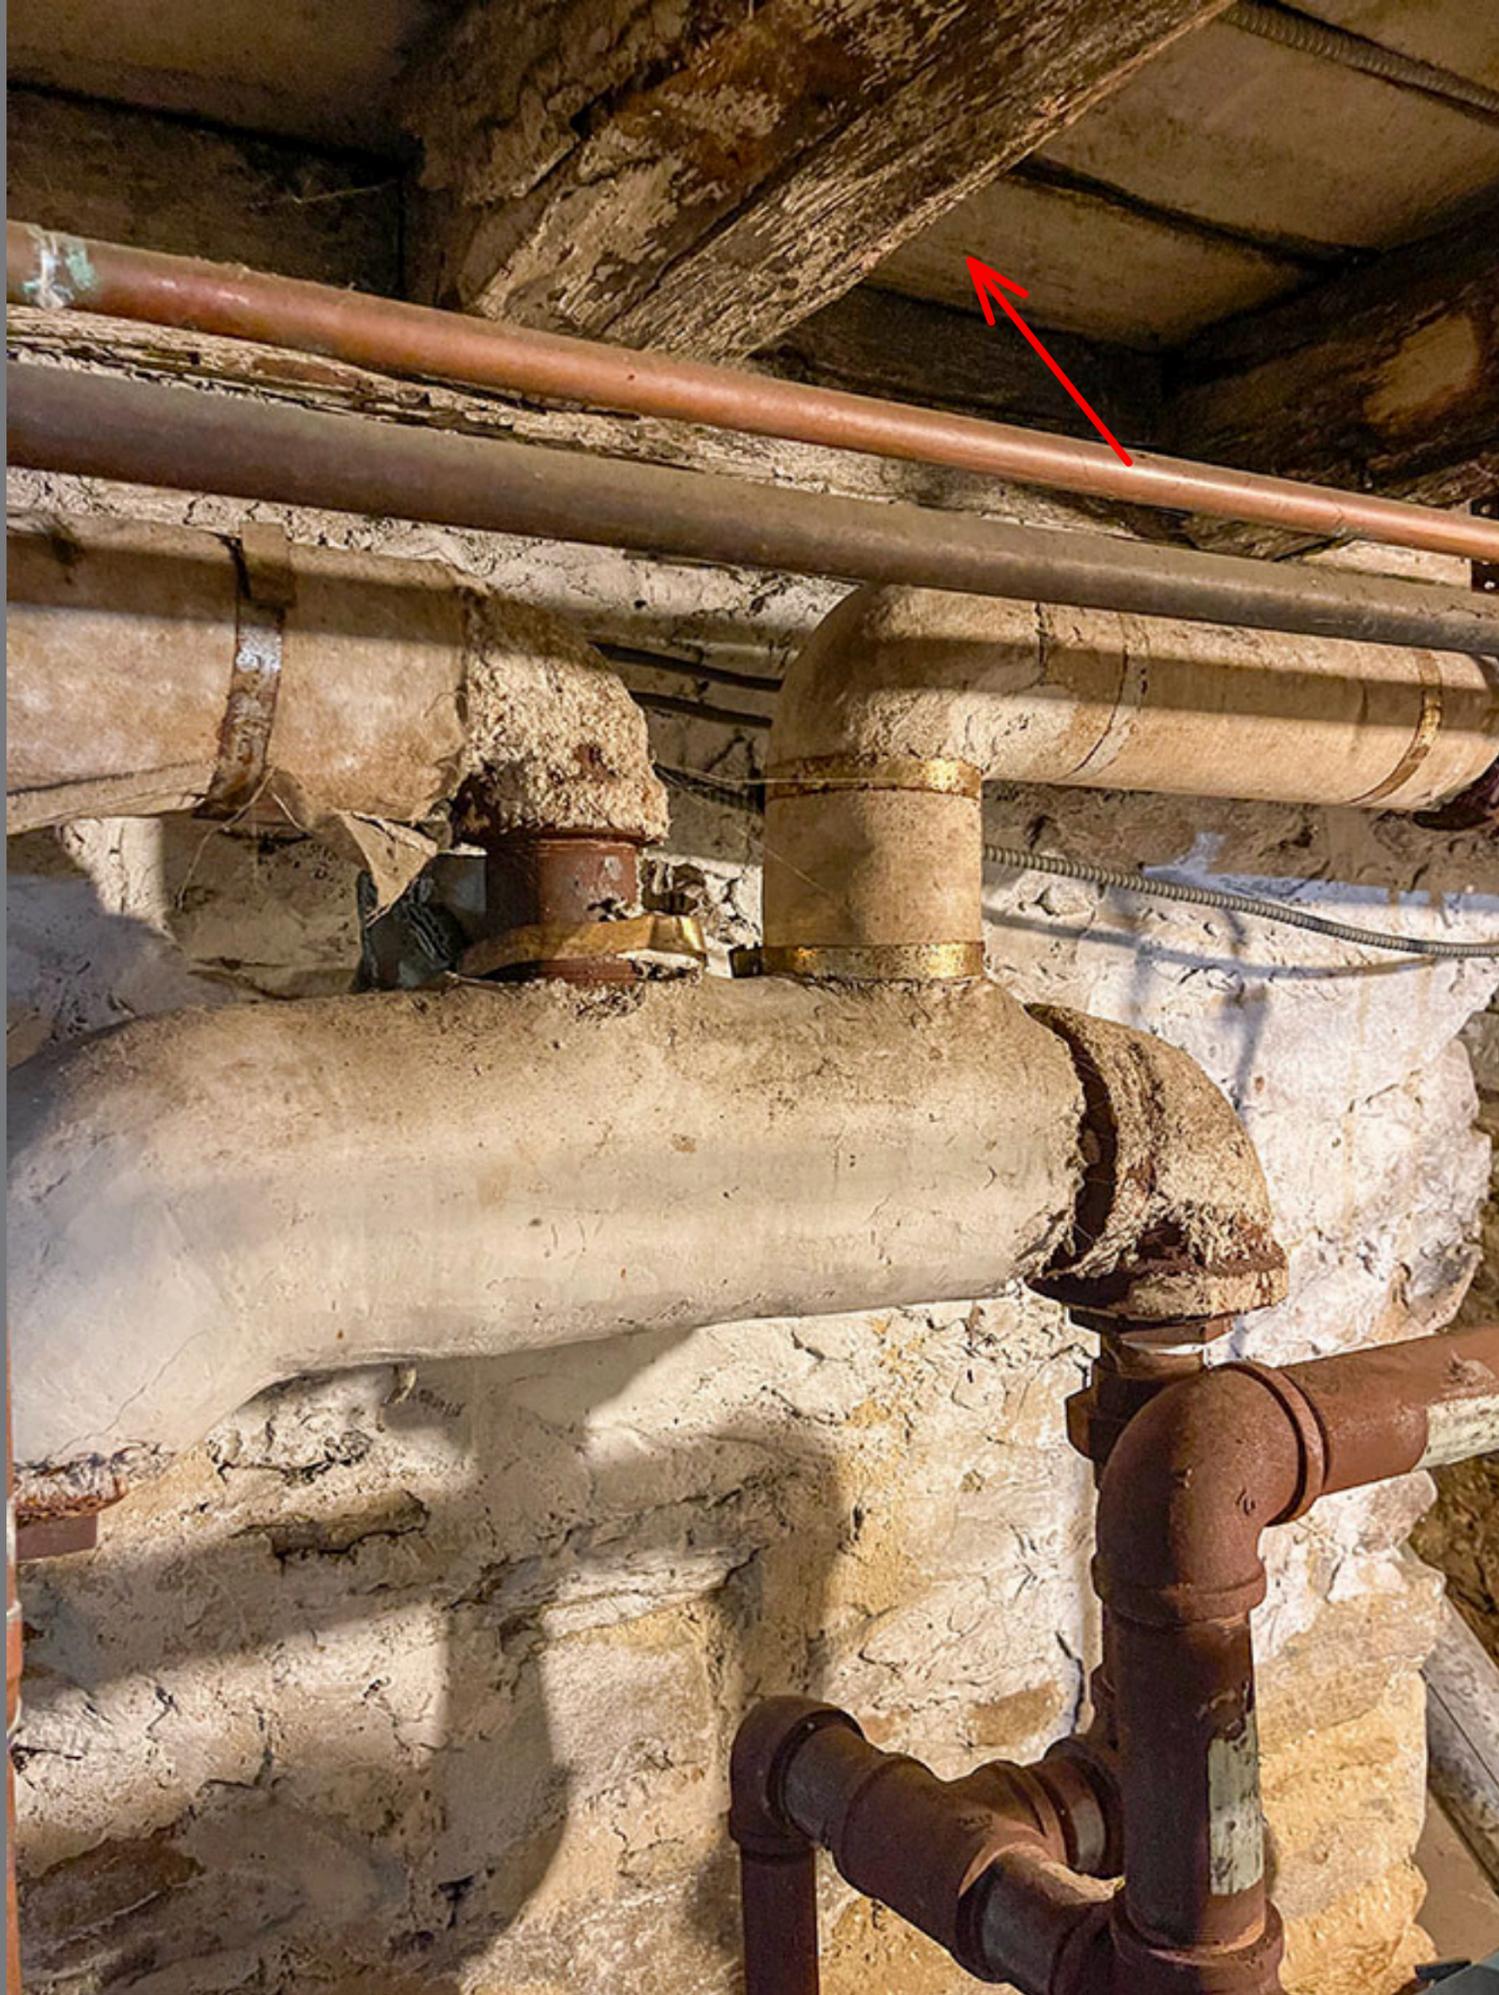
Foundation

There is flood and water damage that was repaired.

There is significant dampness that can lead to mold infestation.

The sill on top of the foundation is rotted in many areas.

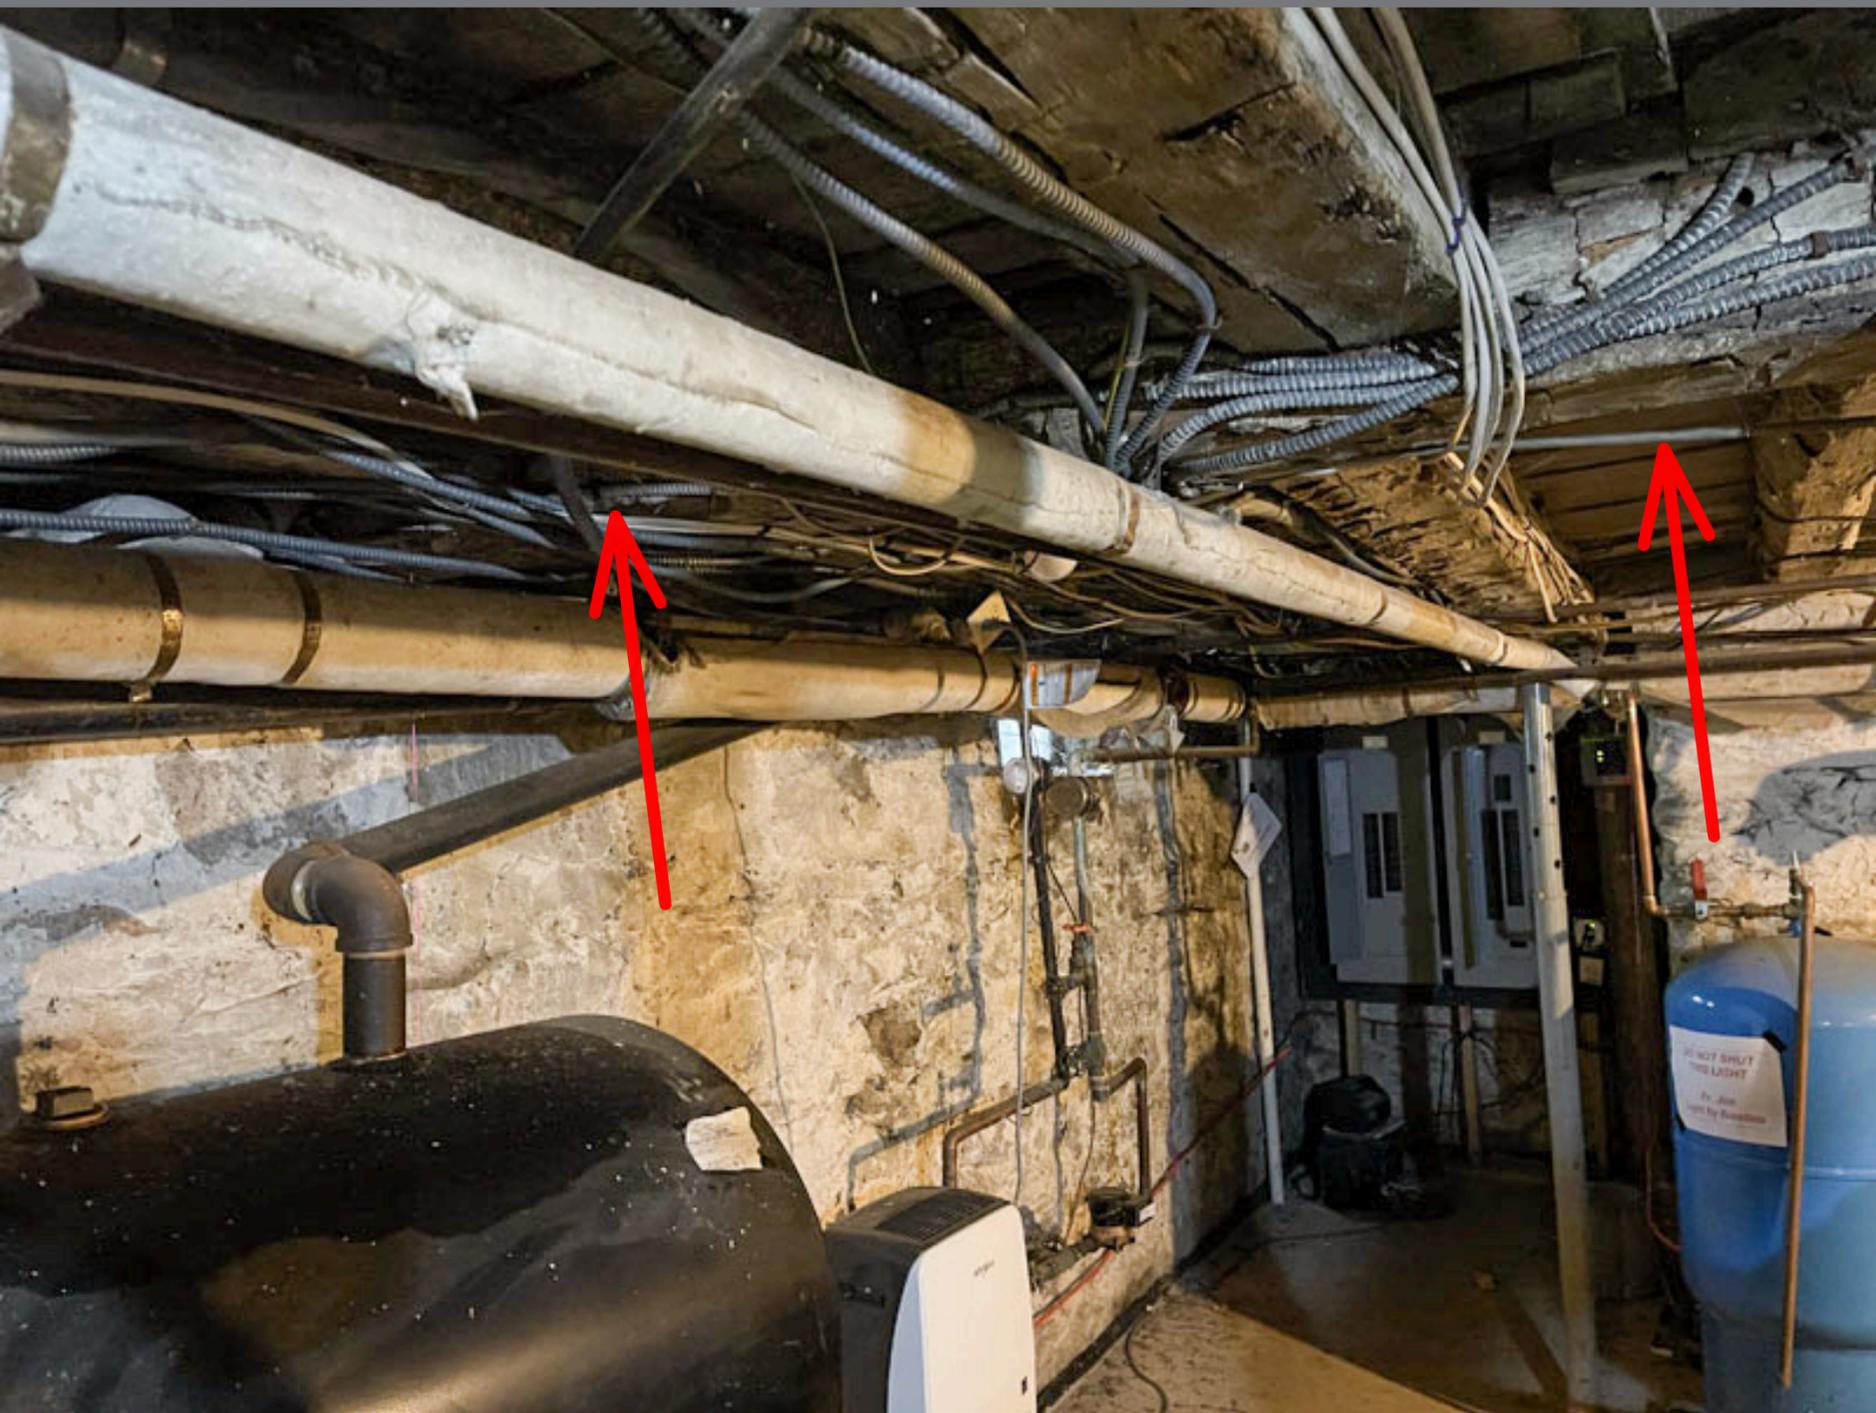
Numerous temporary repairs have been made to reinforce the floor framing with added floor joists and pump jack lally columns.

There are asbestos covered pipes and outdated, metal shield wiring (i.e. bx).

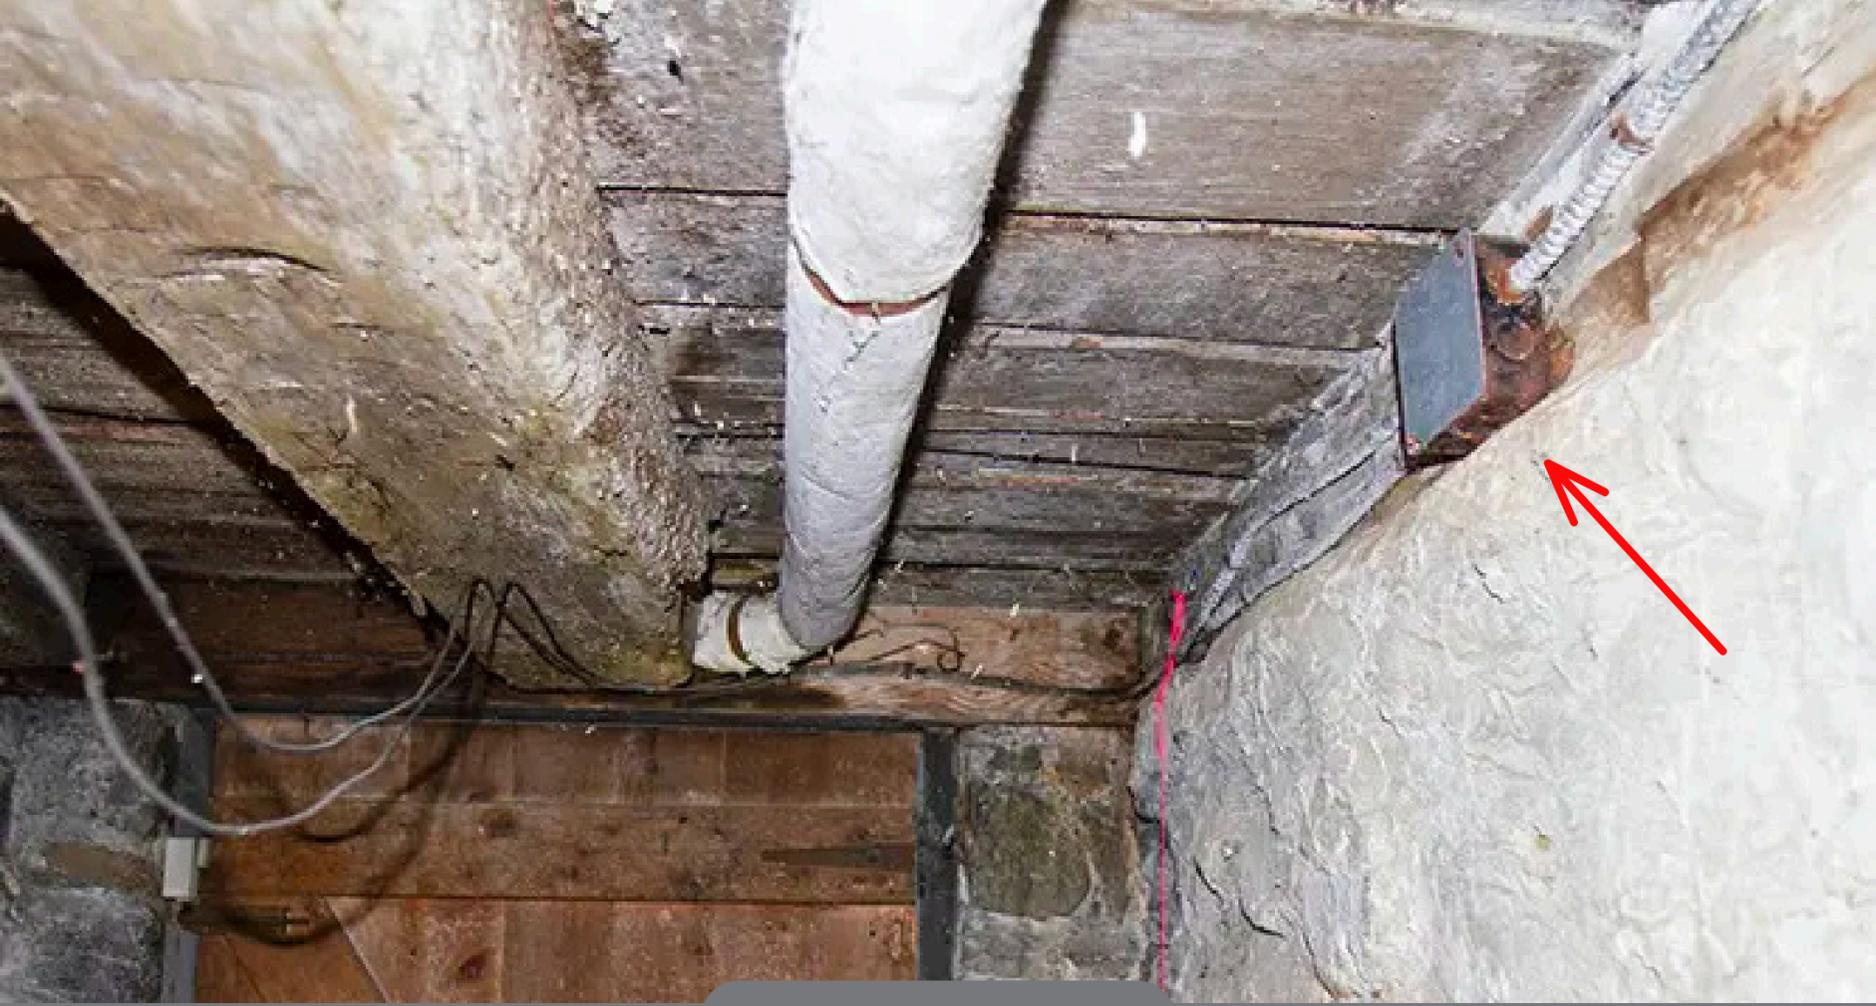
Electrical

The existing wiring is not grounded posing a significant fire hazard.

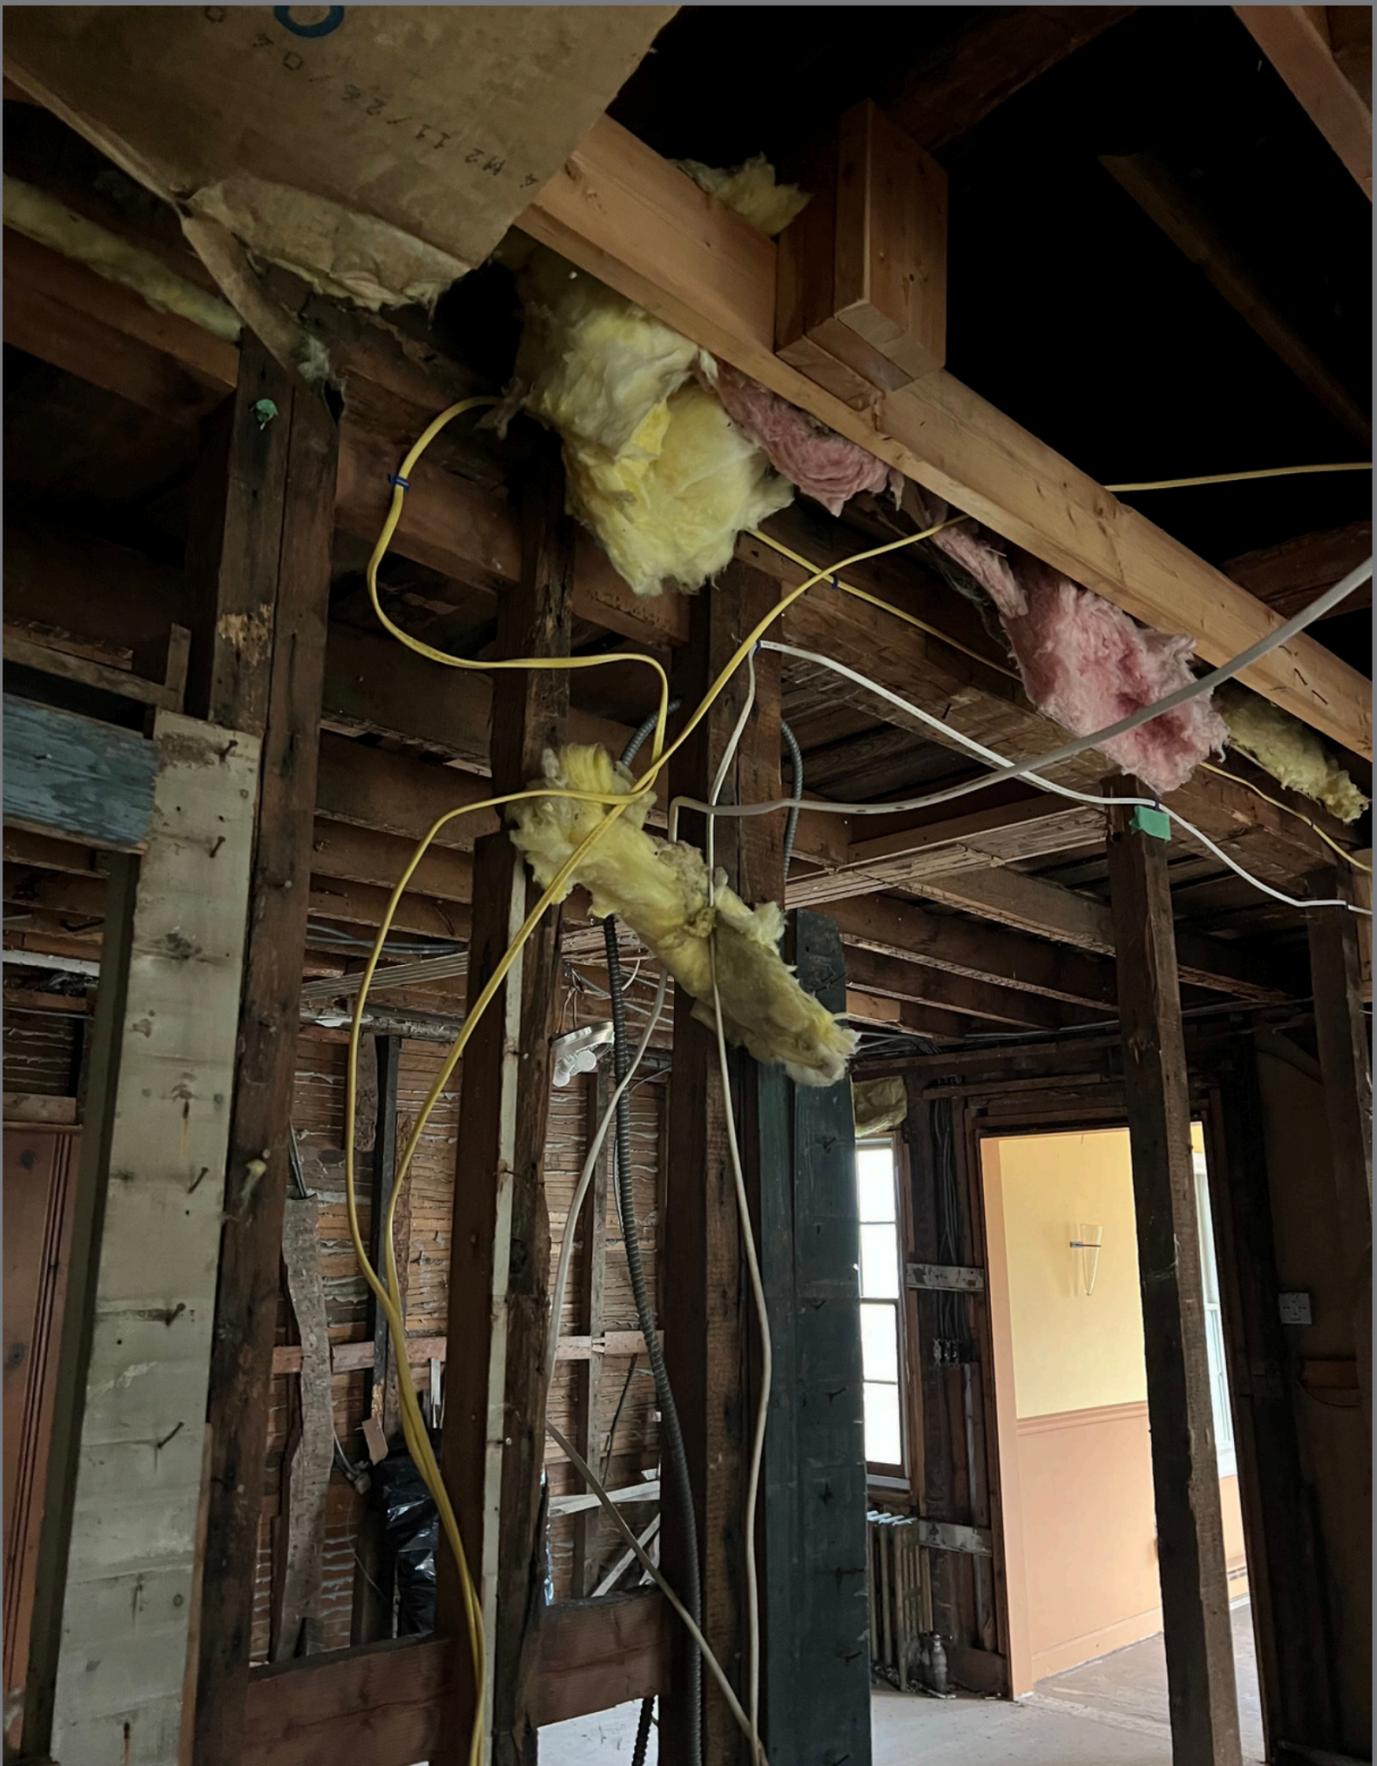
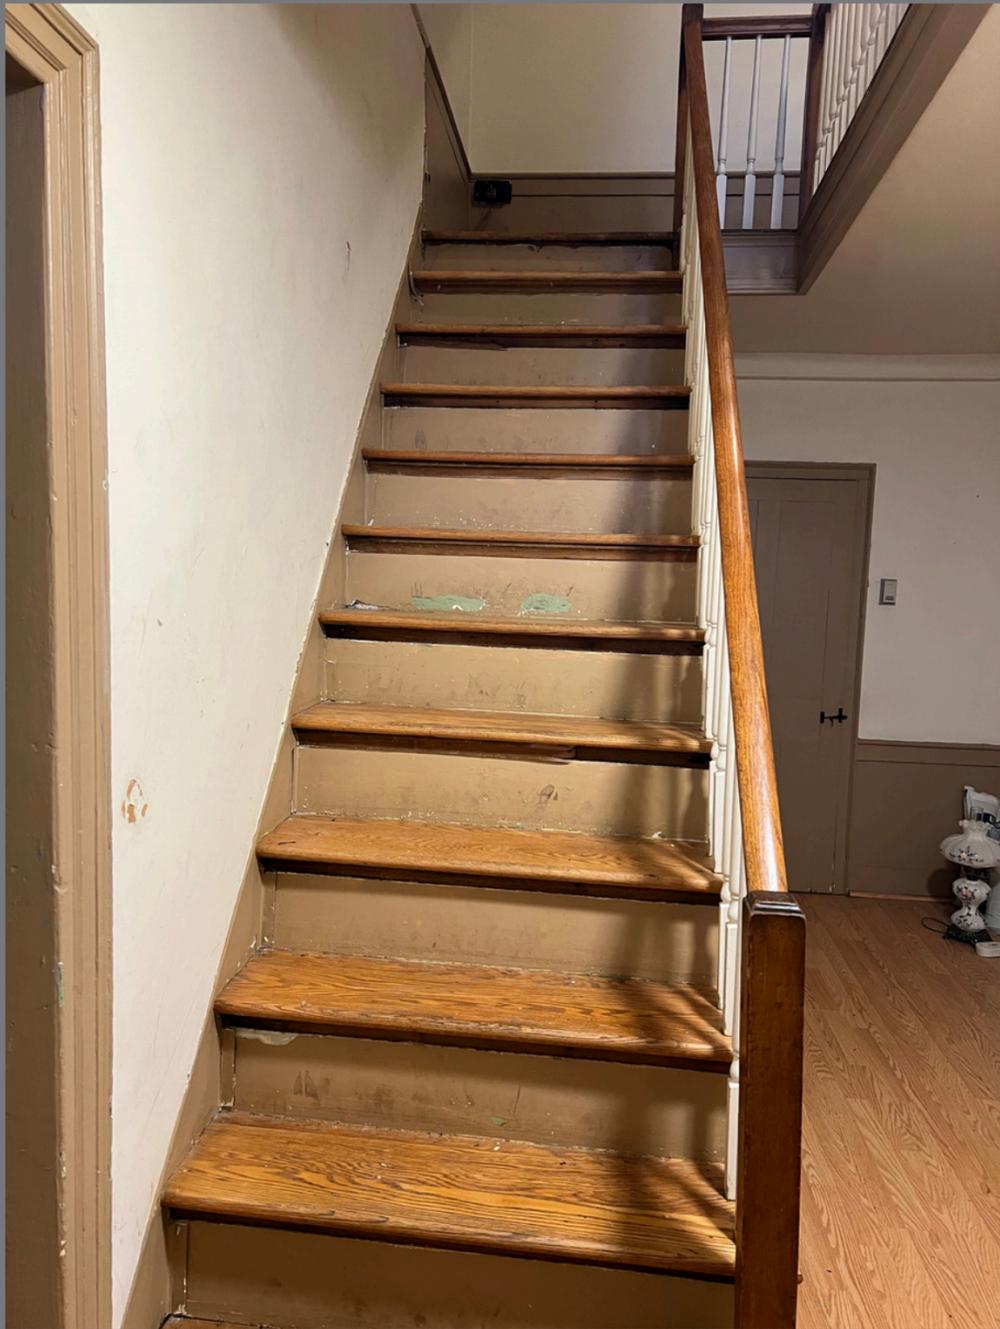
Current staircase risers are too steep, handrail/guardrails are not up to current building code. They are less than 36 inches high. The hallway guardrail is also less than 36 inches high and does not comply with current building code.
