St Francis Xavier Rectory Update

Summary of observations of the
Rectory at 26 Chestnut Land
Road, New Milford

St Francis Xavier Parish Rectory

- 26 Chestnut Land Road, New Milford
- Built in 1810; 3900 square feet
- Not on New Milford Historical Registry

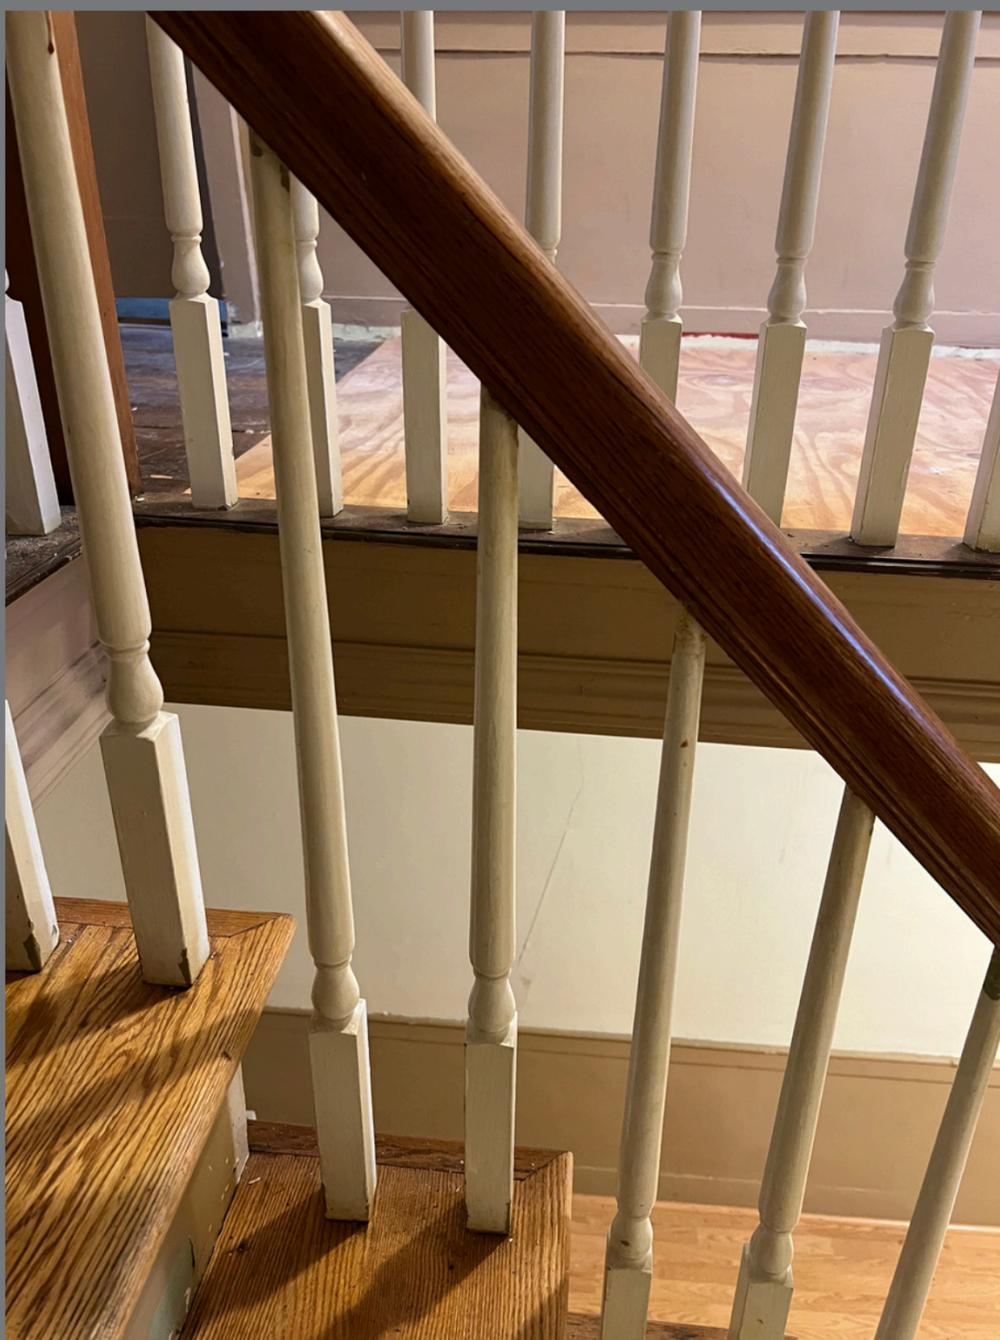
The handrails and guardrails are less than 36 inches wide creating a staircase hazard.

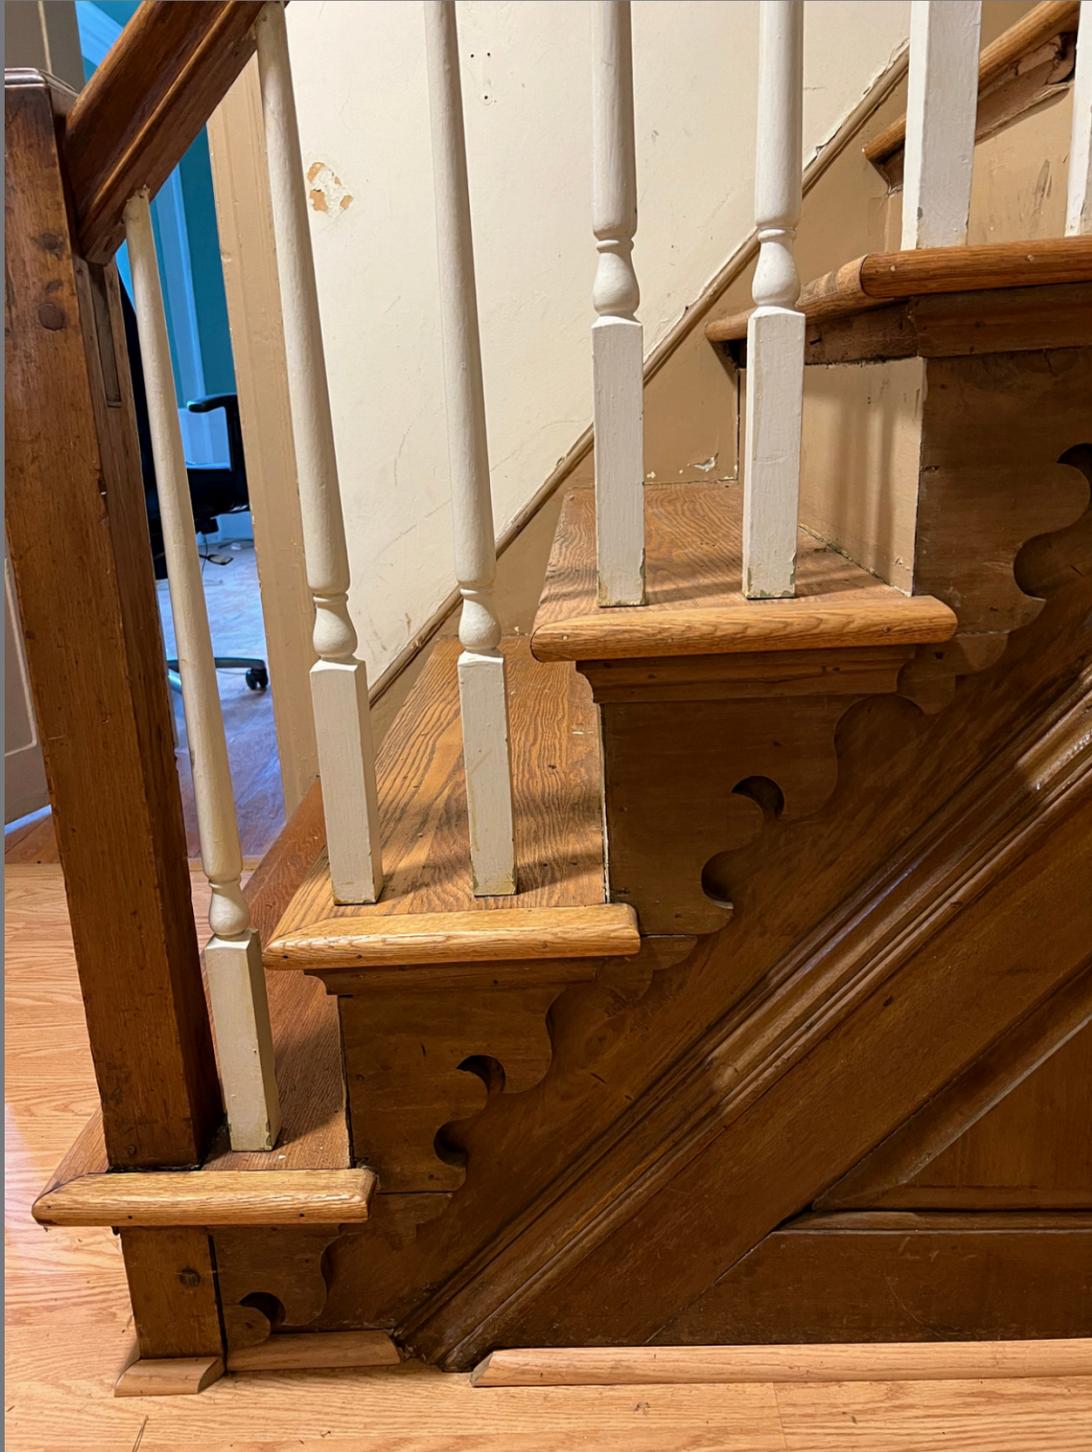
Floor surface is uneven contributing to tripping and falling hazard.

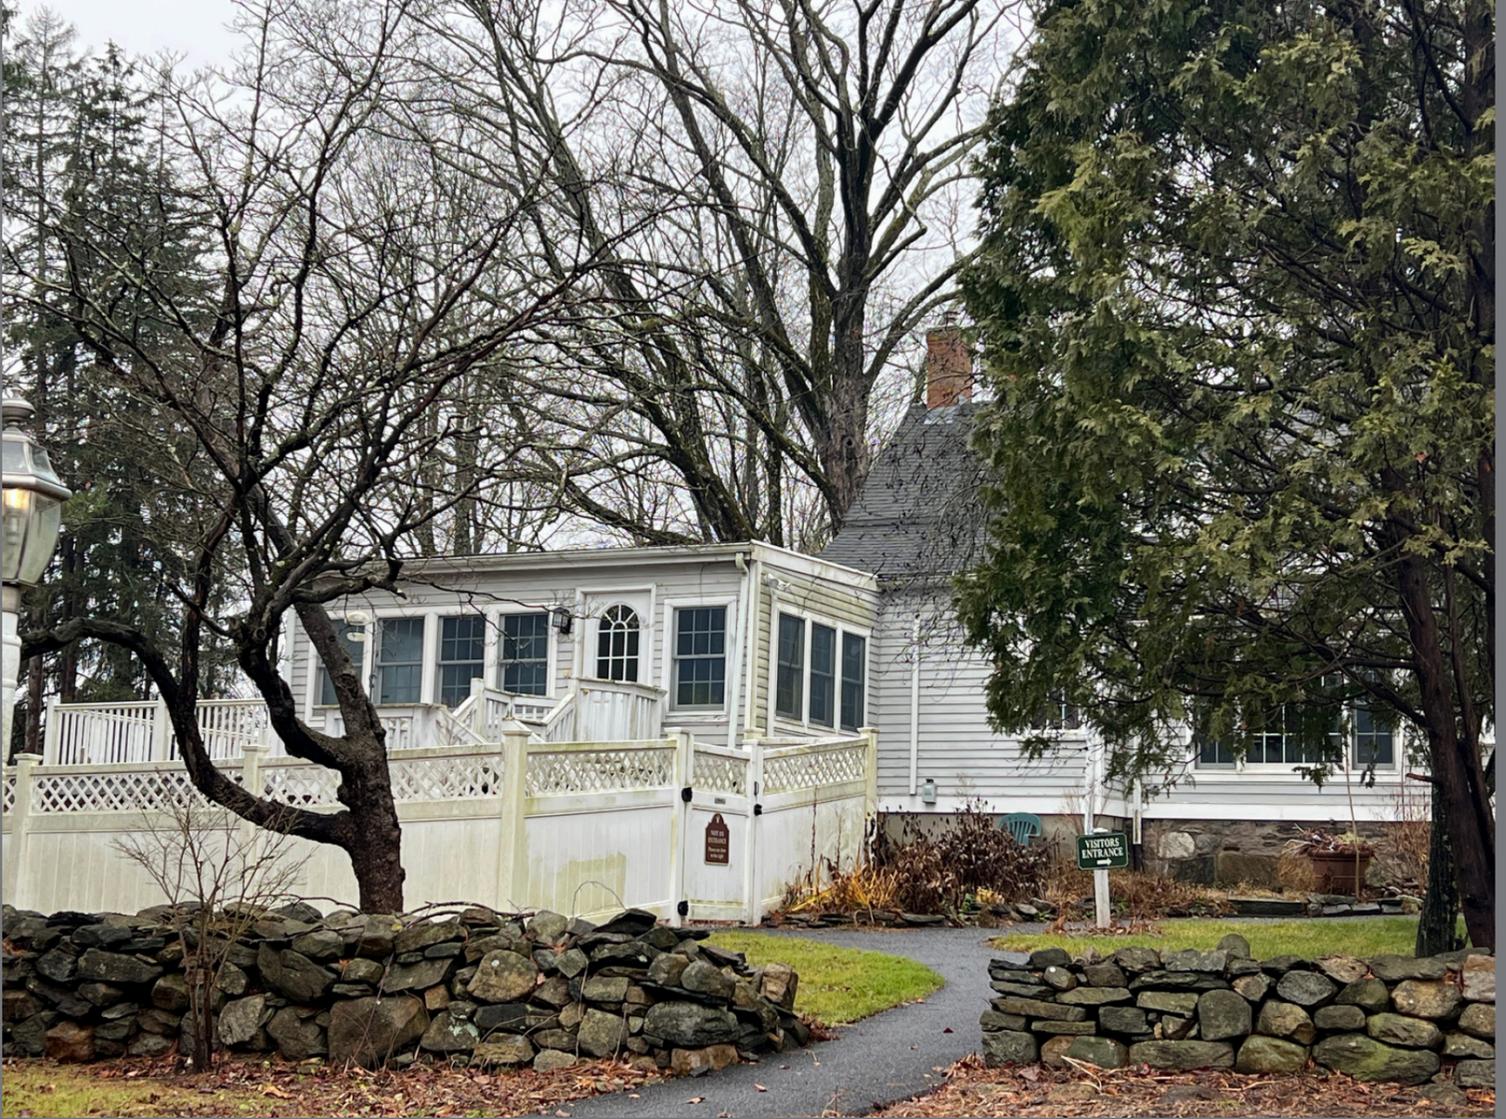
The kitchen porch deck addition built over a crawlspace and has several roof styles creating potential ice buildup and roof leaks.

The crawlspace has rodent infestation.

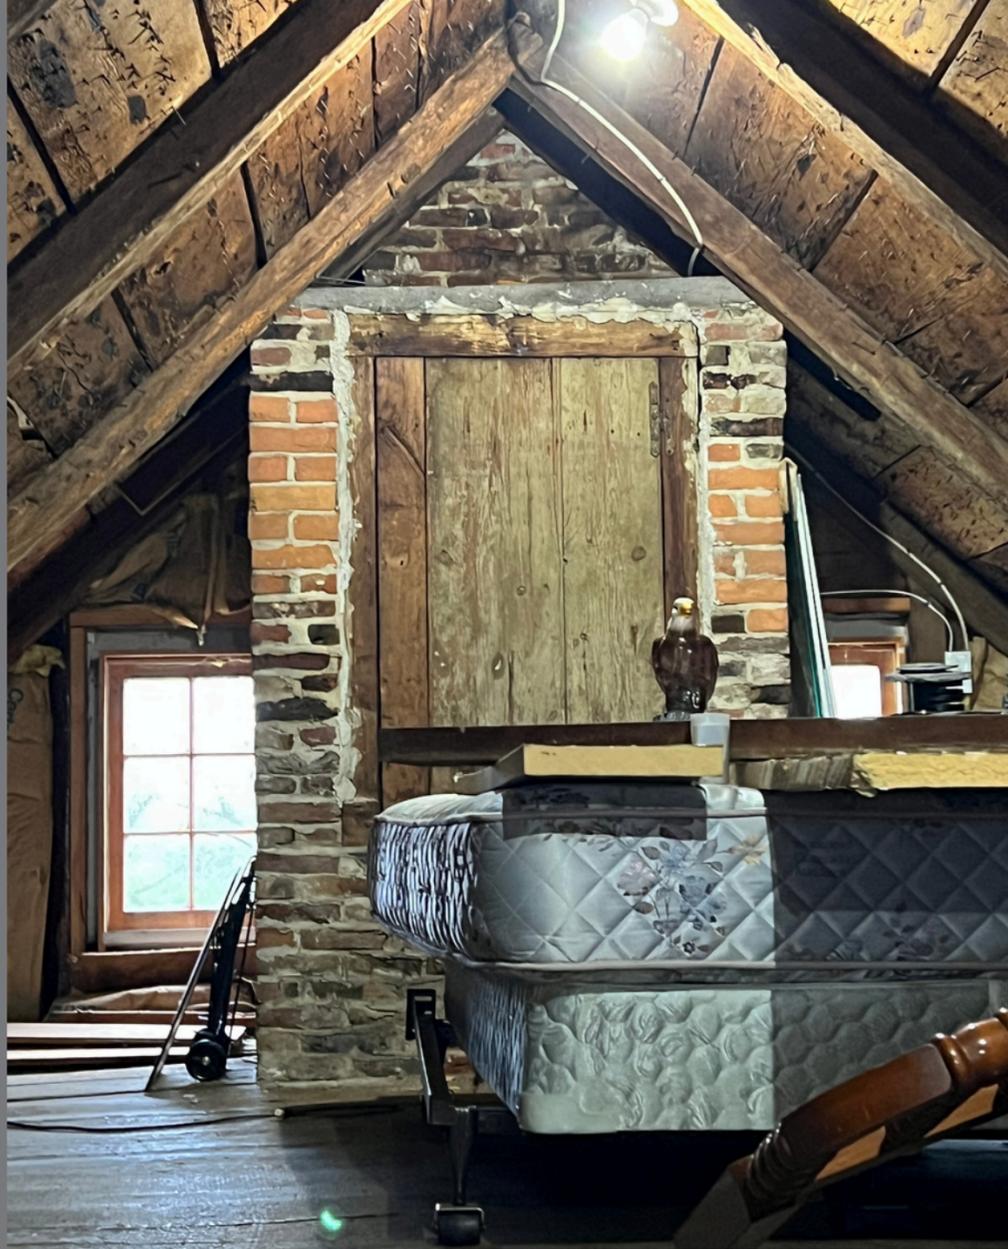
Chimney

The existing chimney that serves the wood stove on the first floor does not exit through the roof.

The door allows smoke from the woodstove to enter the attic.

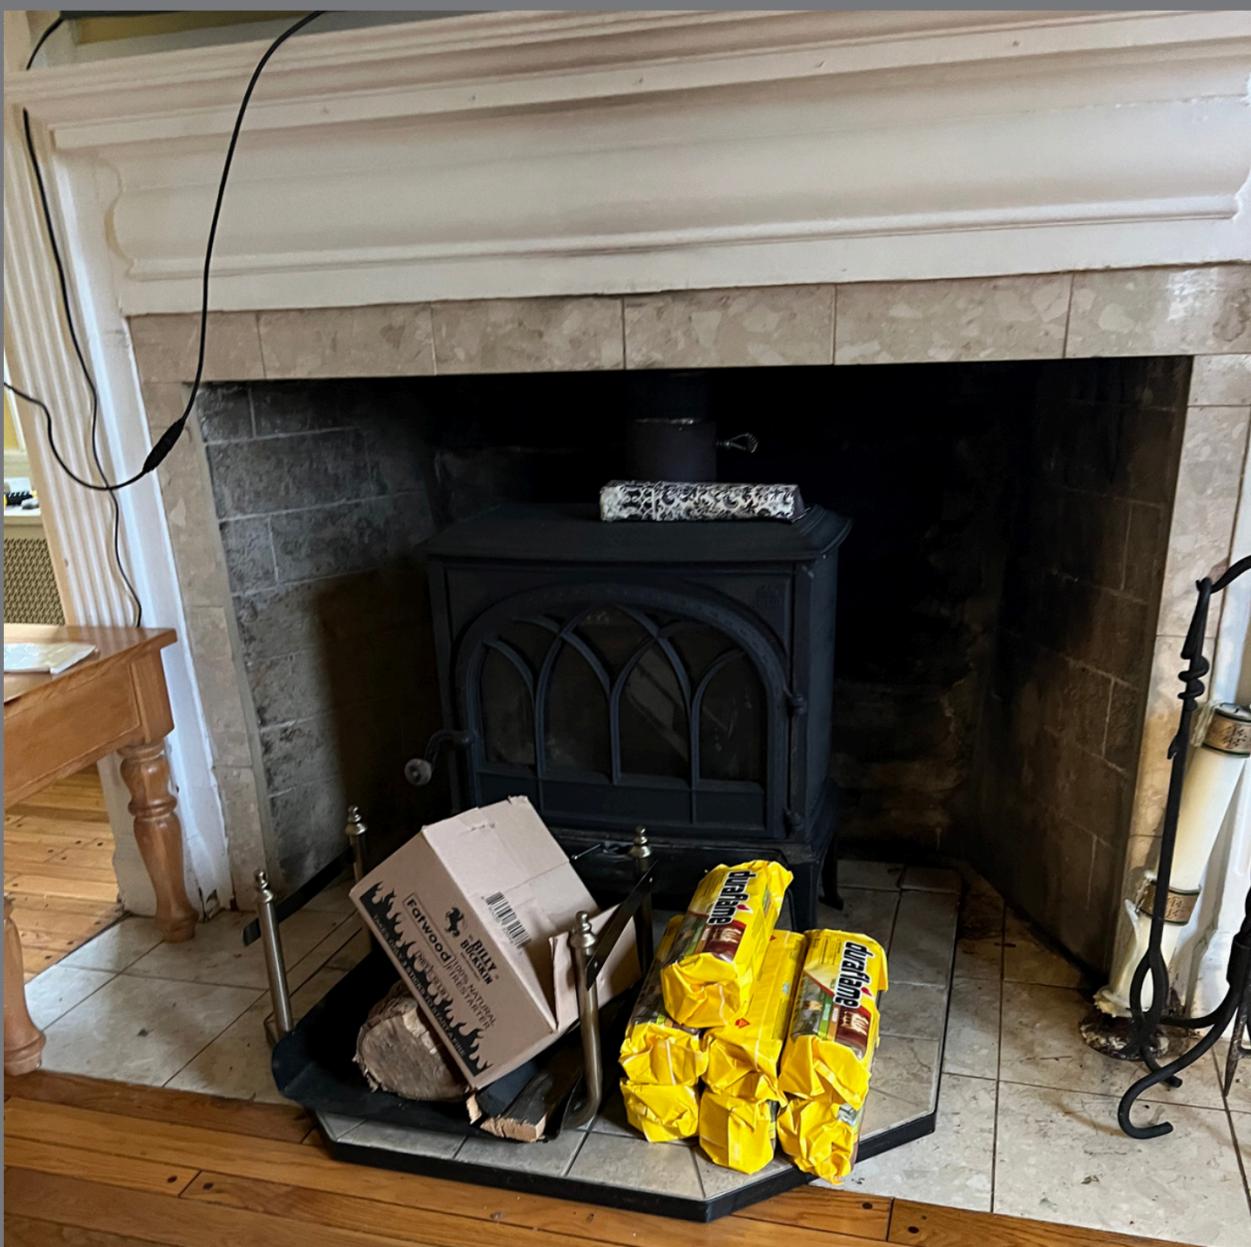
Smoke Remediation

Rectory was fumigated in the spring of 2025 to remove cigar smoke and pet odors.

However, fumigation was not successful.

Sheet rock was removed in an attempt to remove the odors.

This also was not successful to remediate the smell of cigar smoke and pet odors.

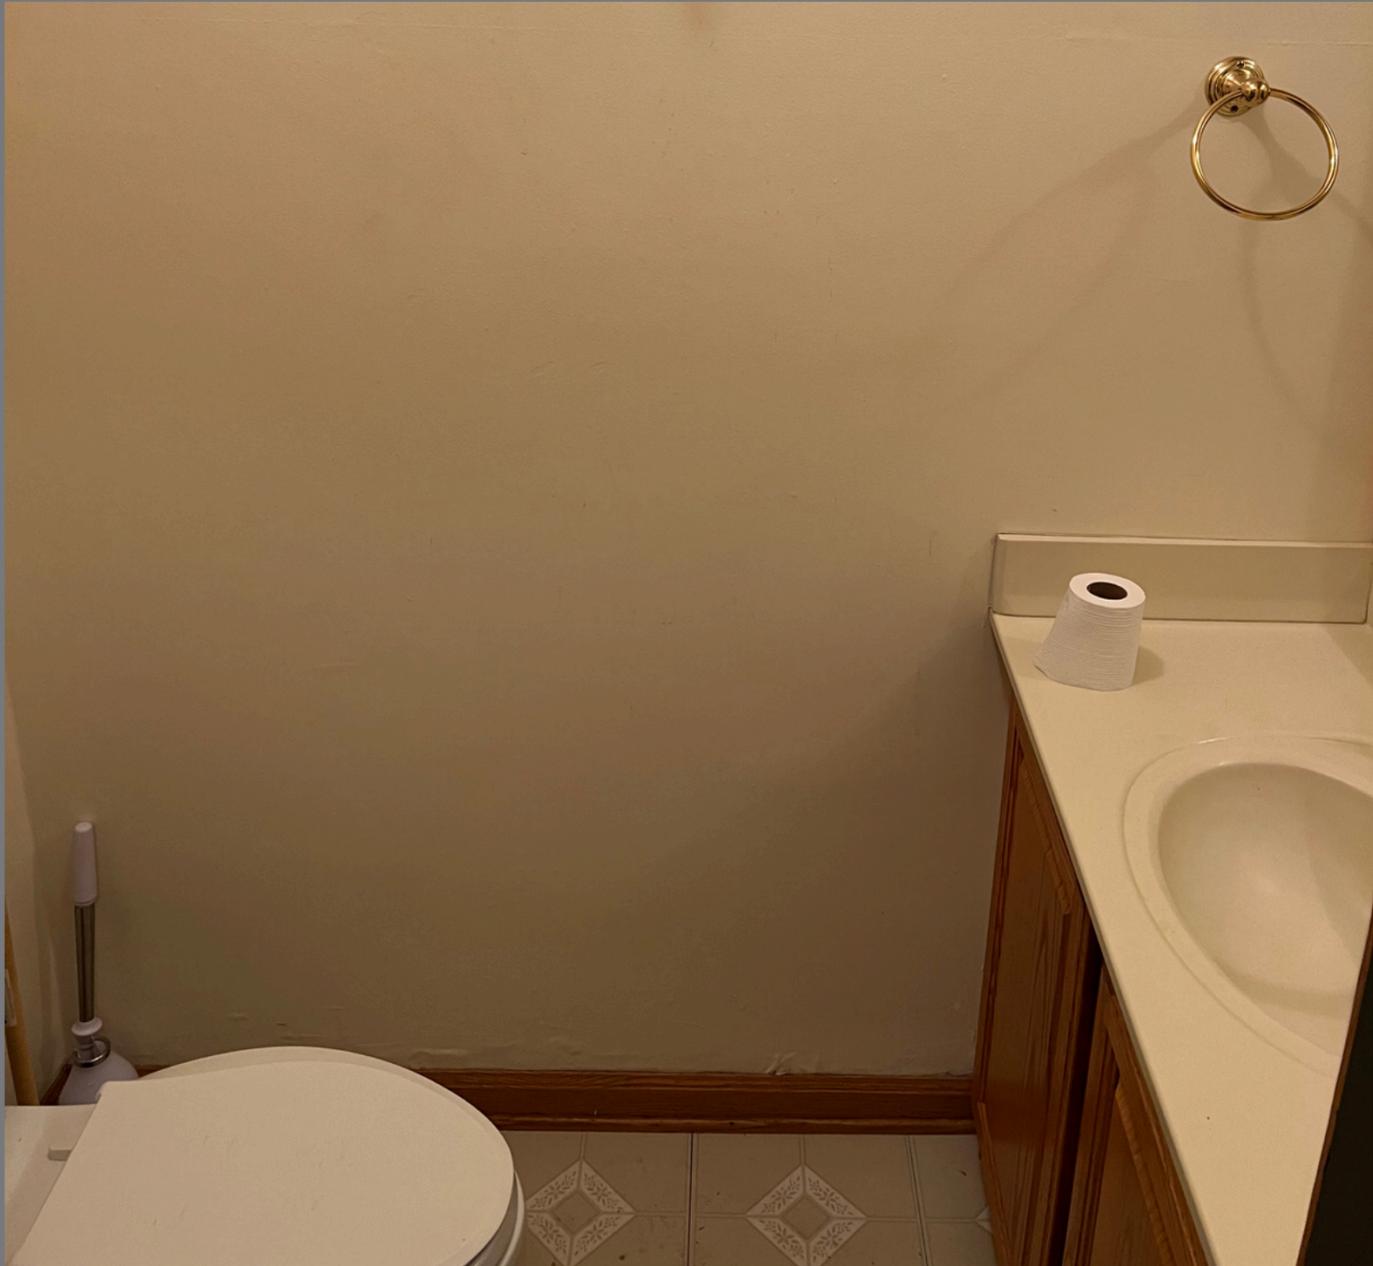
Bathroom is too narrow and not ADA compliant.

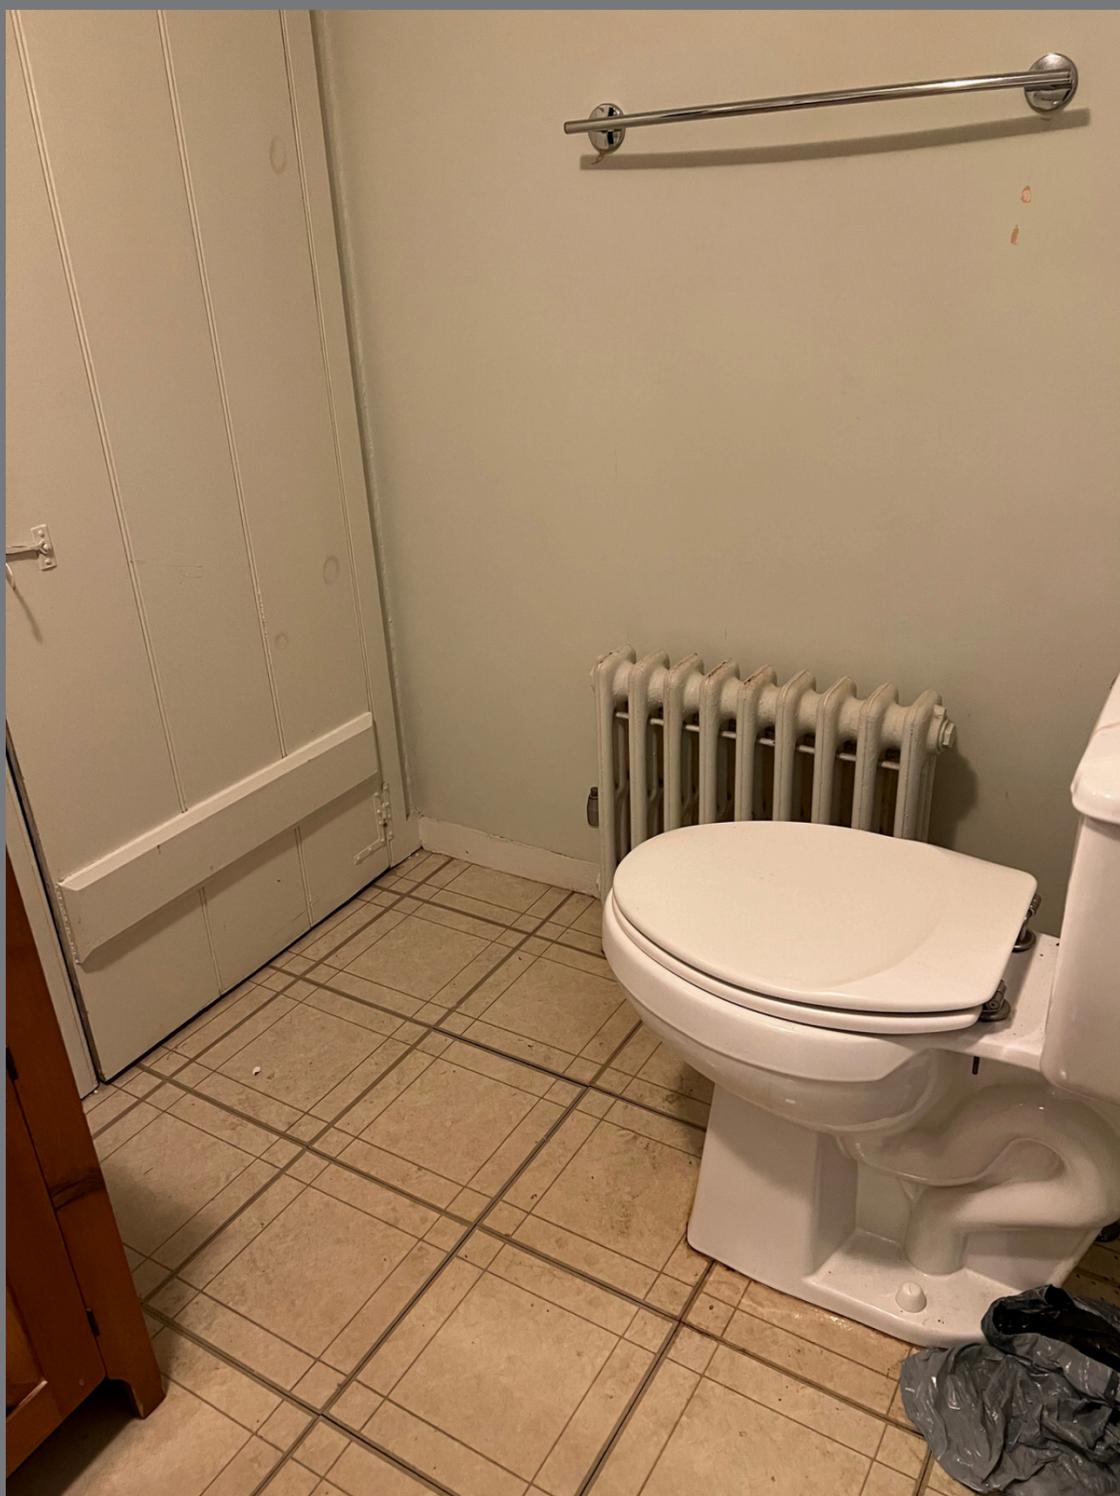
Bathroom is too small for the average sized person.

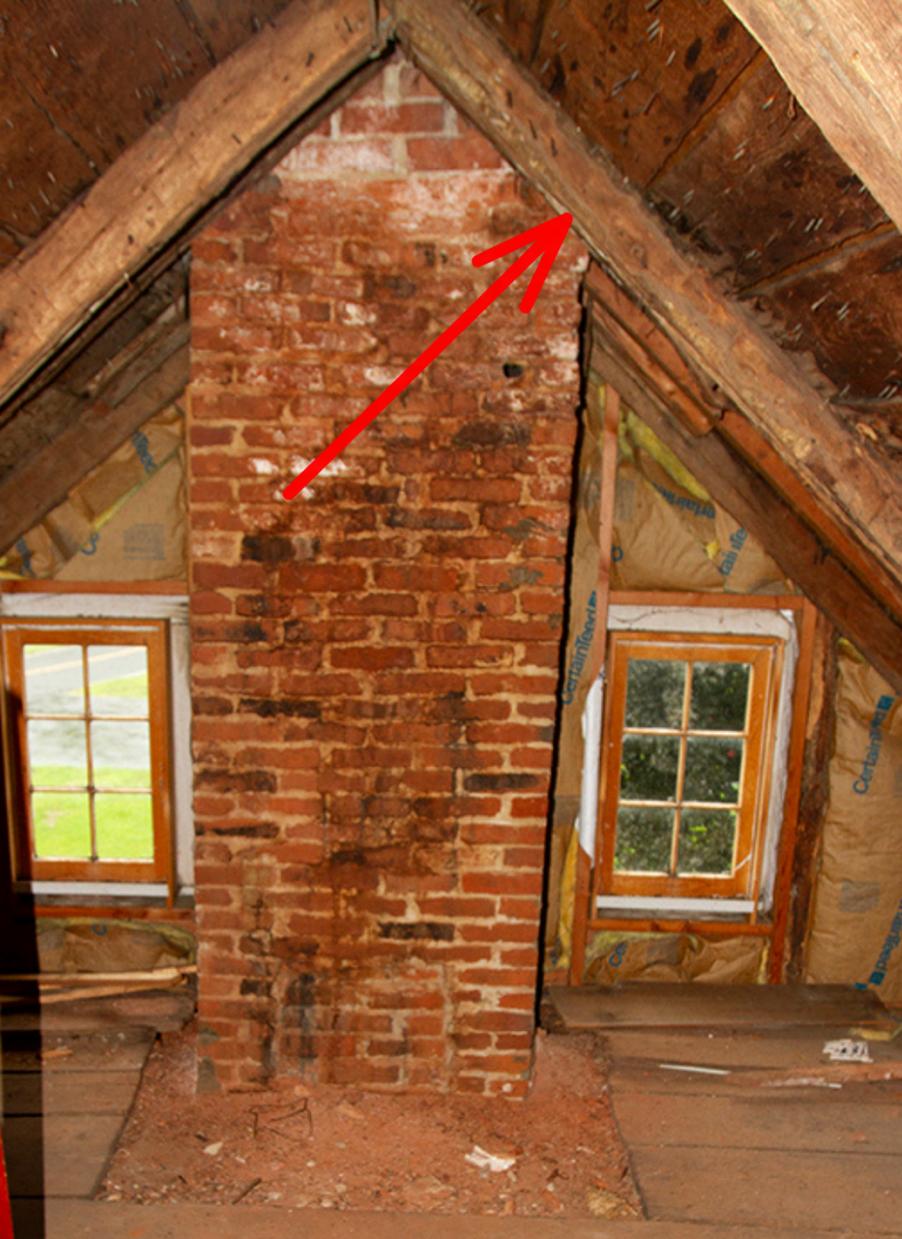
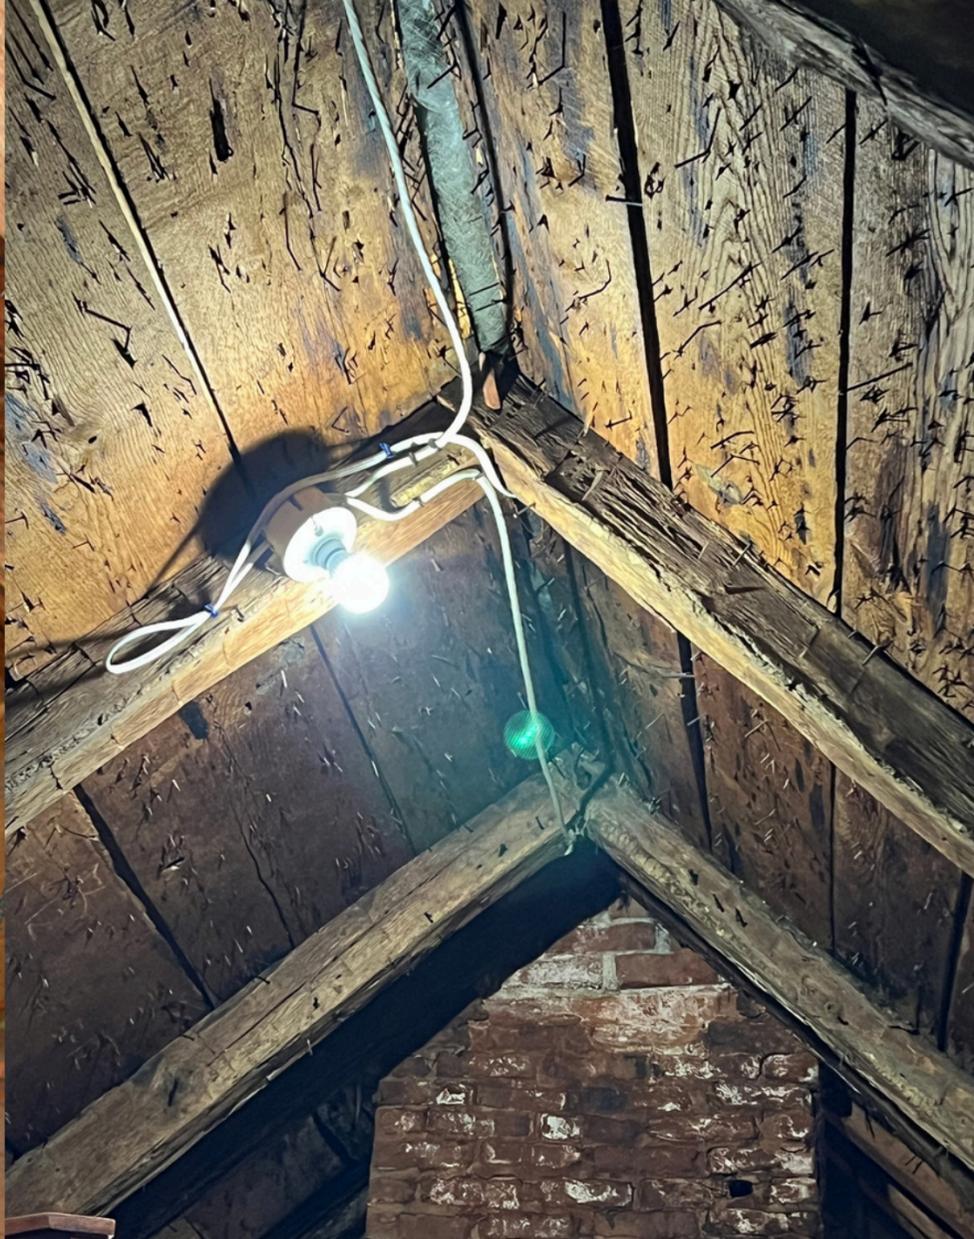
Attic / Roof

There are loose and missing bricks on the exterior.

Excessive nailing in the roof has compromised the sheathing making the roof vulnerable to leaks.

This is the reason why the rectory will be uninsurable.
