# St Francis Xavier Rectory Update

Summary of observations of the  
Rectory at 26 Chestnut Land  
Road, New Milford

- 26 Chestnut Land Road, New Milford
- Built in 1810; 3900 square feet
- Not on New Milford Historical Registry

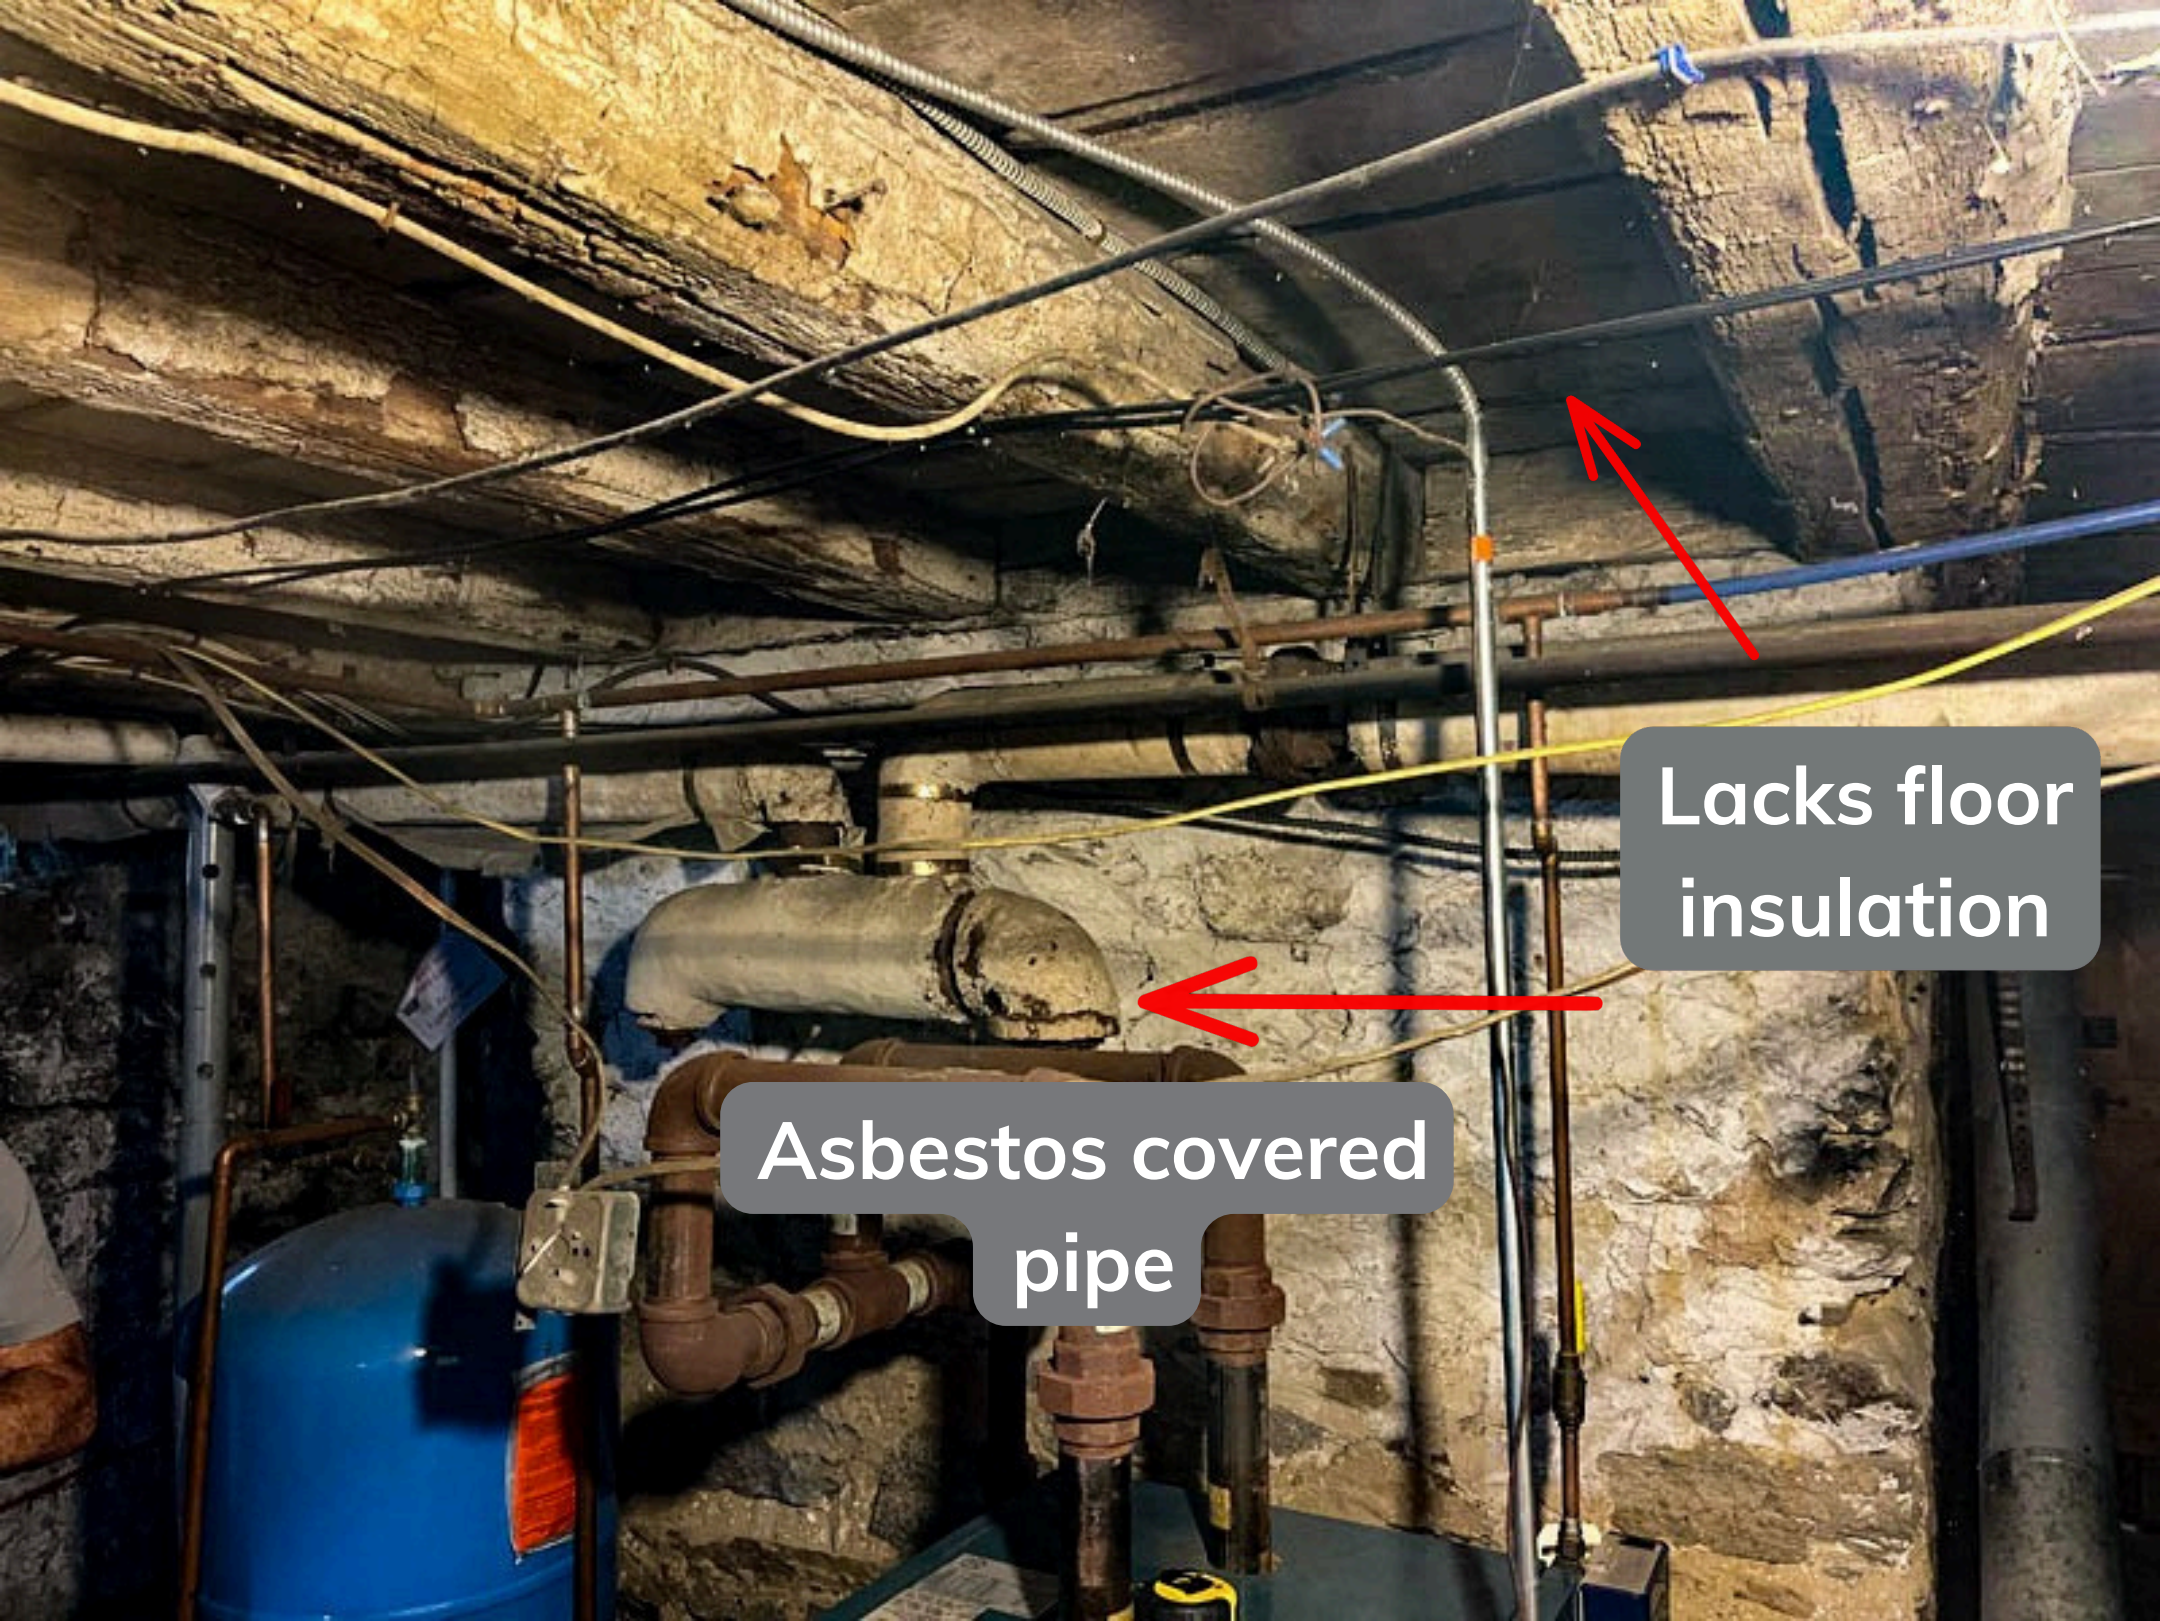
Existing timber joists have deteriorated and appear to be no longer structurally sound.

The resulting risk is the compromised ability of the floor system to support its design loads, e.g. weight of occupants, furniture, and building materials, which could cause a failure in the floor assembly.

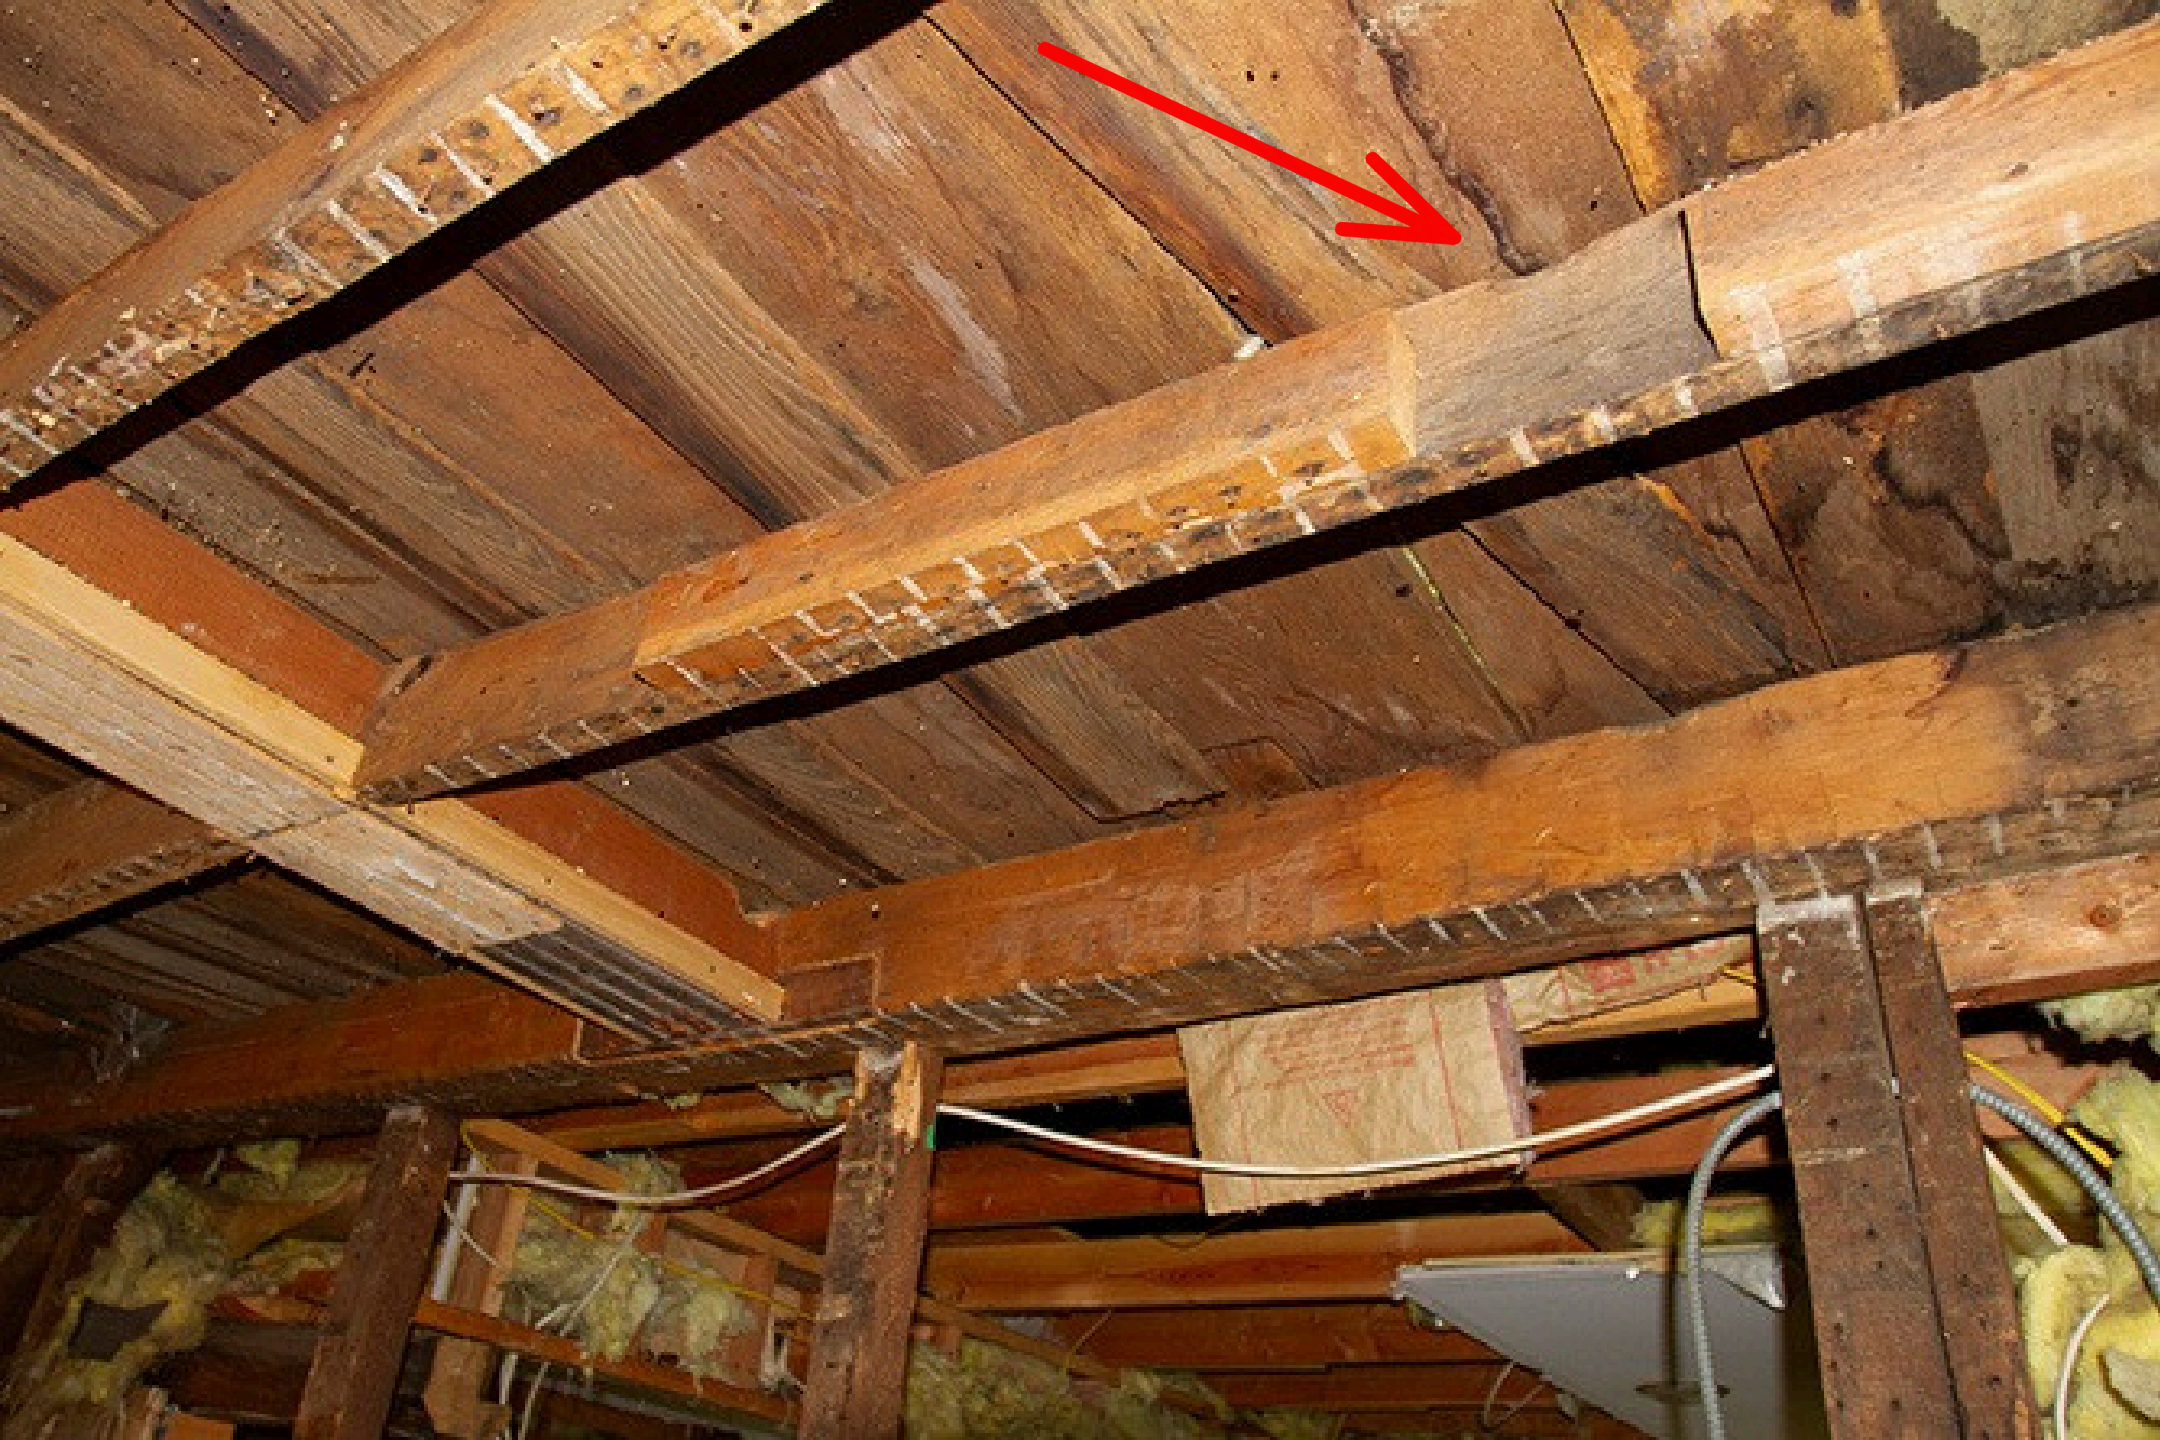
Existing framing with splices that impact structural integrity.

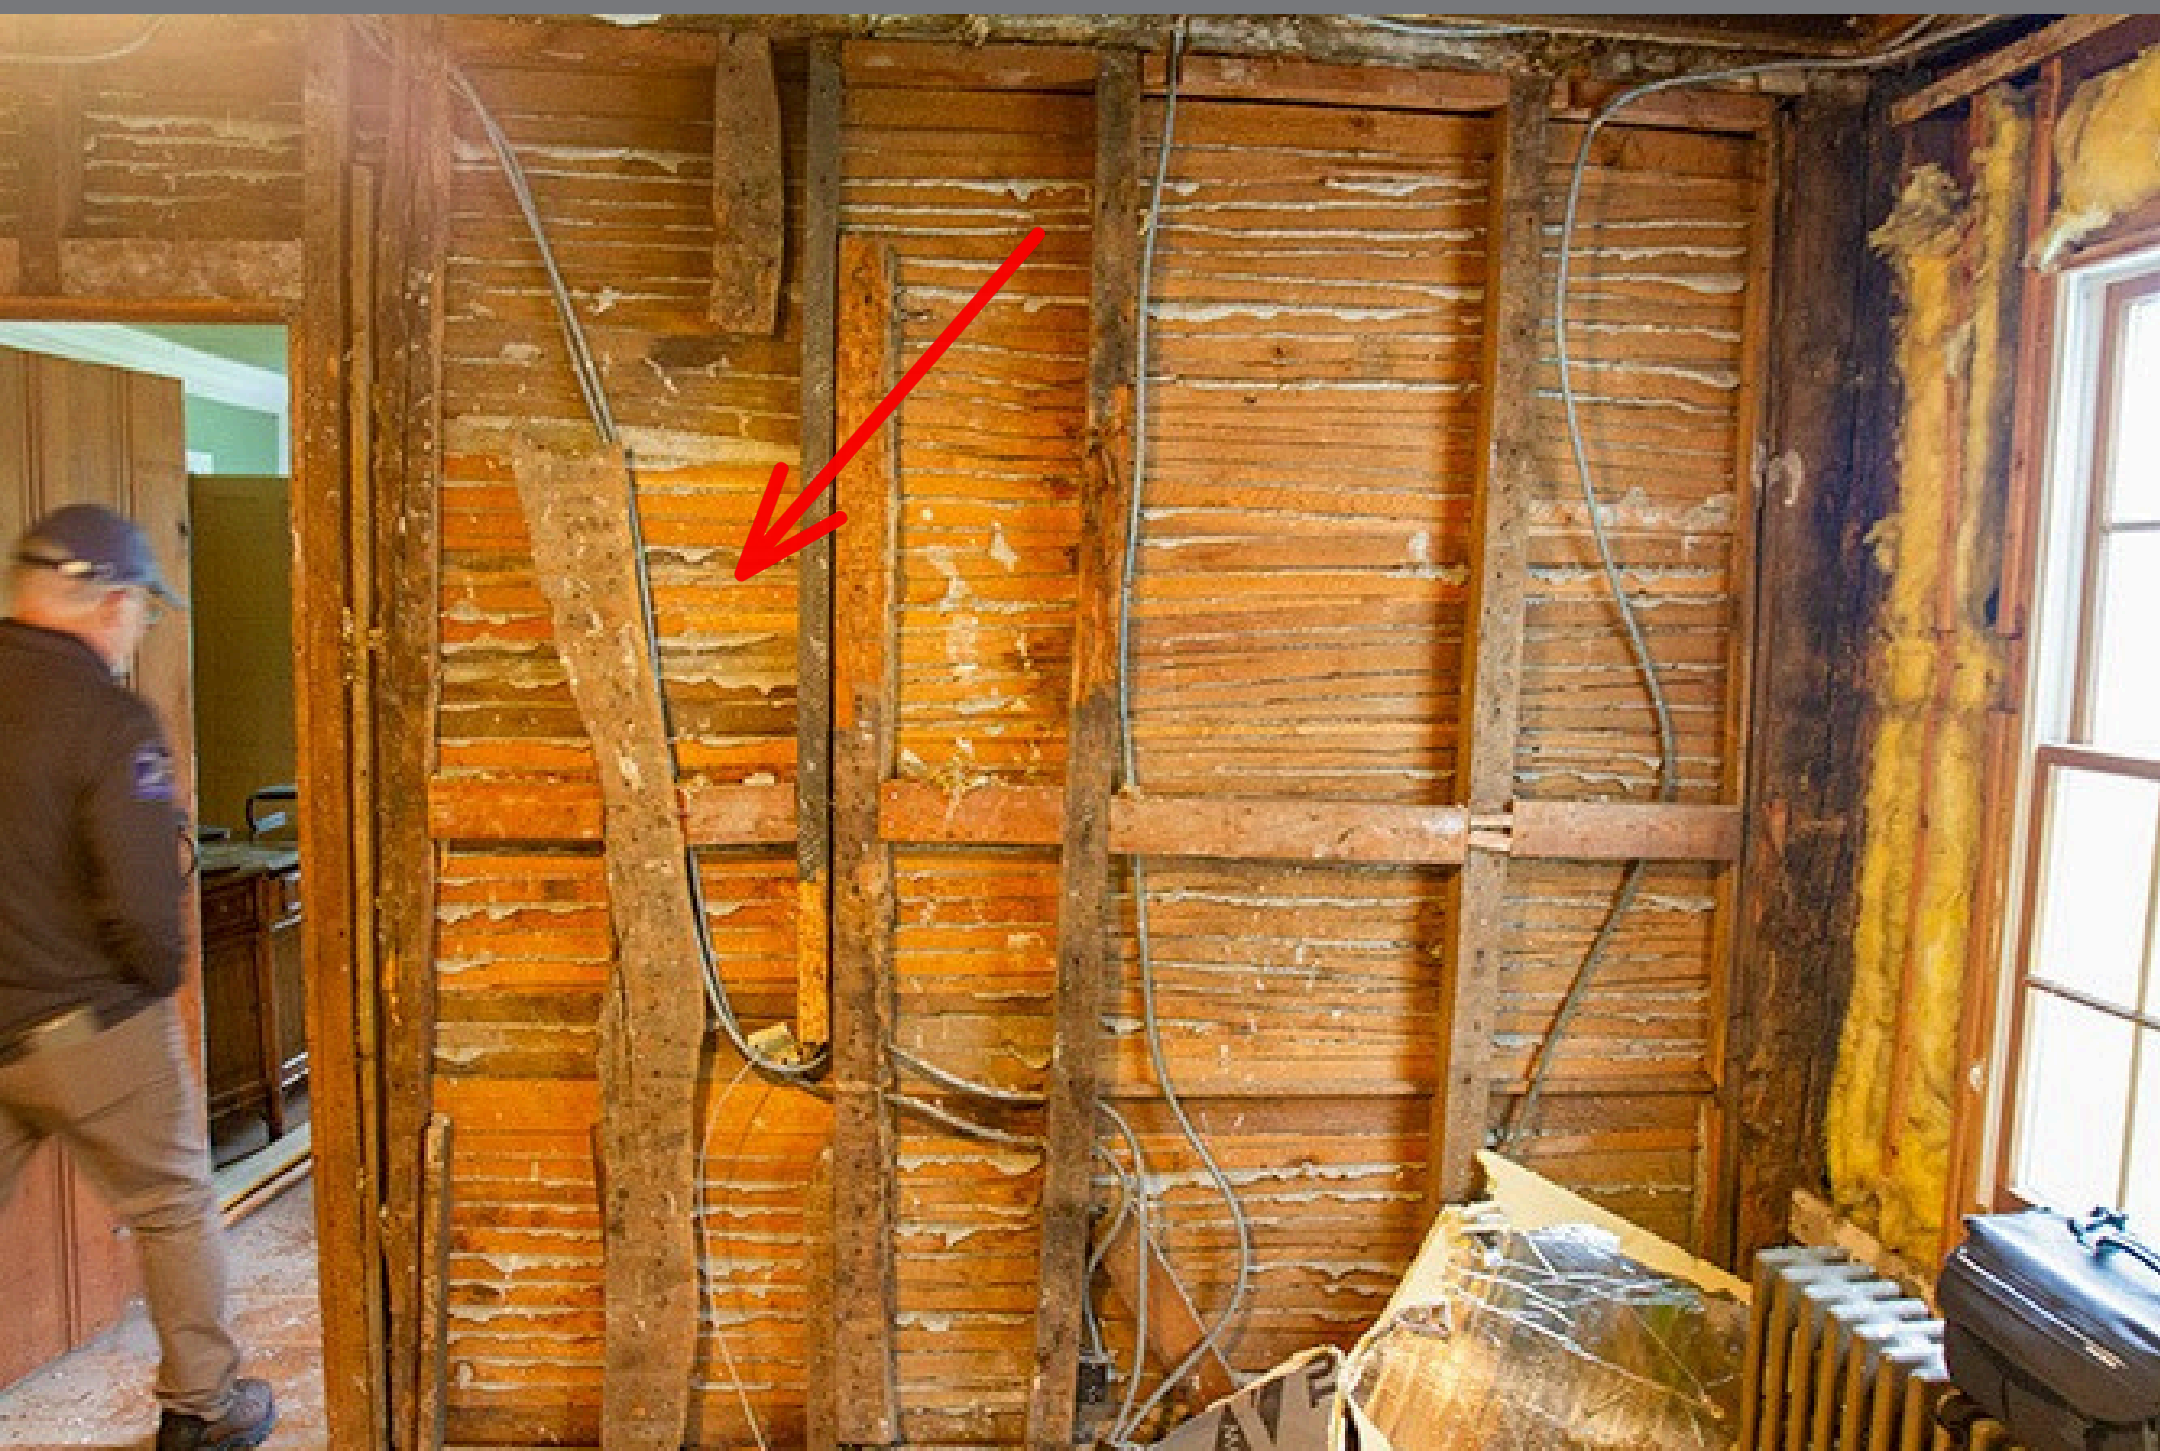
Due to the age of the rectory, we observed existing framing showing its lack of structural integrity.

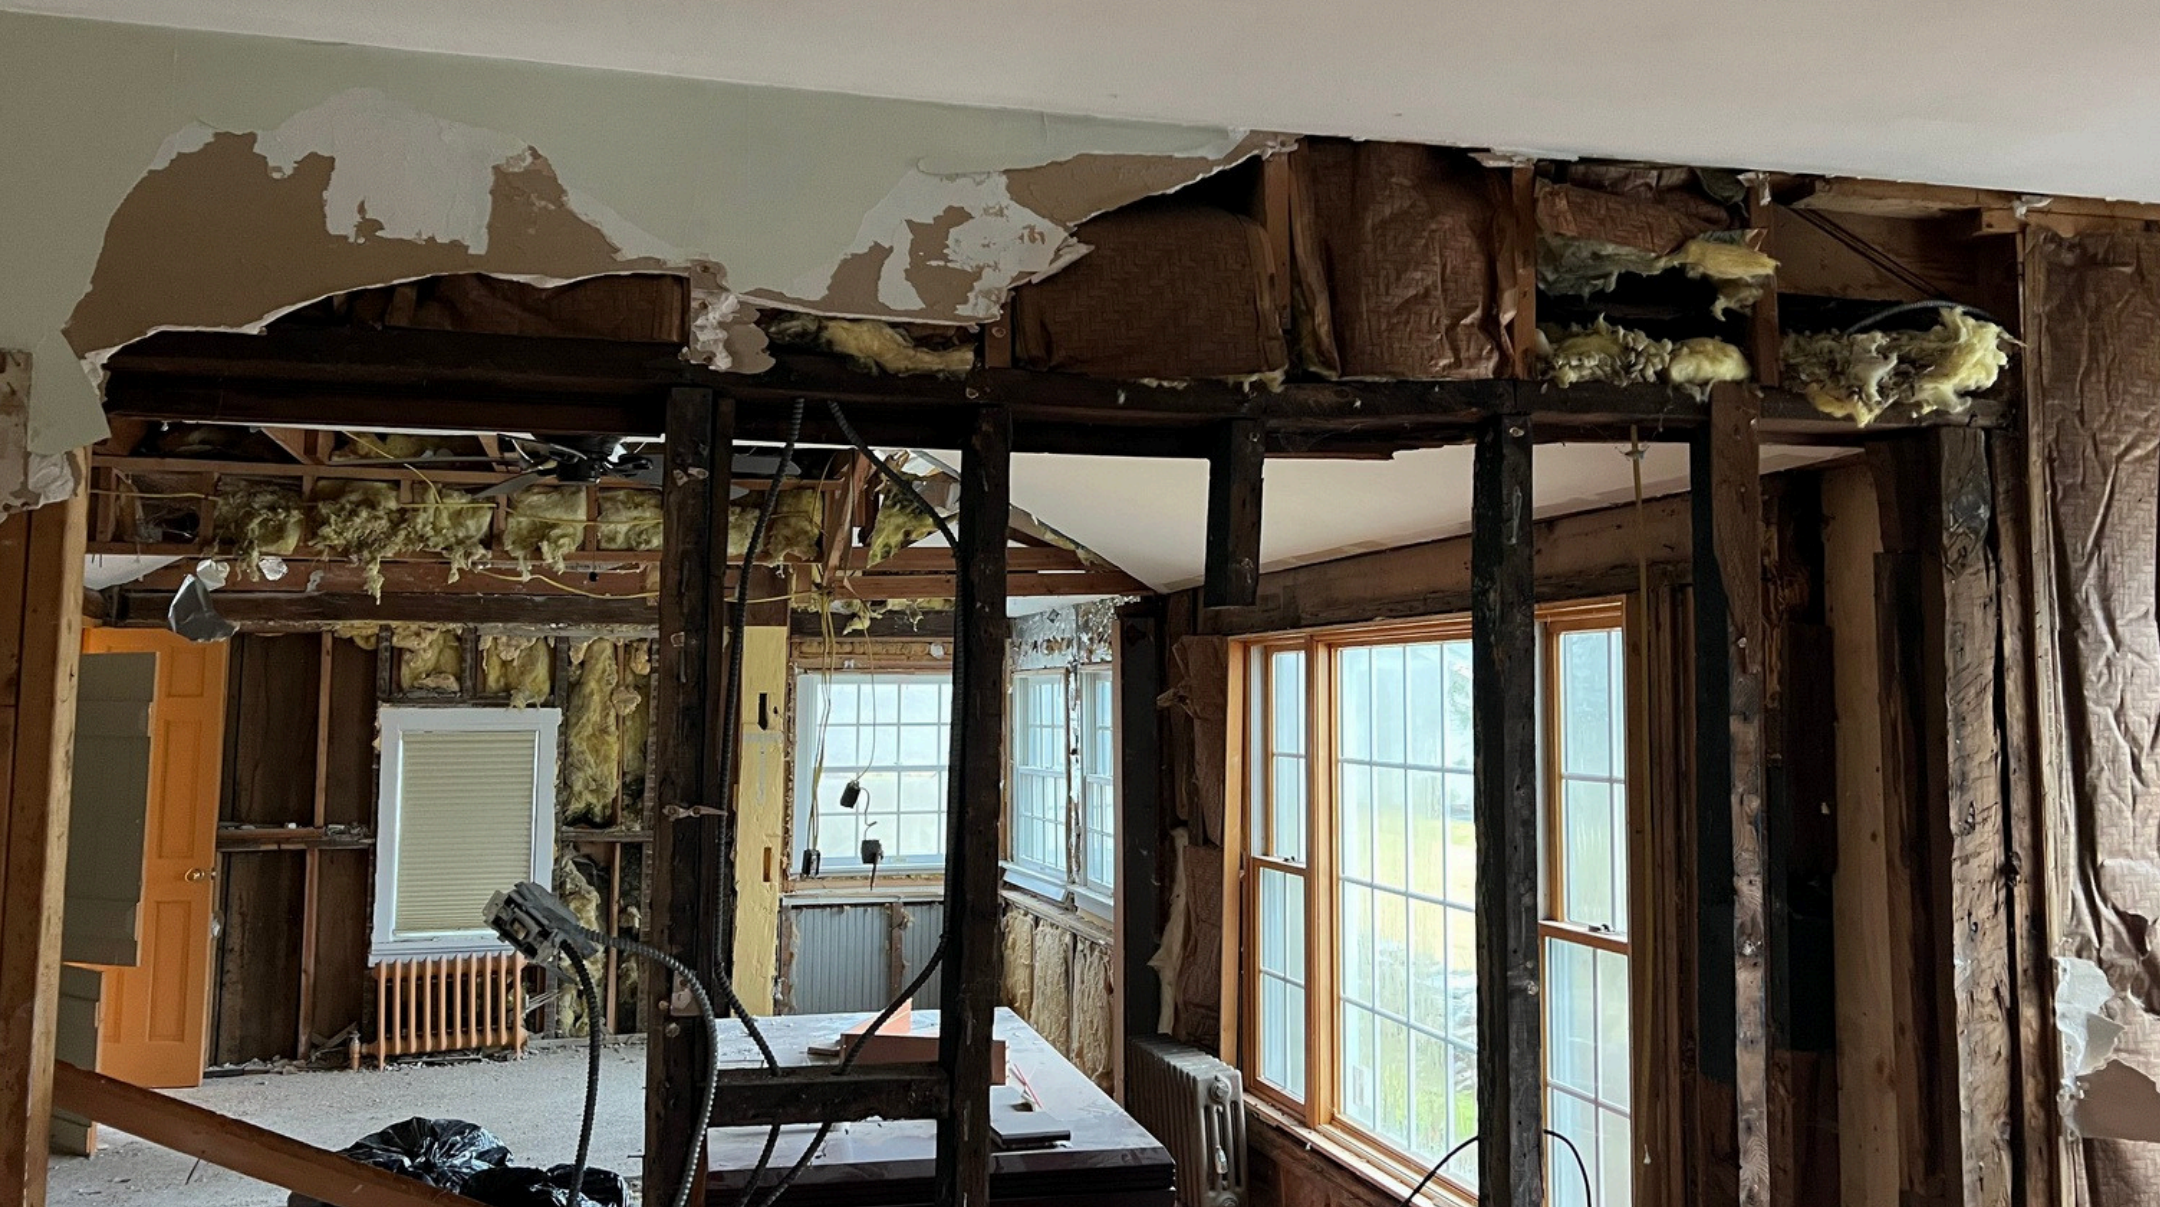
After exposing the interior framing, we discovered more outdated electrical wiring.

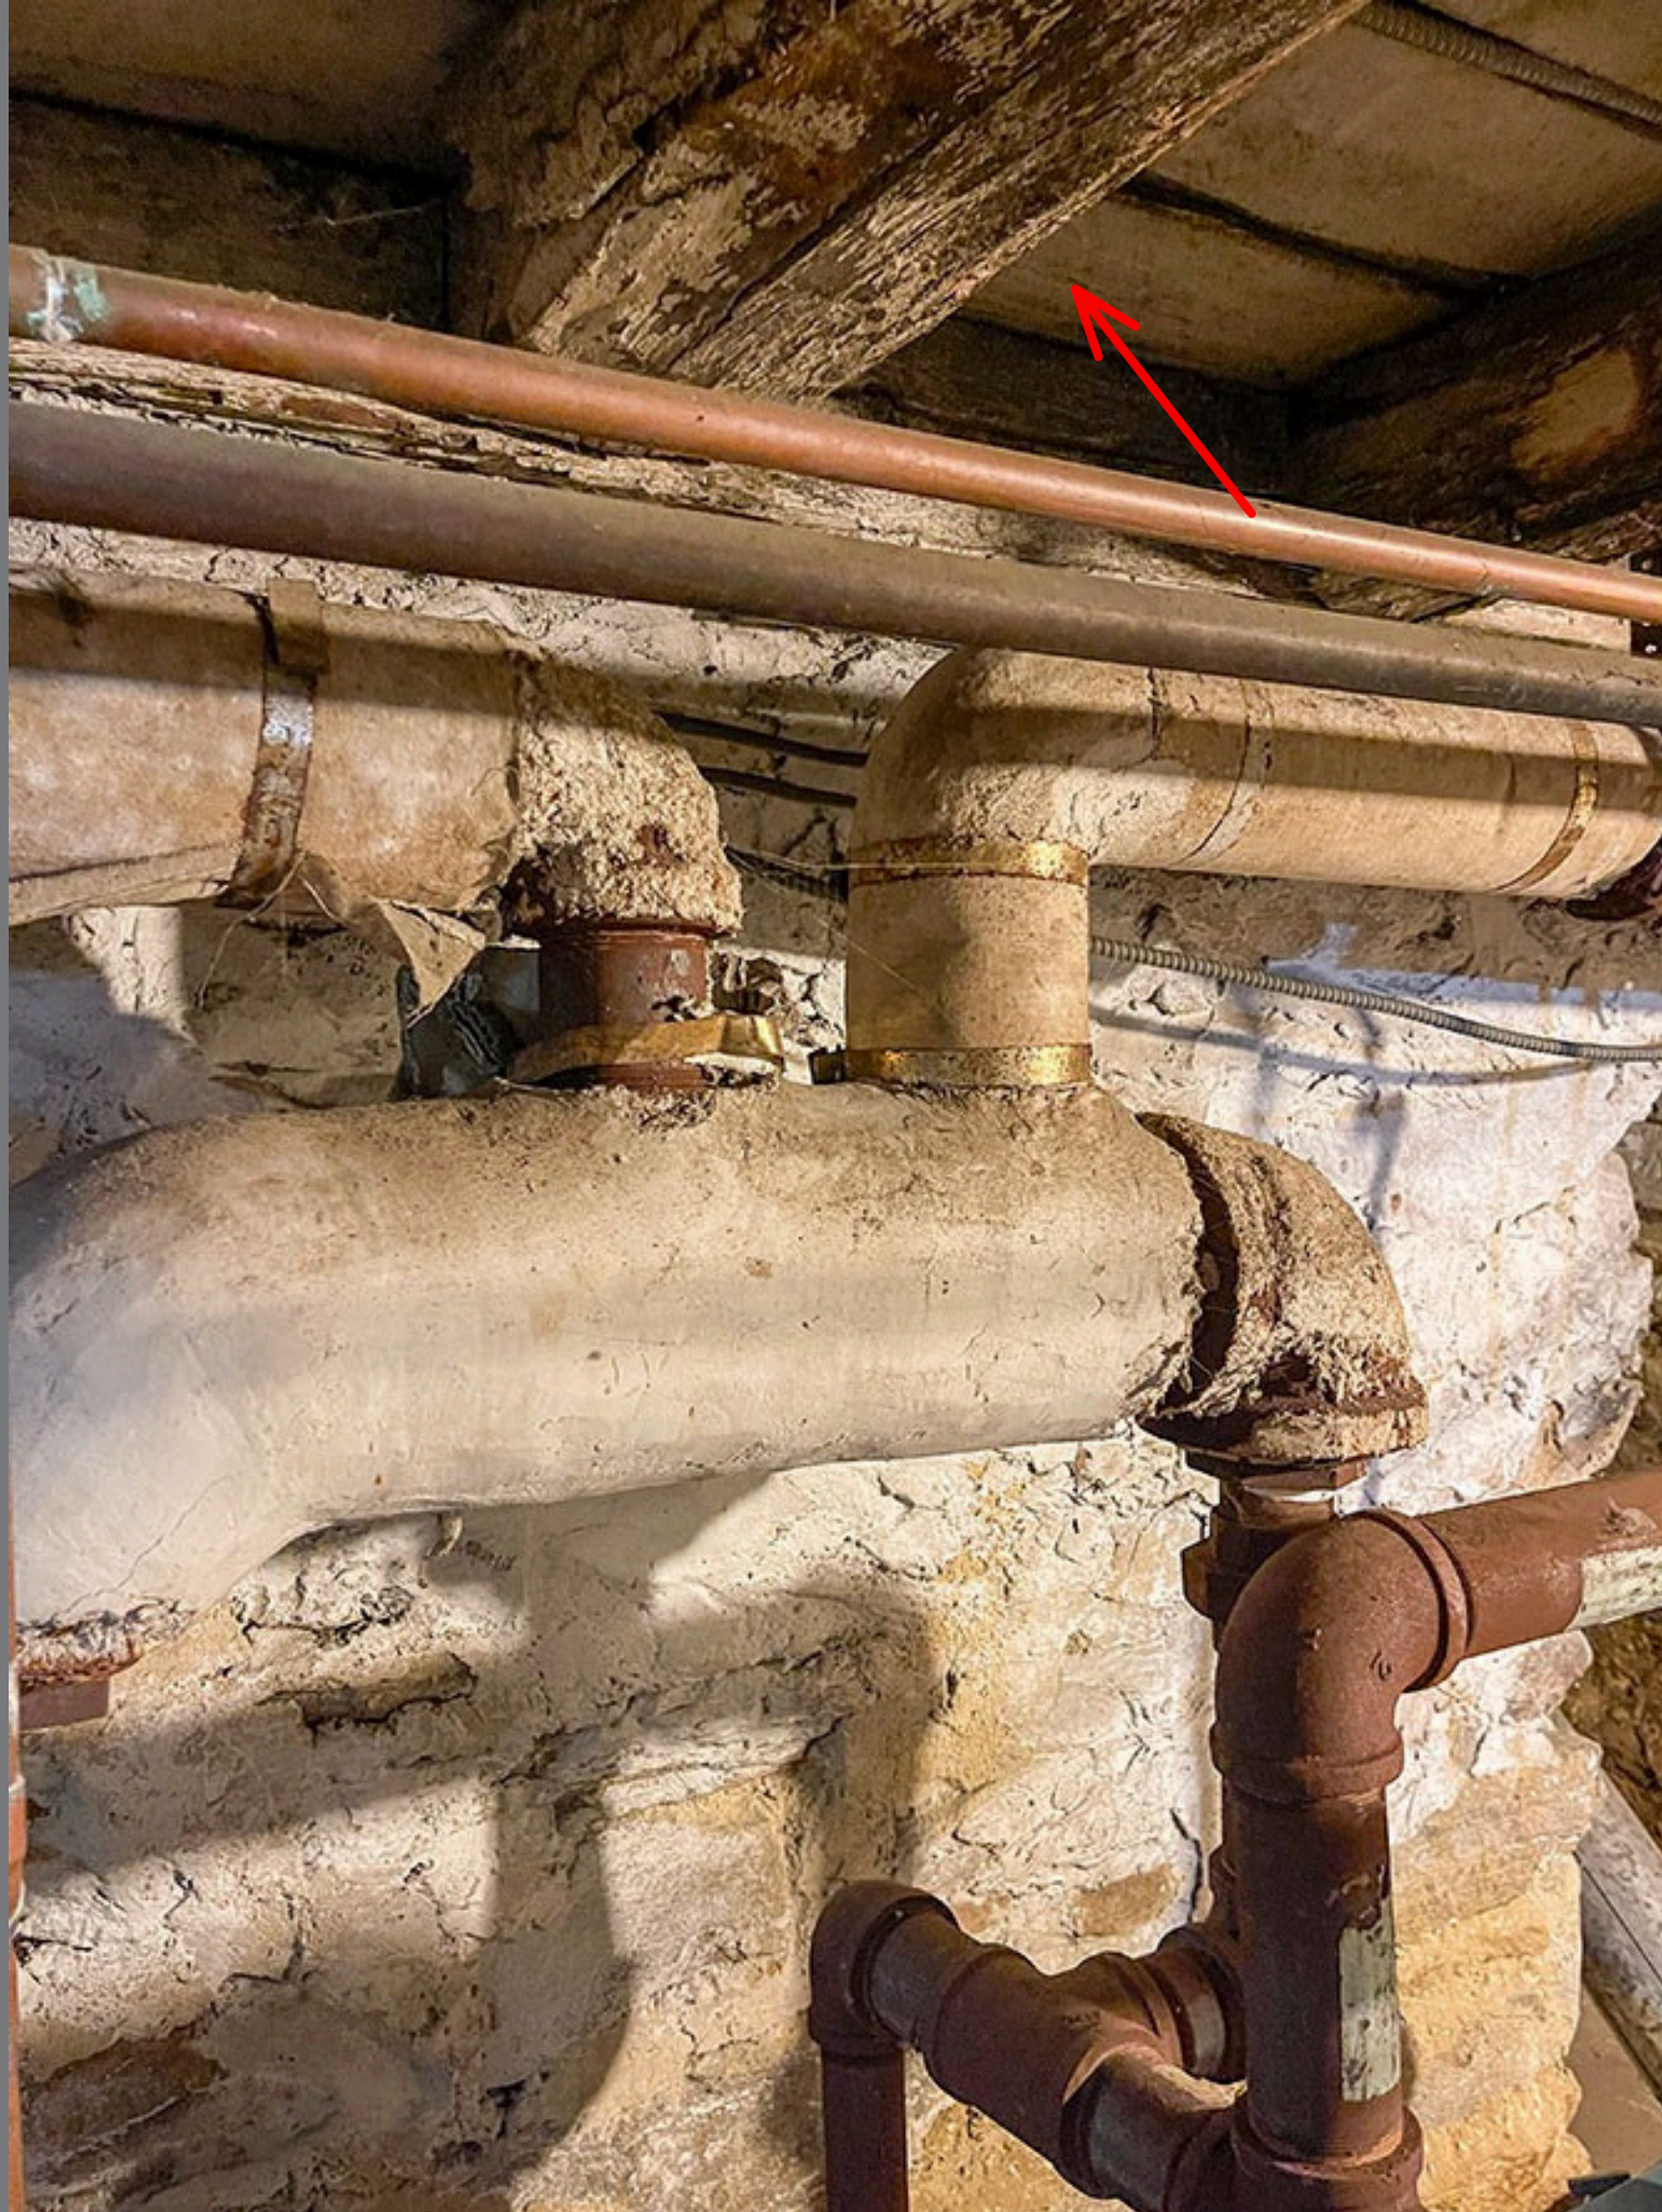
There is flood and water damage that was repaired.

There is significant dampness that can lead to mold infestation.

The sill on top of the foundation is rotted in many areas.

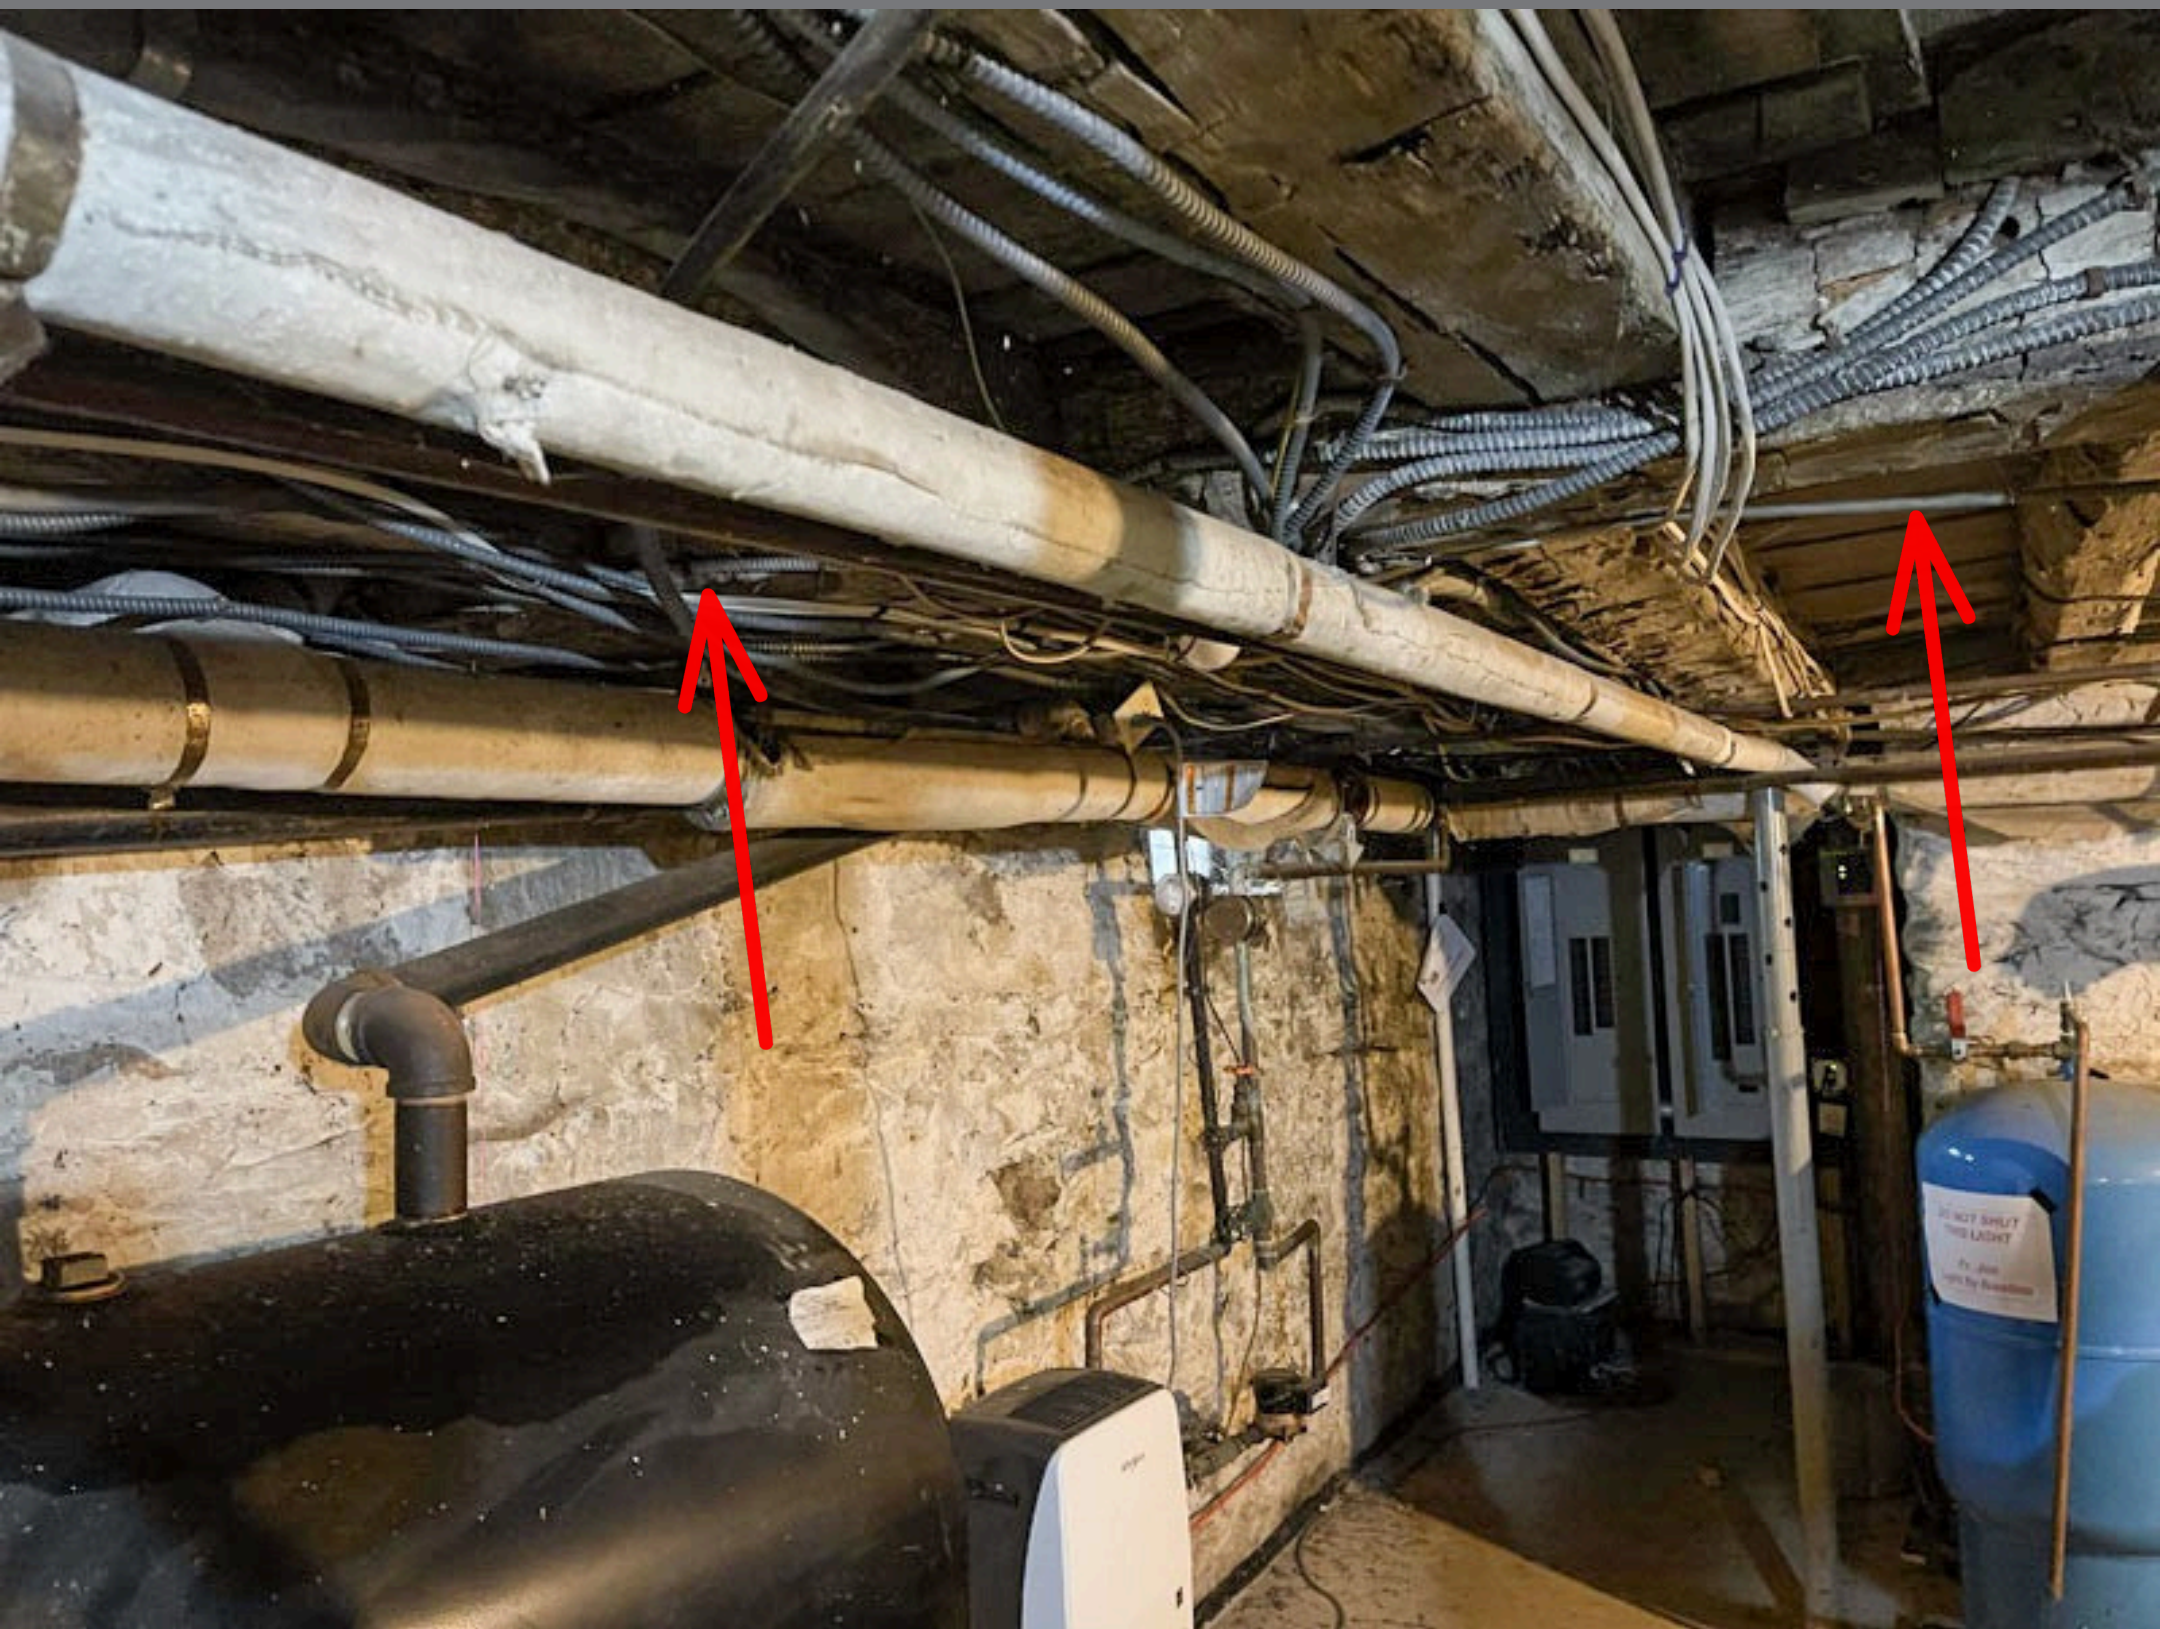
Numerous temporary repairs have been made to reinforce the floor framing with added floor joists and pump jack lally columns.

There are asbestos covered pipes and outdated, metal shield wiring (i.e. bx).

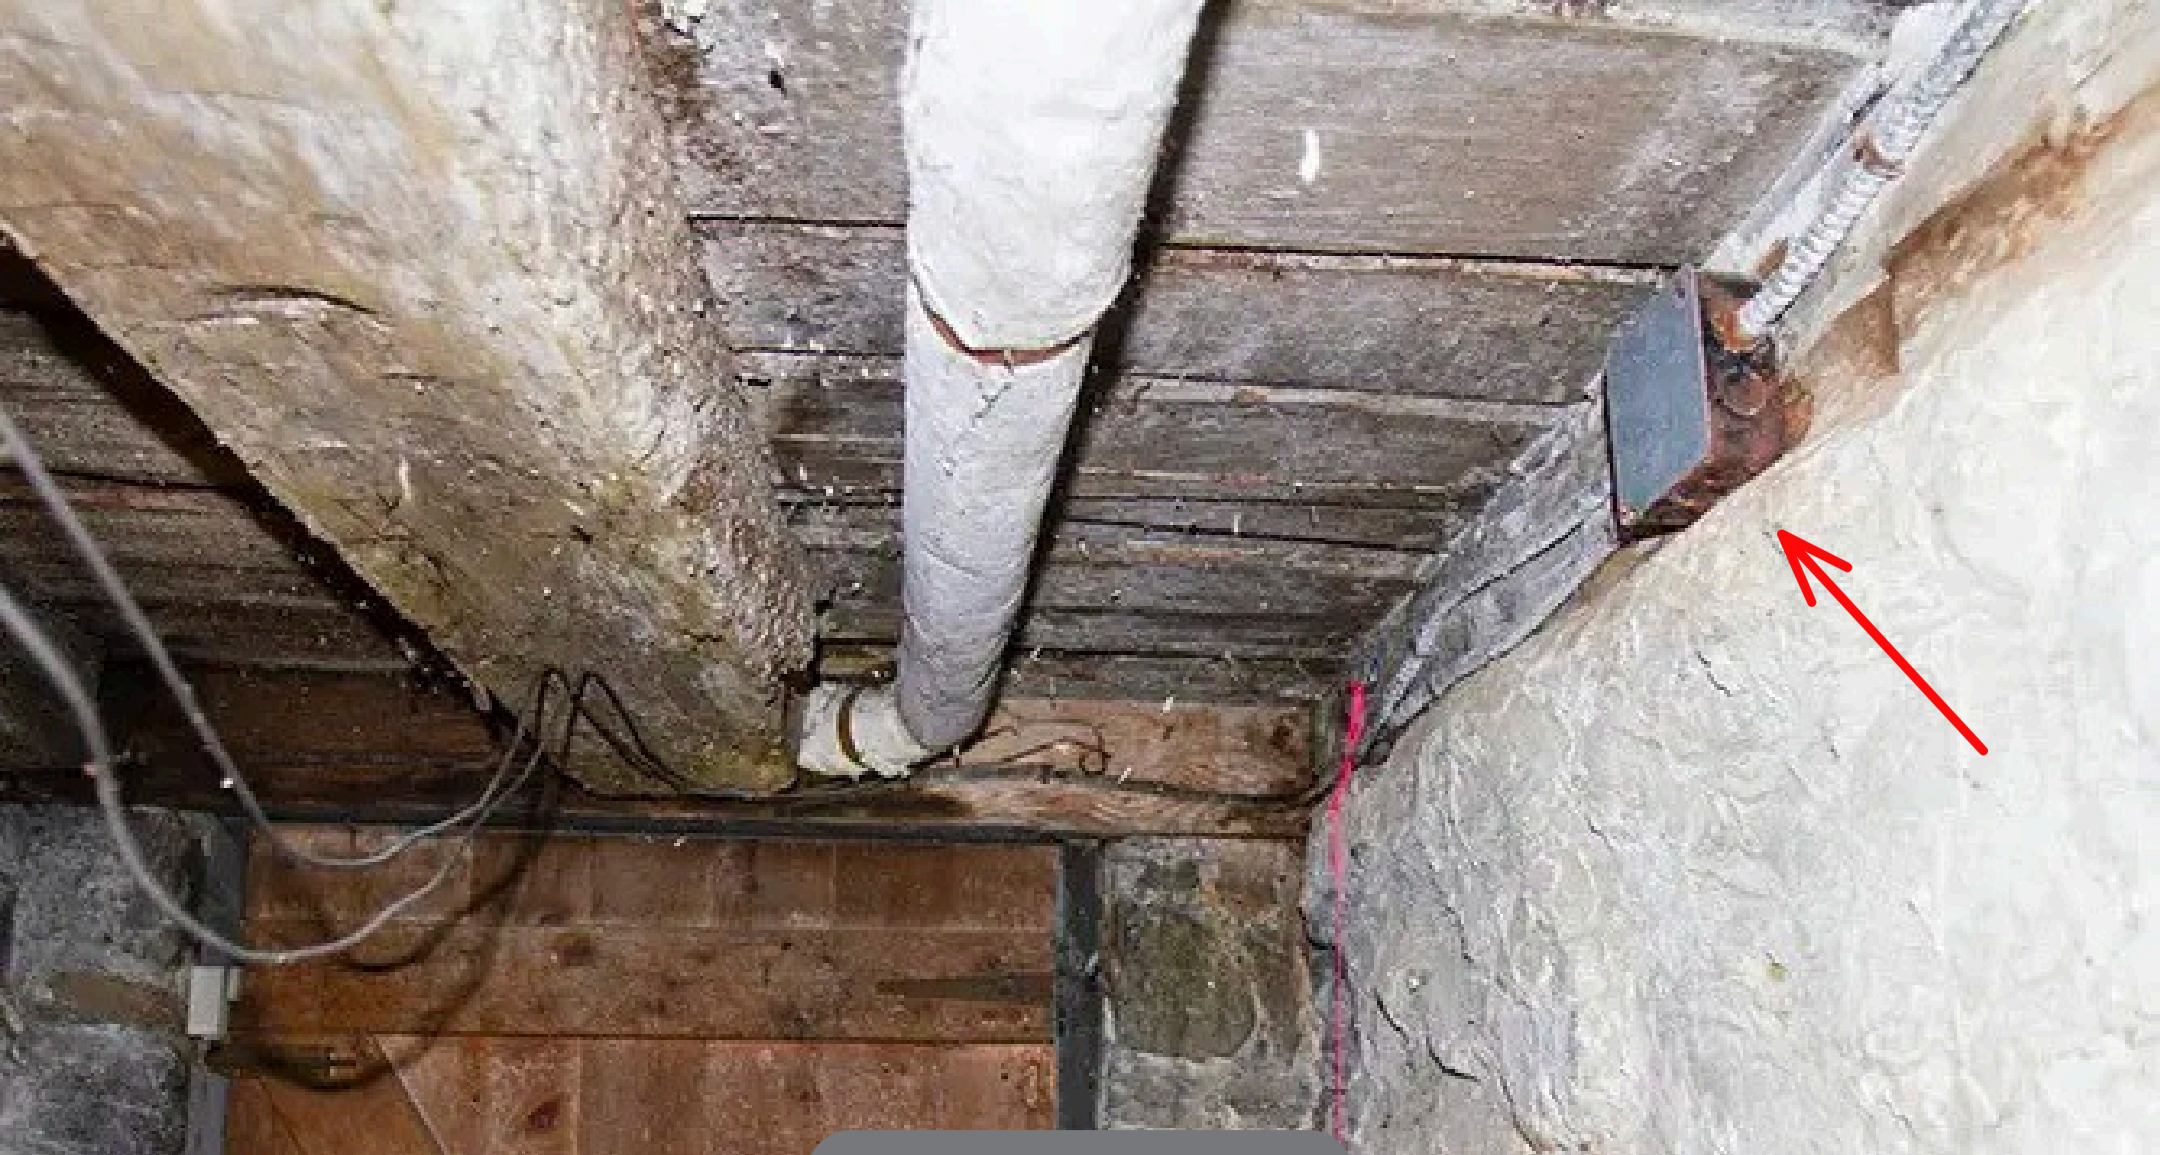
The existing wiring is not grounded posing a significant fire hazard.
