# St Francis Xavier Rectory Update

Summary of observations of the  
Rectory at 26 Chestnut Land  
Road, New Milford

- 26 Chestnut Land Road, New Milford
- Built in 1810; 3900 square feet
- Not on New Milford Historical Registry

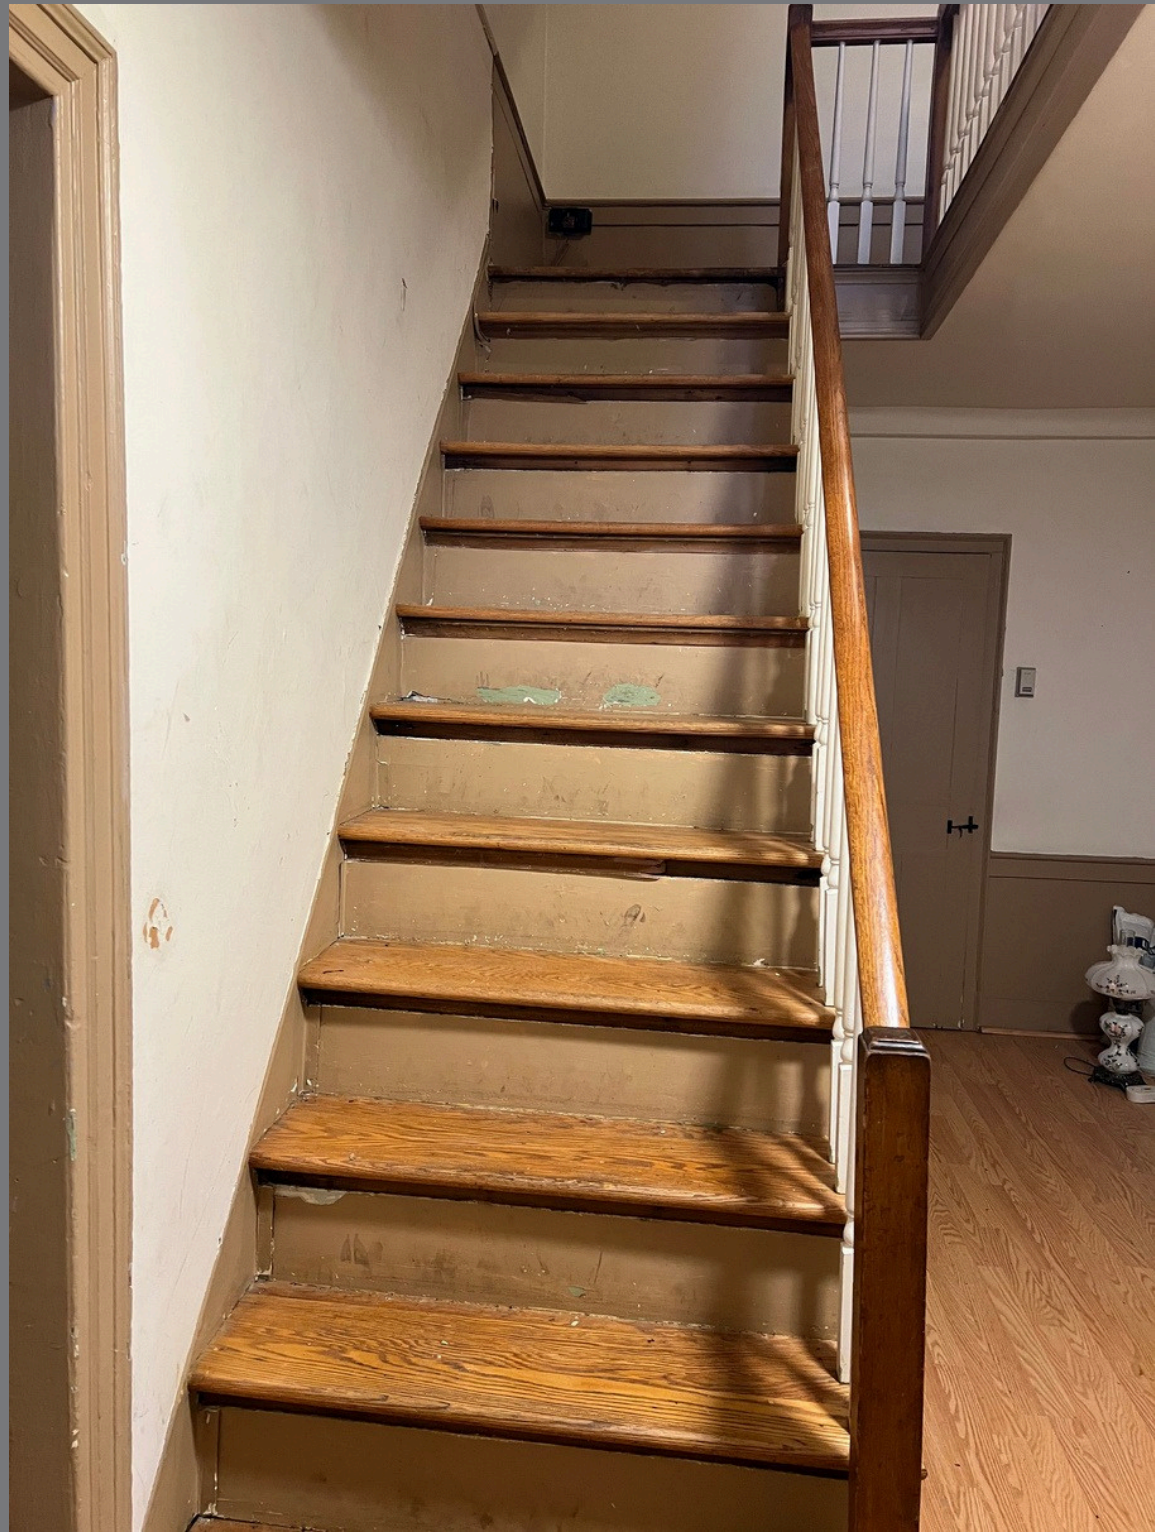
Current staircase risers are too steep, handrail/guardrails are not up to current building code. They are less than 36 inches high. The hallway guardrail is also less than 36 inches high and does not comply with current building code.

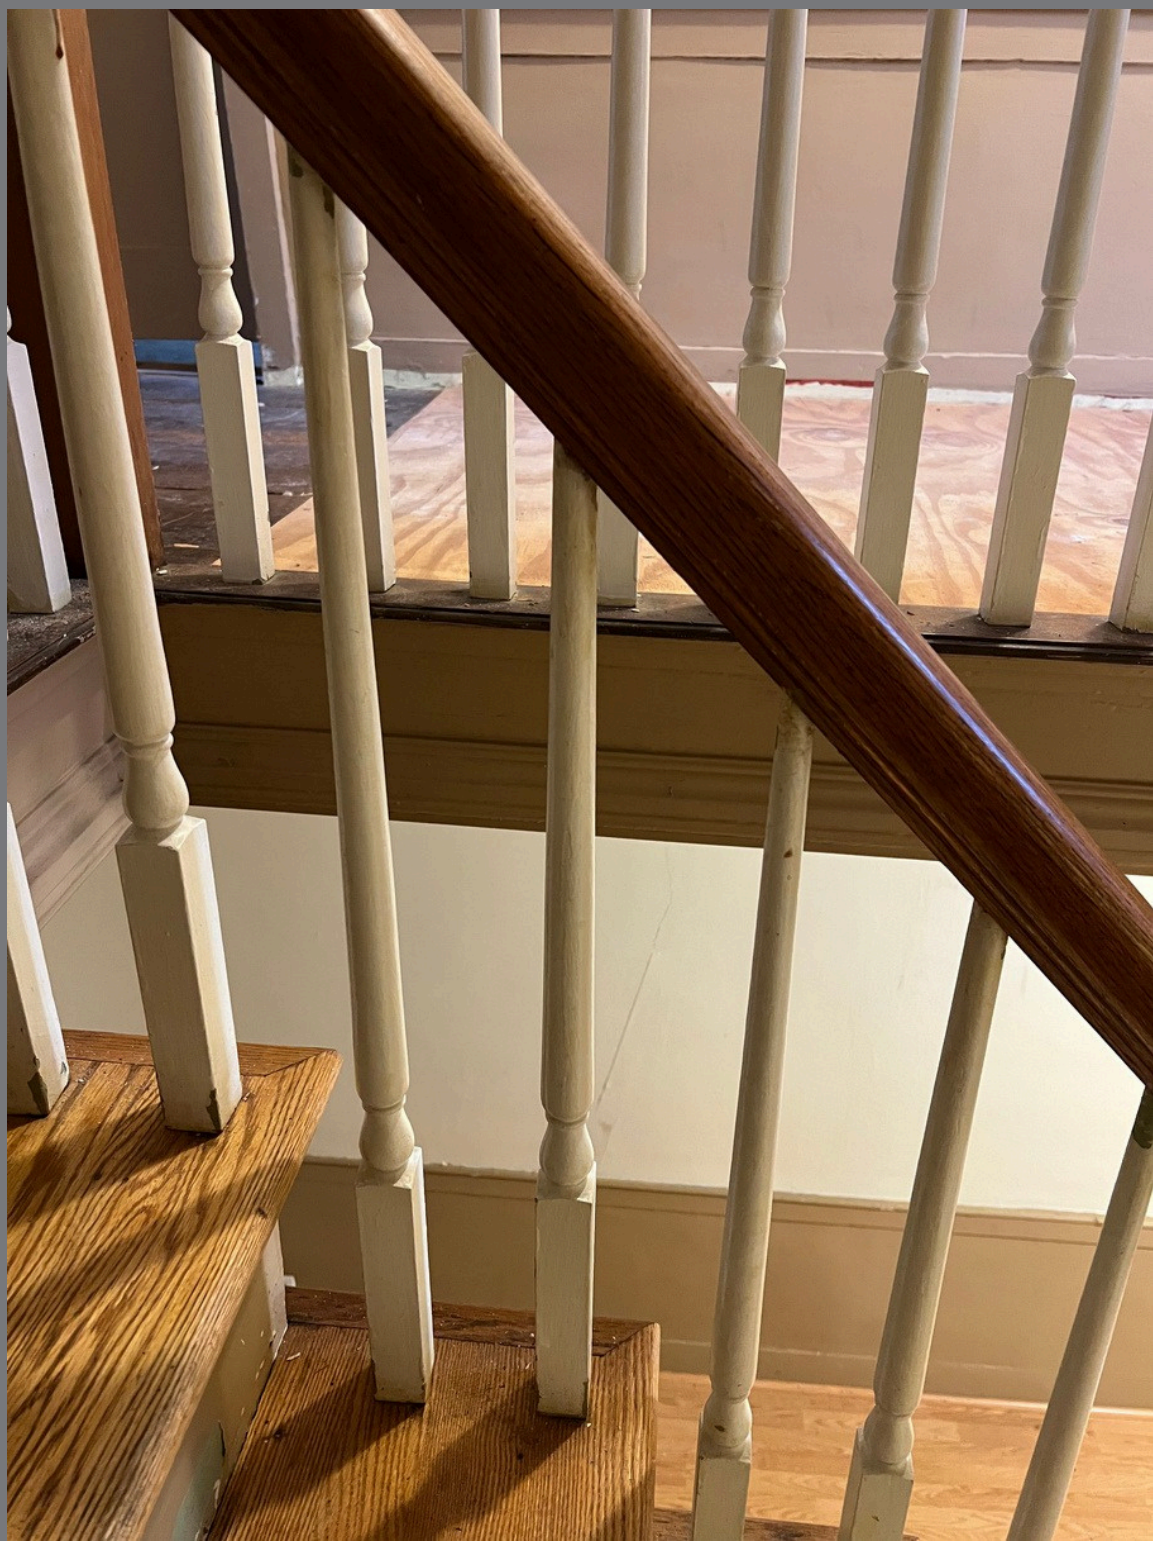
The handrails and guardrails are less than 36 inches wide creating a staircase hazard.

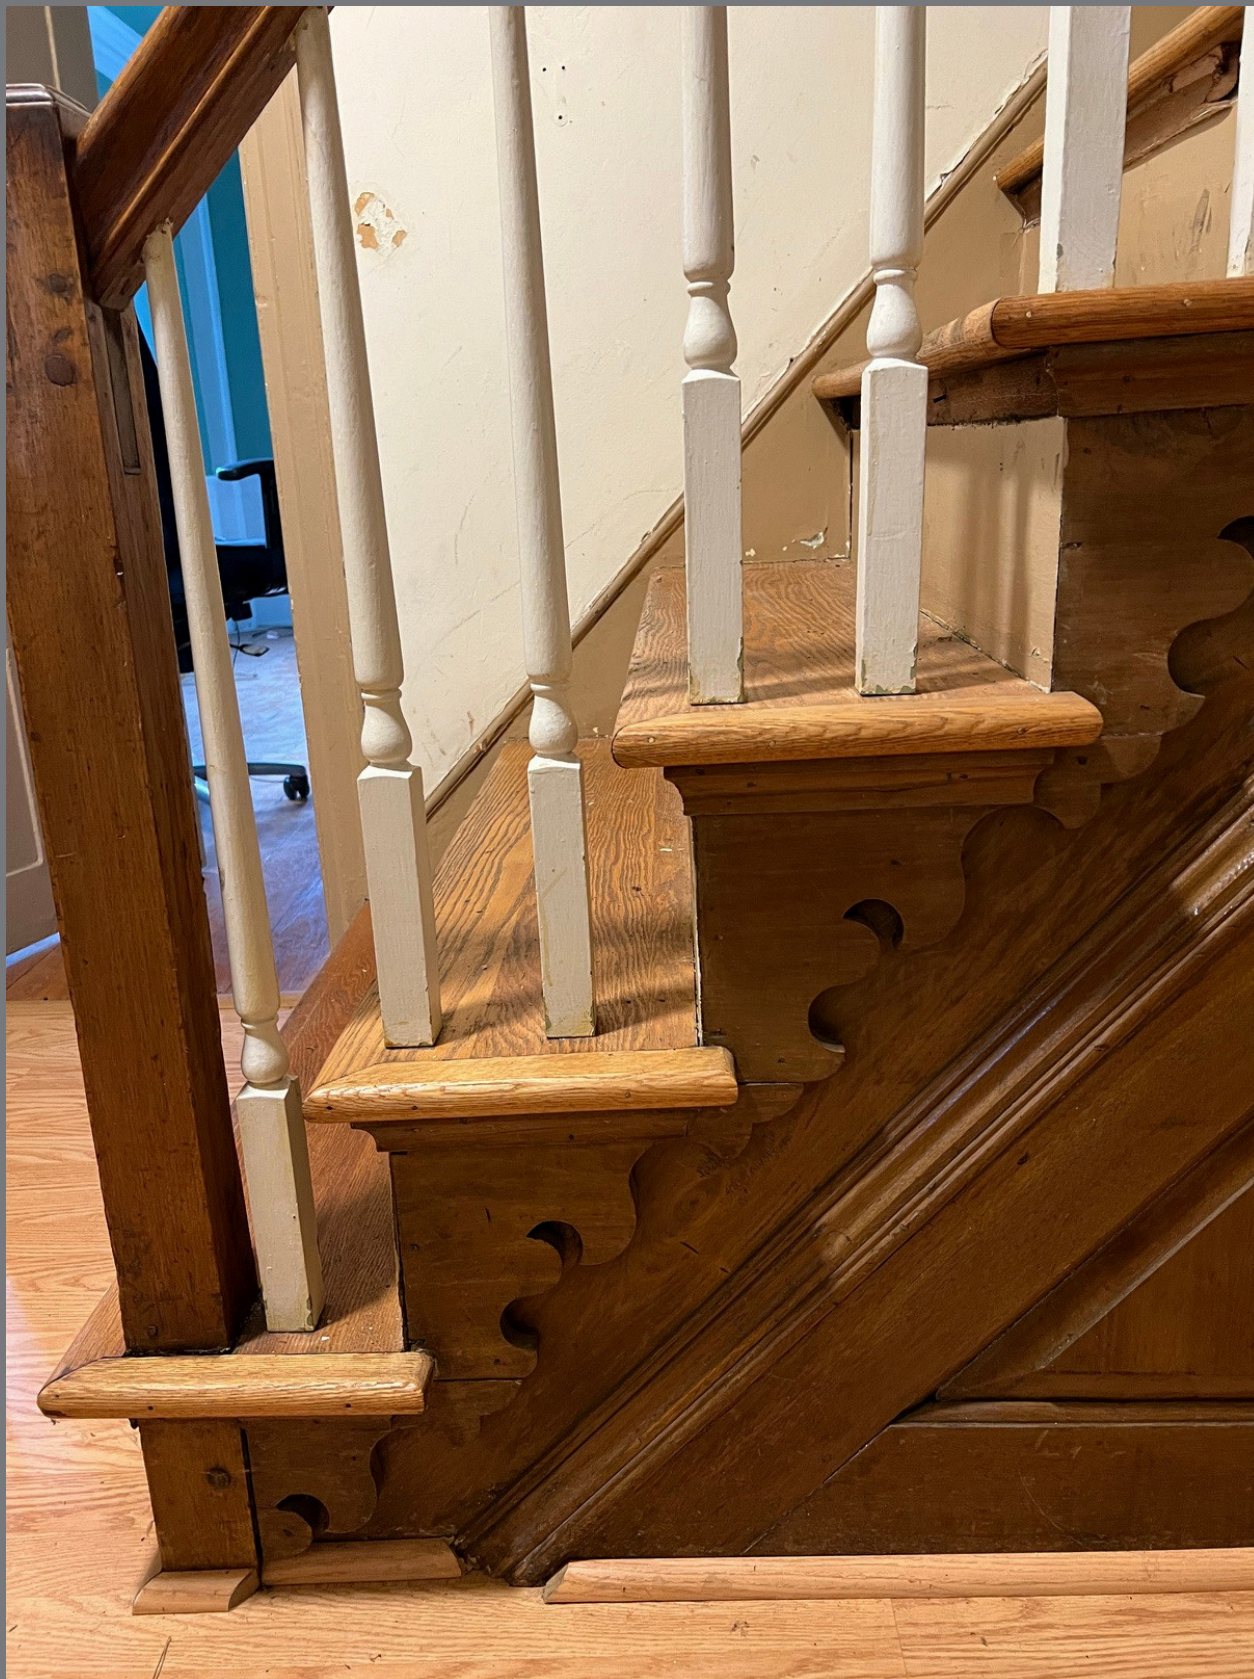
Floor surface is uneven contributing to tripping and falling hazard.

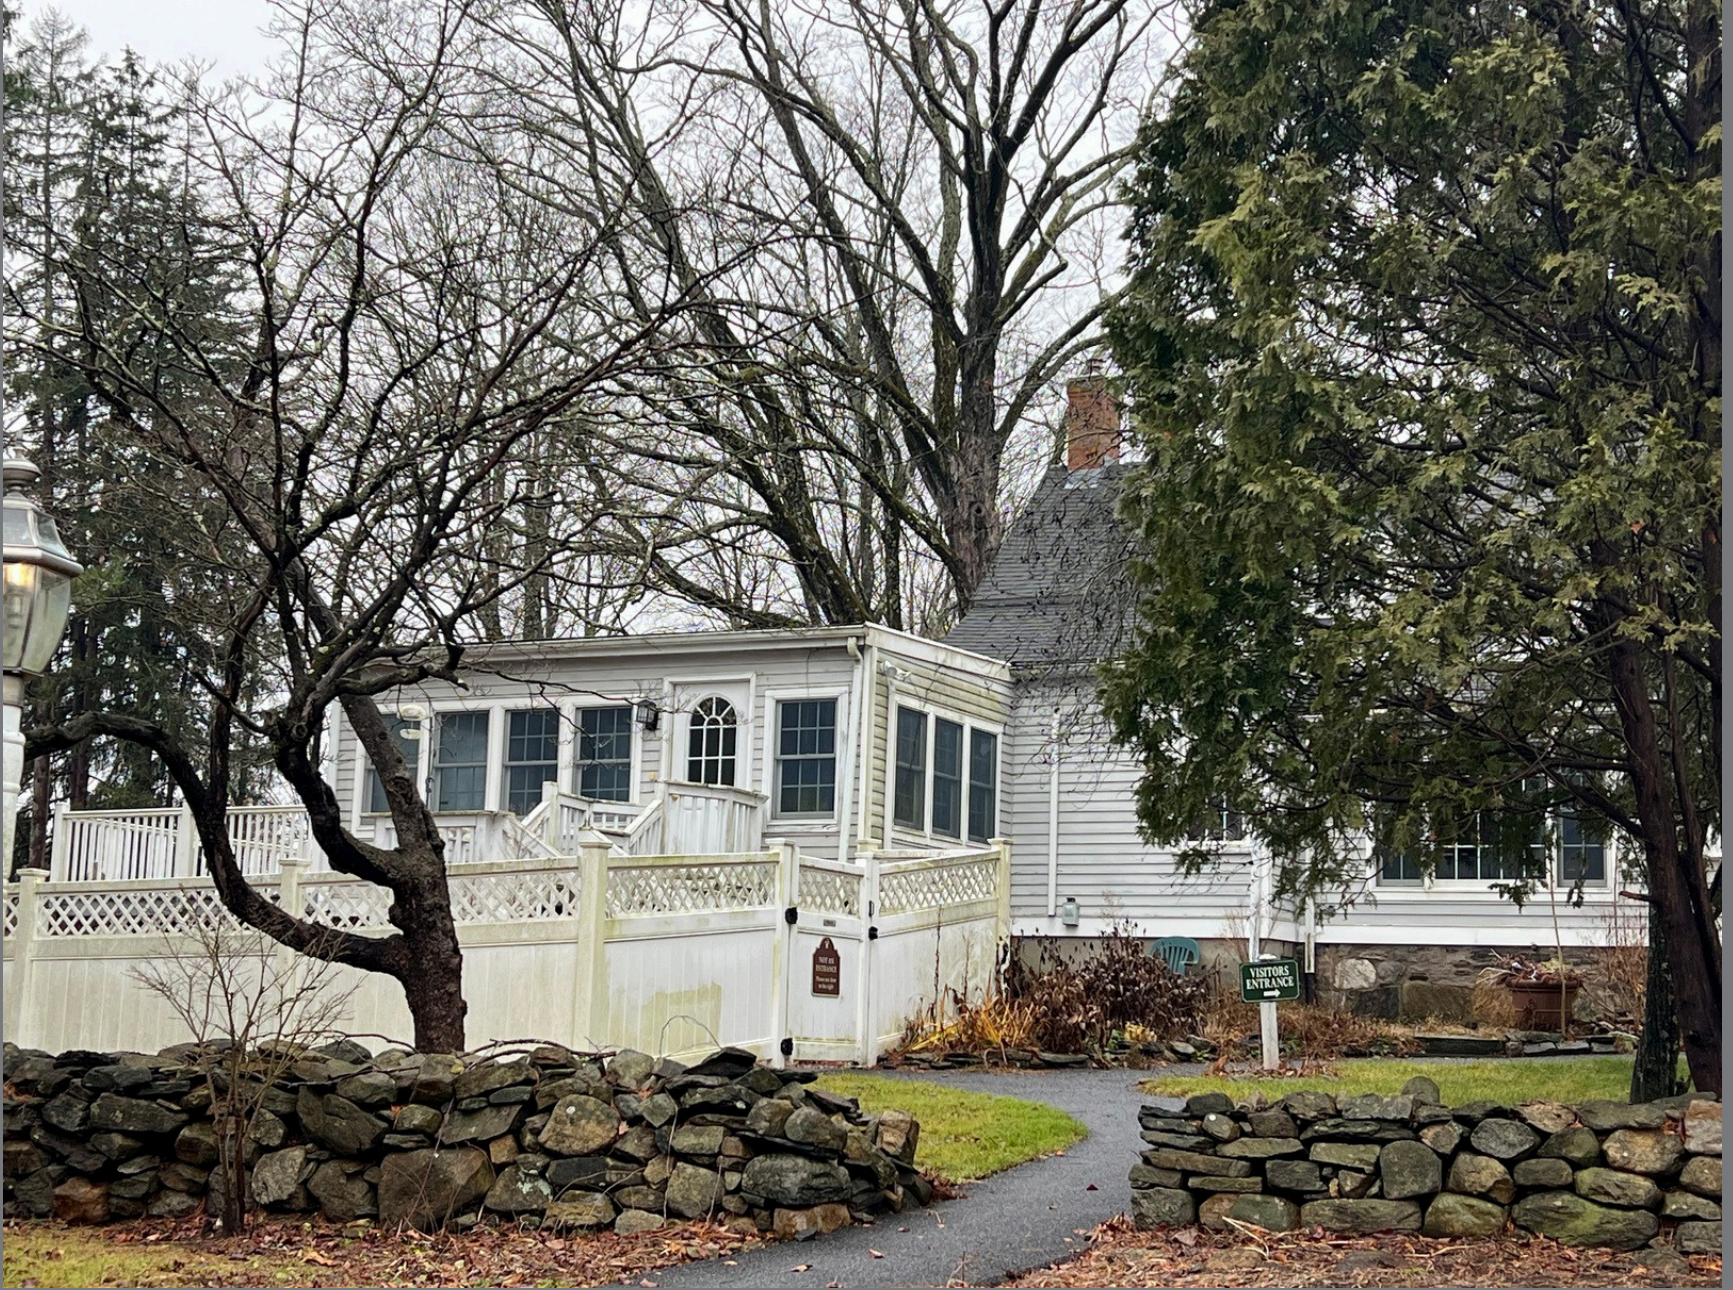
The kitchen porch deck addition built over a crawlspace and has several roof styles creating potential ice buildup and roof leaks.

The crawlspace has rodent infestation.

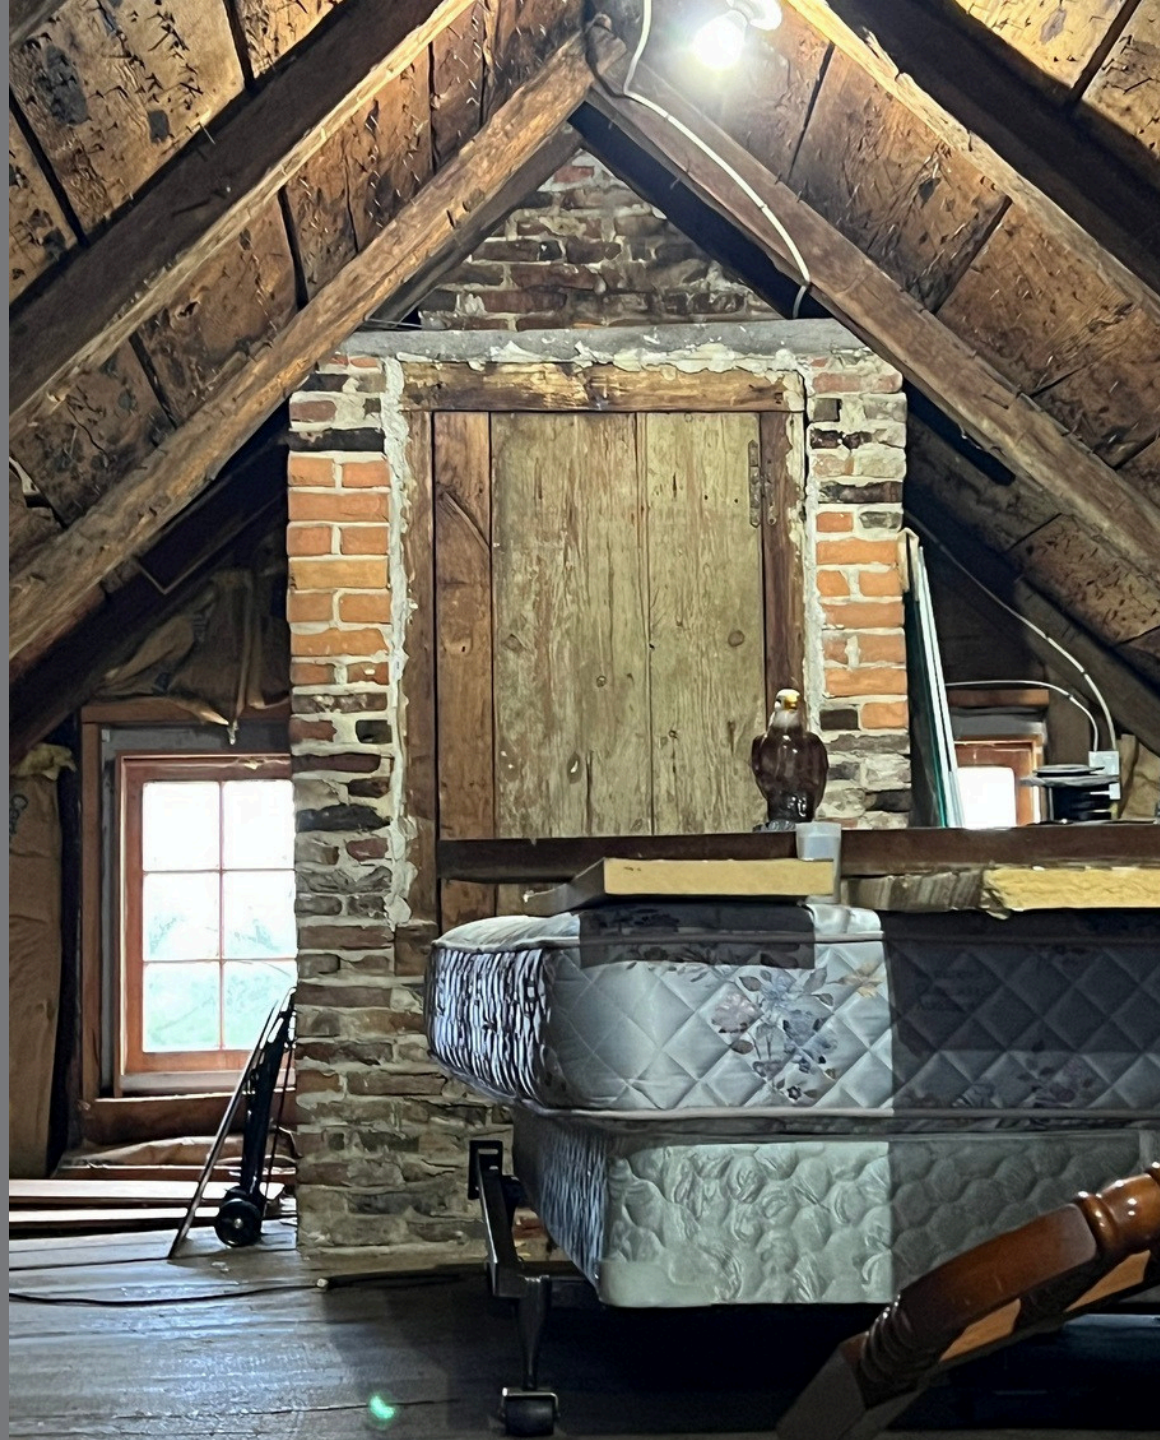
The existing chimney that serves the wood stove on the first floor does not exit through the roof.

The door allows smoke from the woodstove to enter the attic.

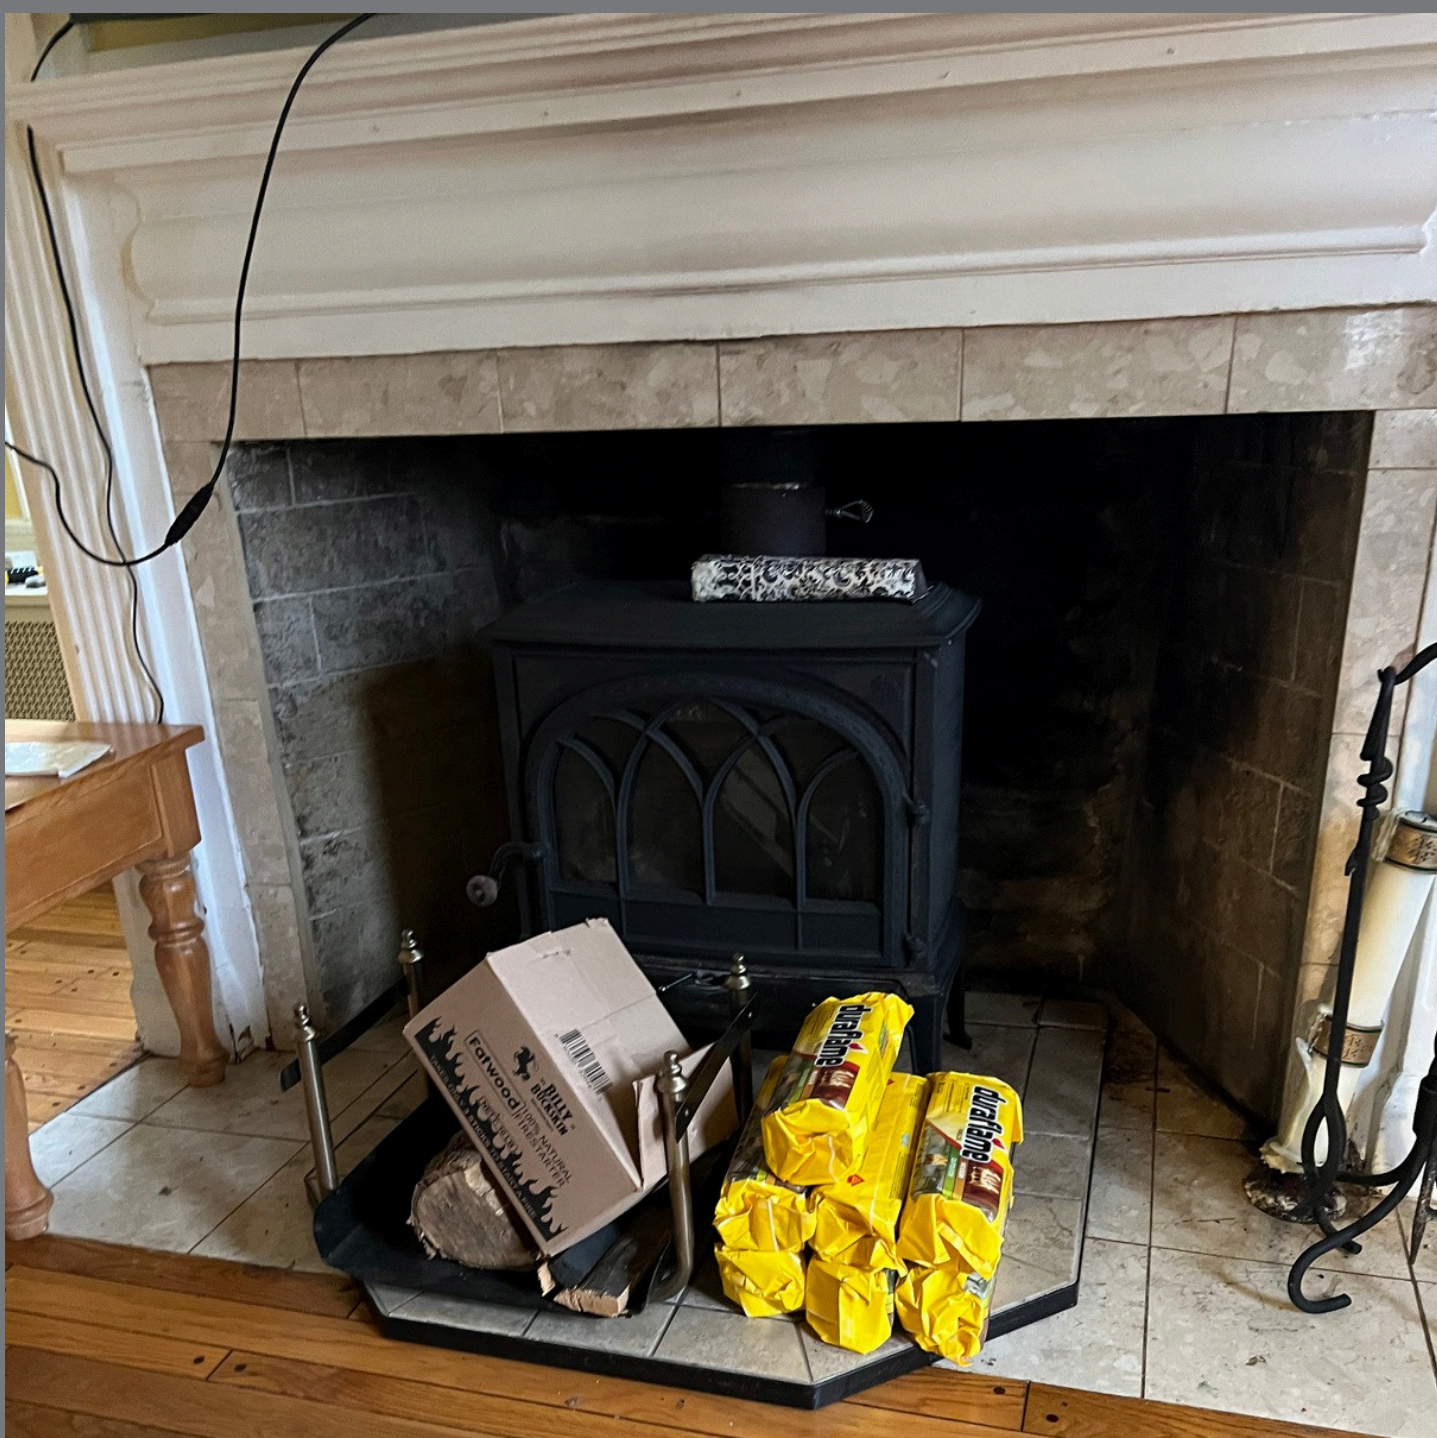
Rectory was fumigated in the spring of 2025 to remove cigar smoke and pet odors.

However, fumigation was not successful.

Sheet rock was removed in an attempt to remove the odors.

This also was not successful to remediate the smell of cigar smoke and pet odors.

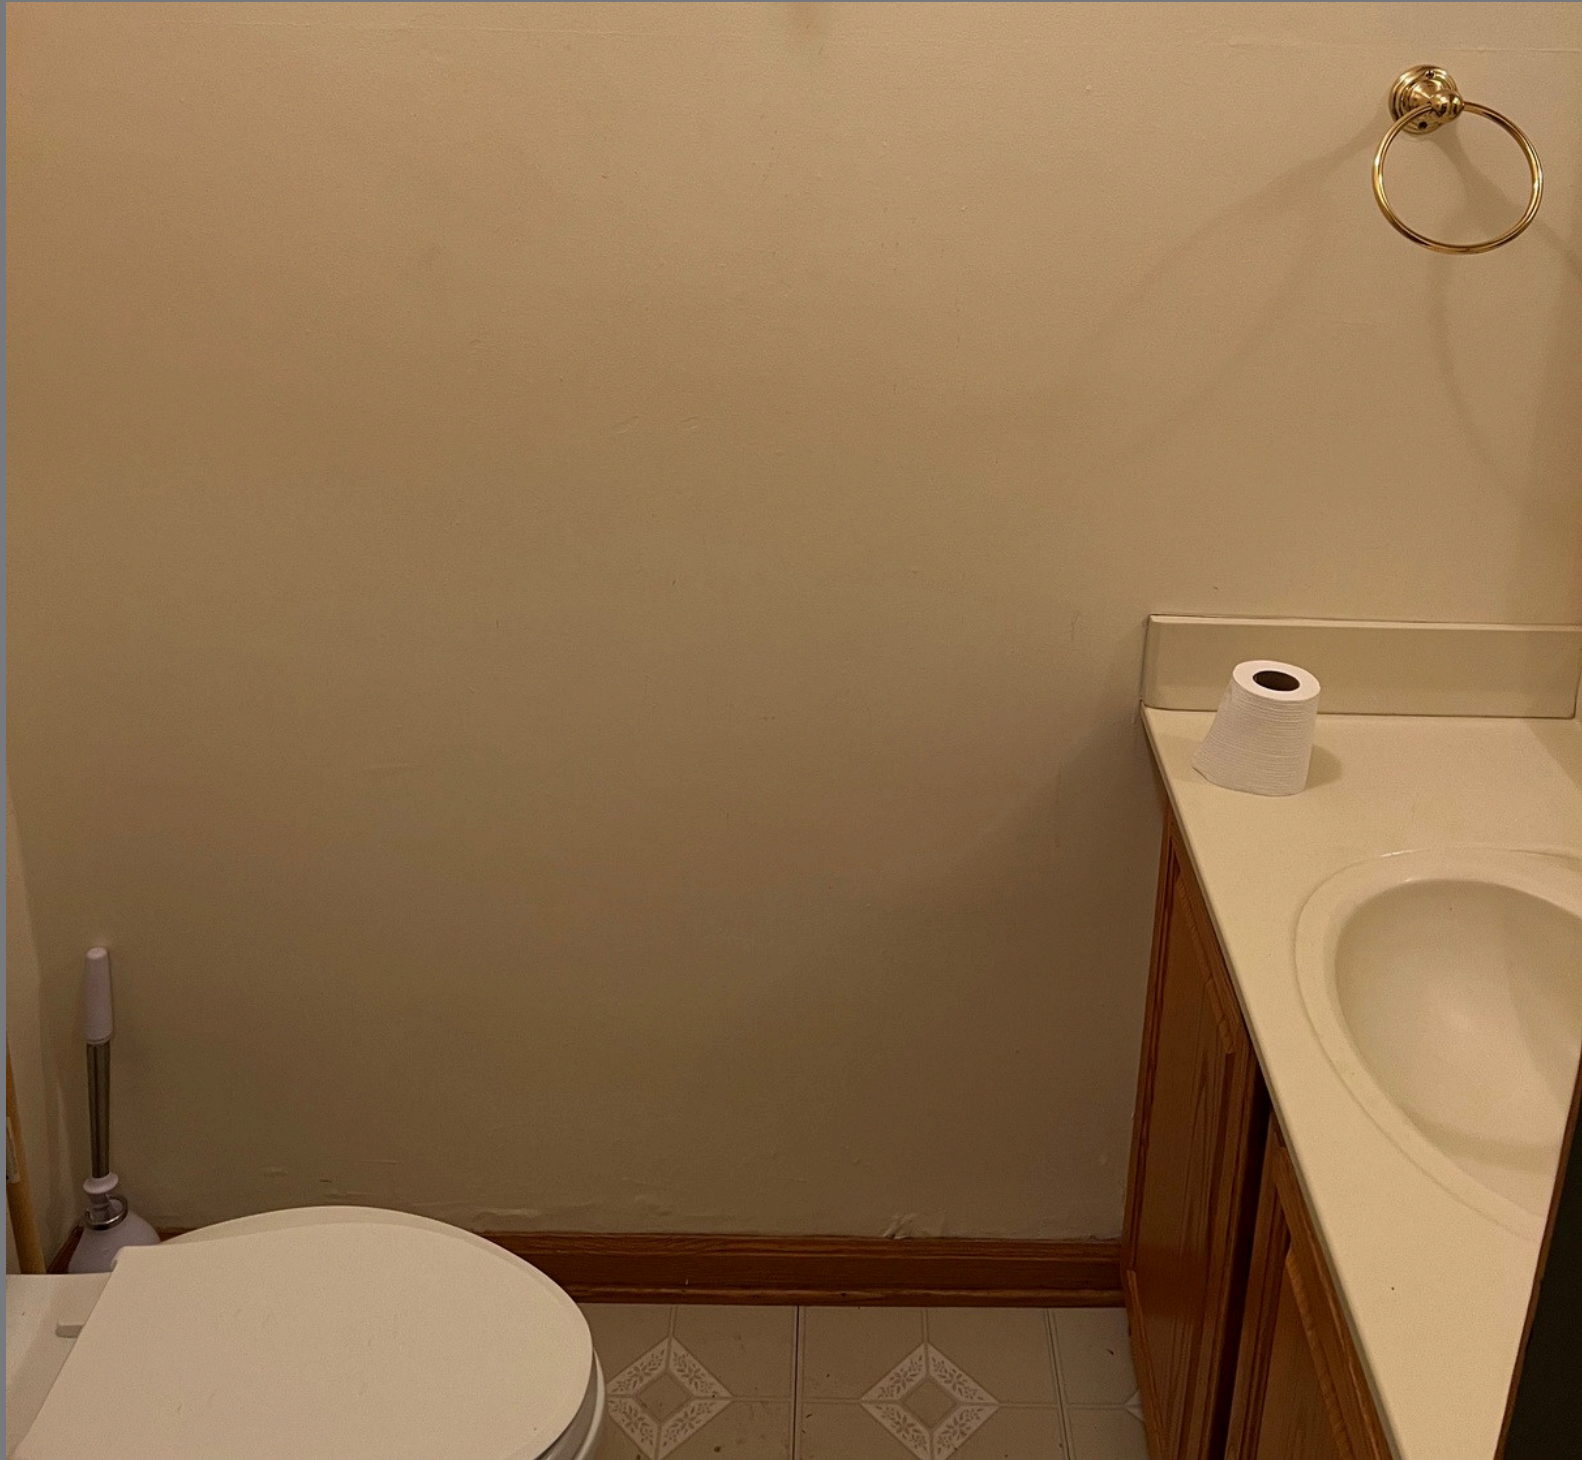
**Bathroom is too narrow and not ADA compliant .**

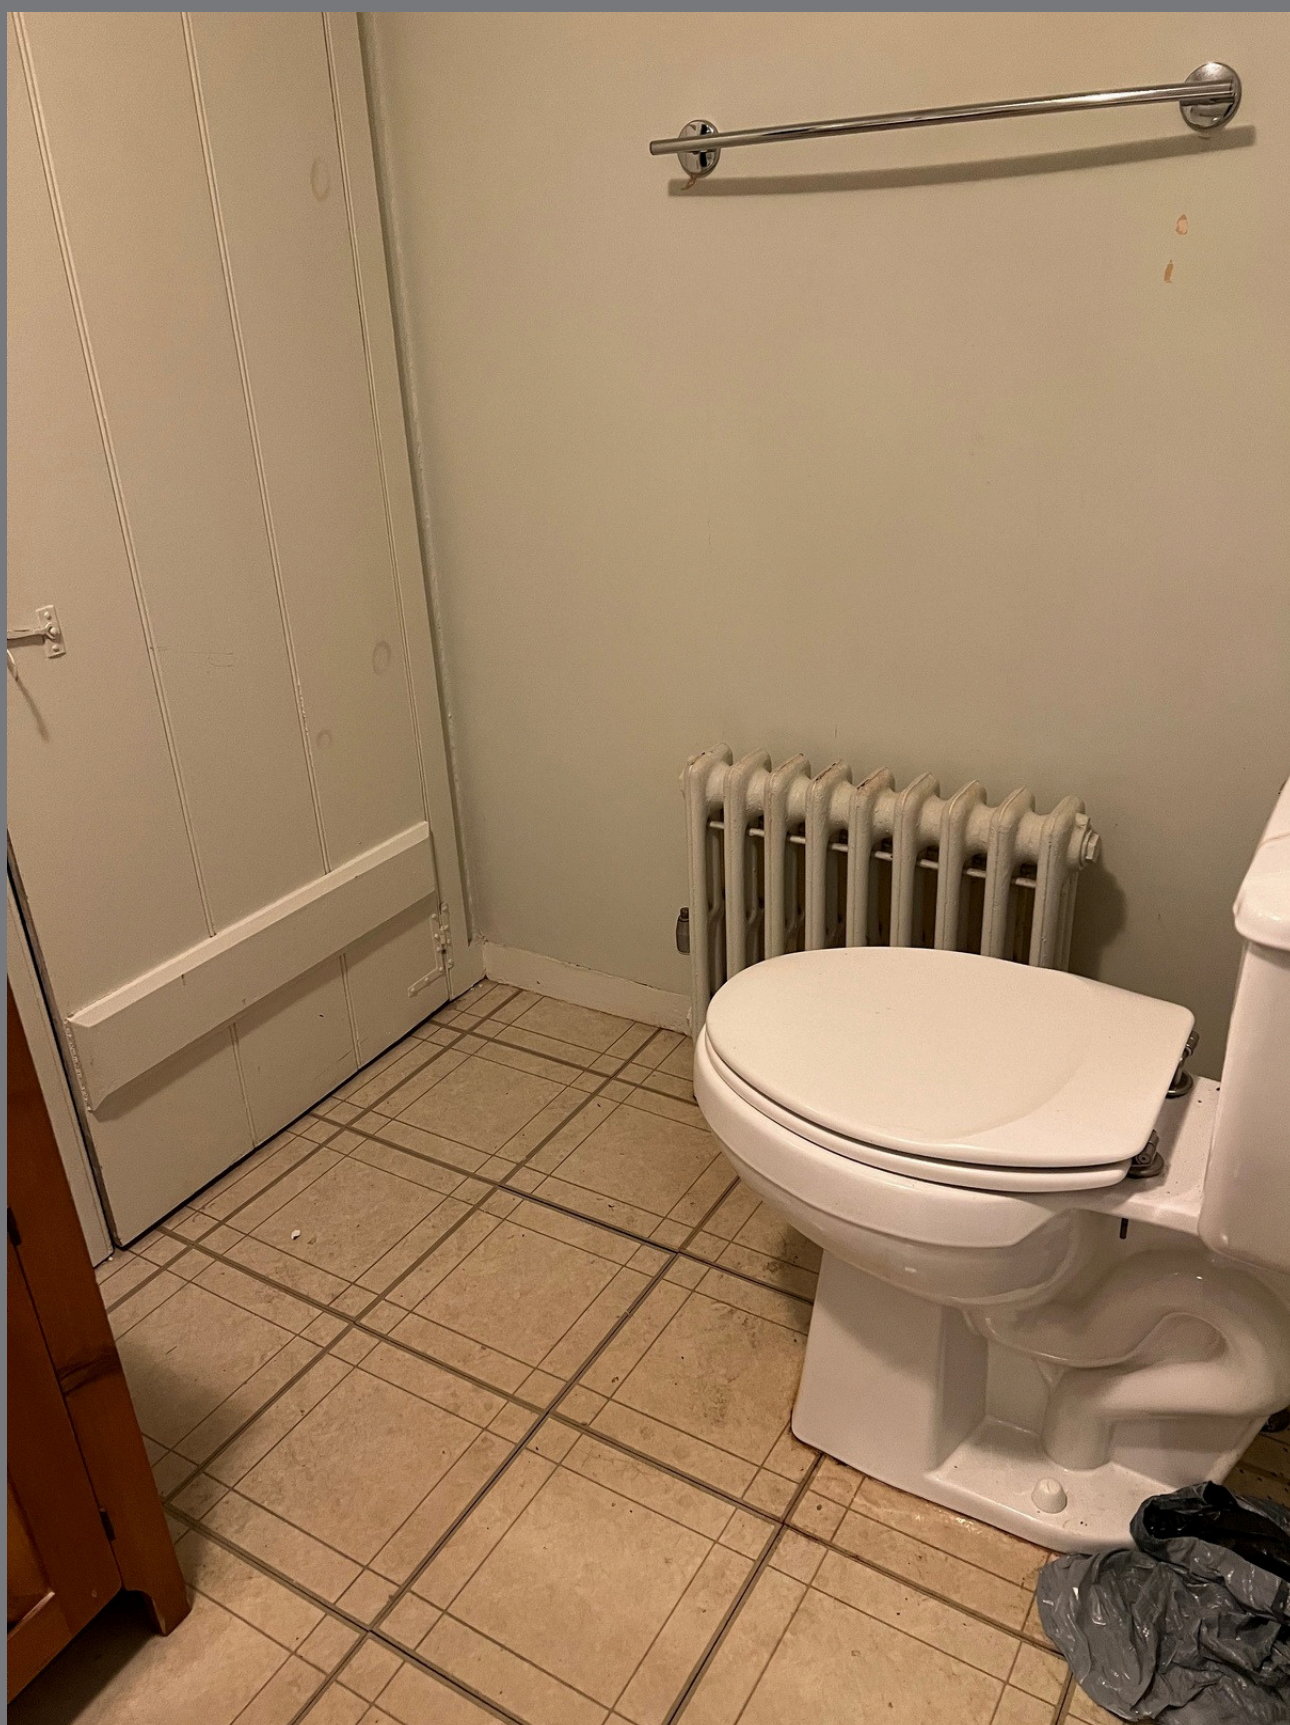
**Bathroom is too small for the average sized person.**

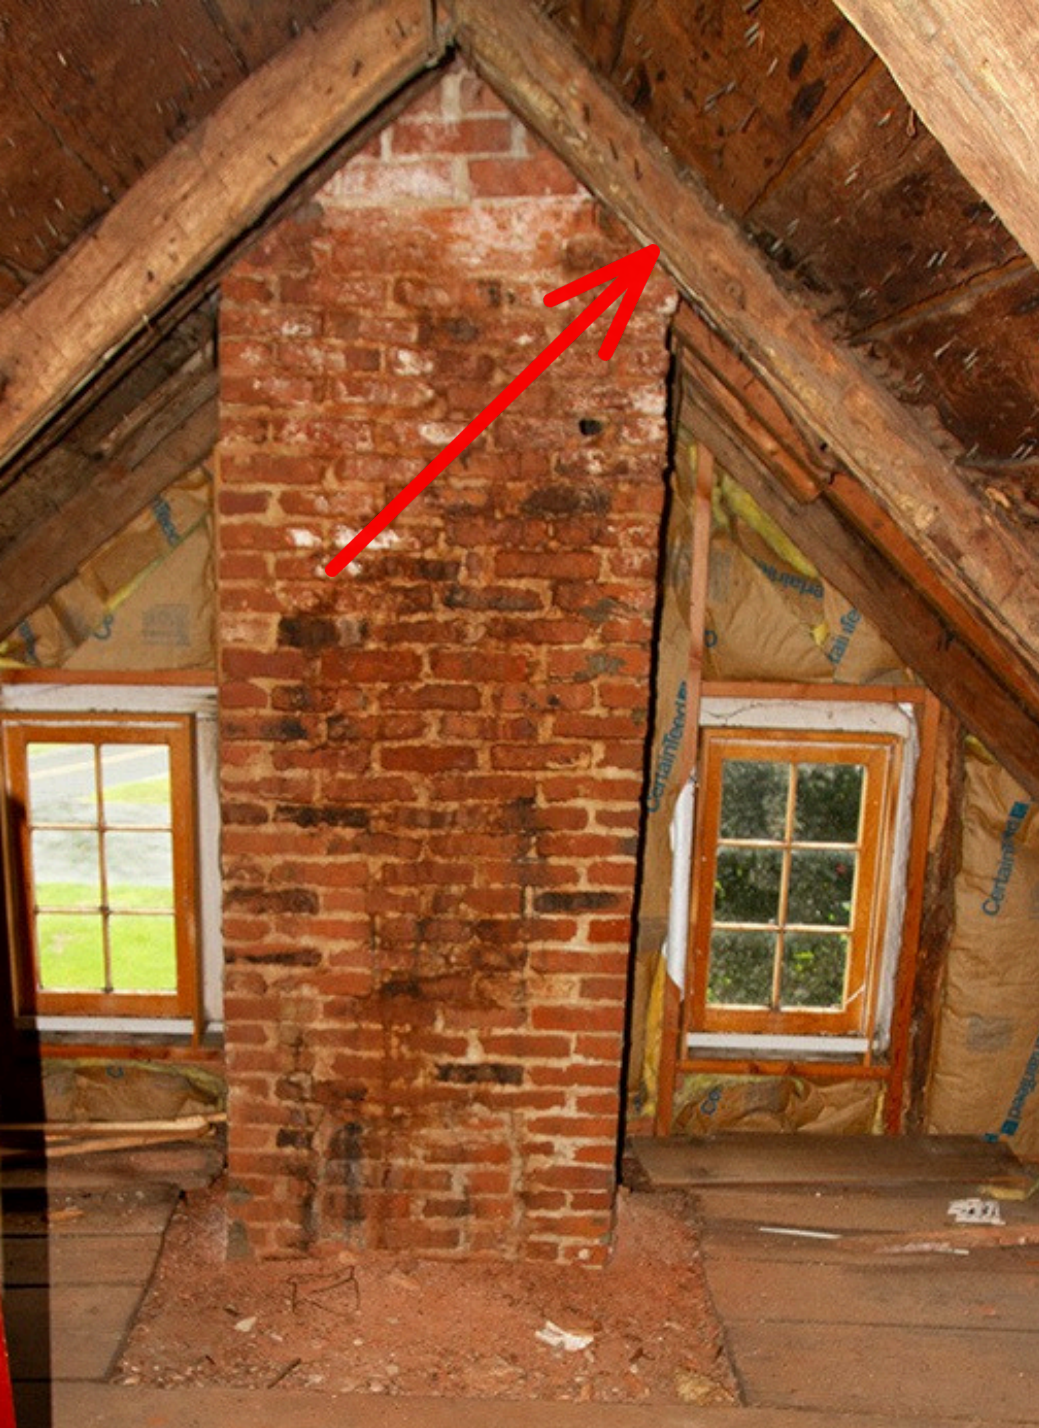
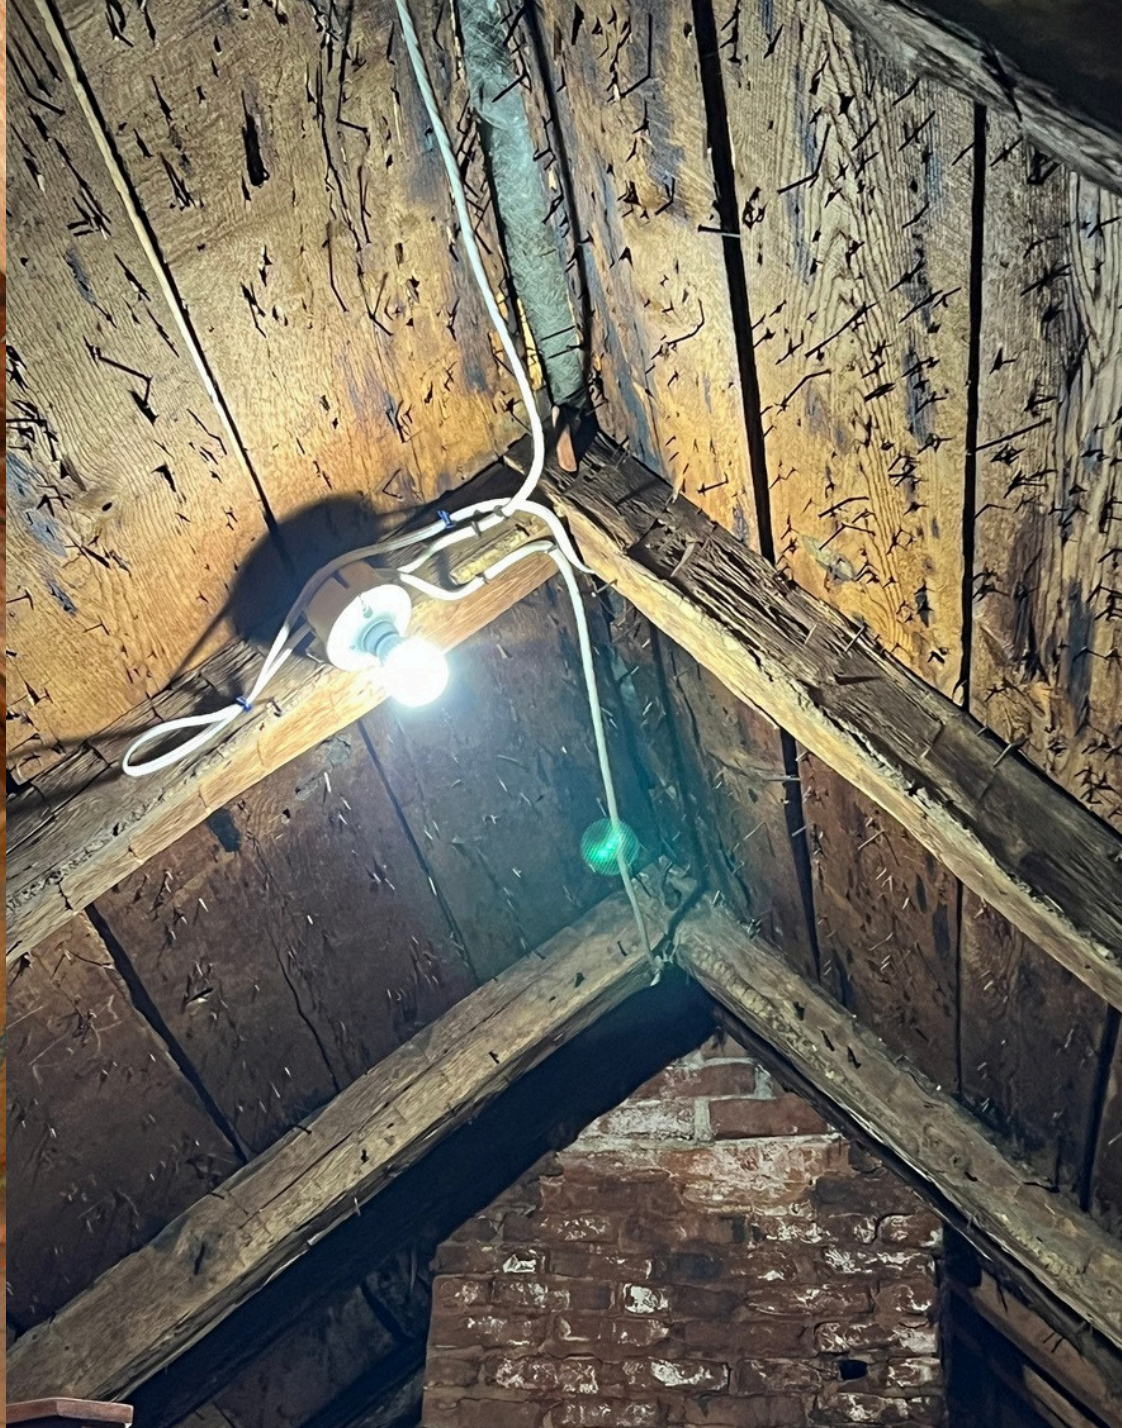
There are loose and missing bricks on the exterior.

Excessive nailing in the roof has compromised the sheathing making the roof vulnerable to leaks.

This is the reason why the rectory will be uninsurable.
