St Francis Xavier Rectory Update

Summary of observations of the
Rectory at 26 Chestnut Land
Road, New Milford

St Francis Xavier Parish Rectory

- 26 Chestnut Land Road, New Milford
- Built in 1810; 3900 square feet
- Not on New Milford Historical Registry

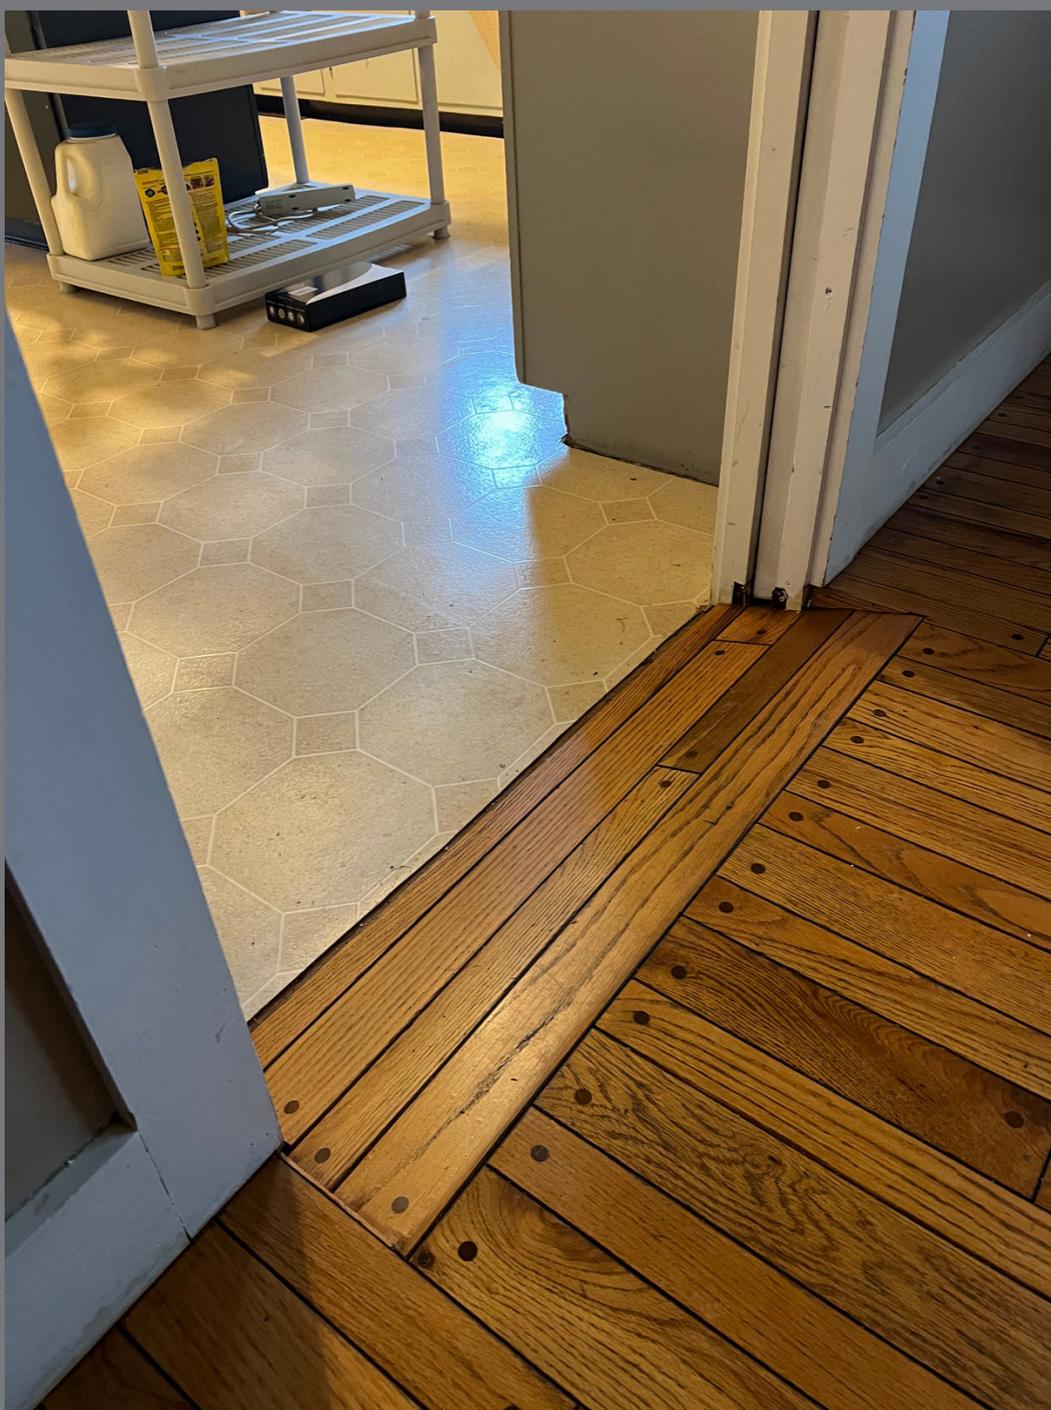
Floor surface is uneven contributing to tripping and falling hazard.

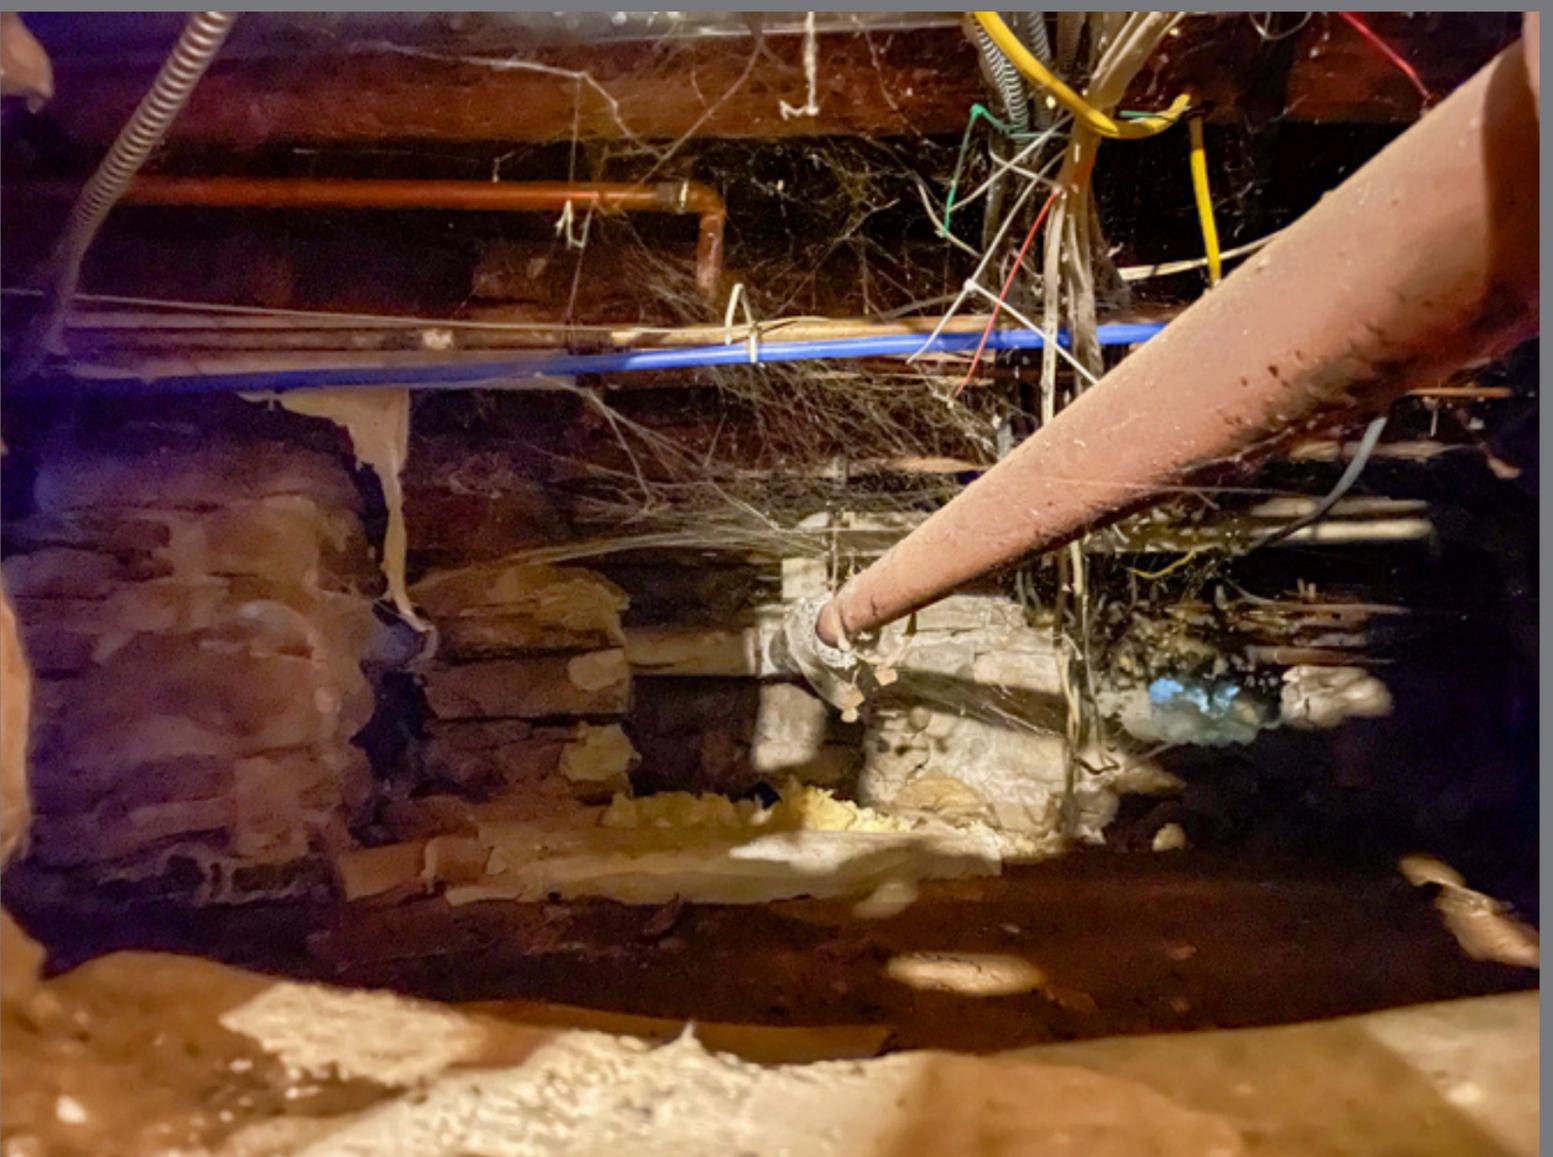
The kitchen porch deck addition built over a crawlspace and has several roof styles creating potential ice buildup and roof leaks.

The crawlspace has rodent infestation.
